14-16MY Highlander POST C/M Trailing Arm Noise

14-16MY Highlander

POST TSB Rear Trailing Arm Noise.

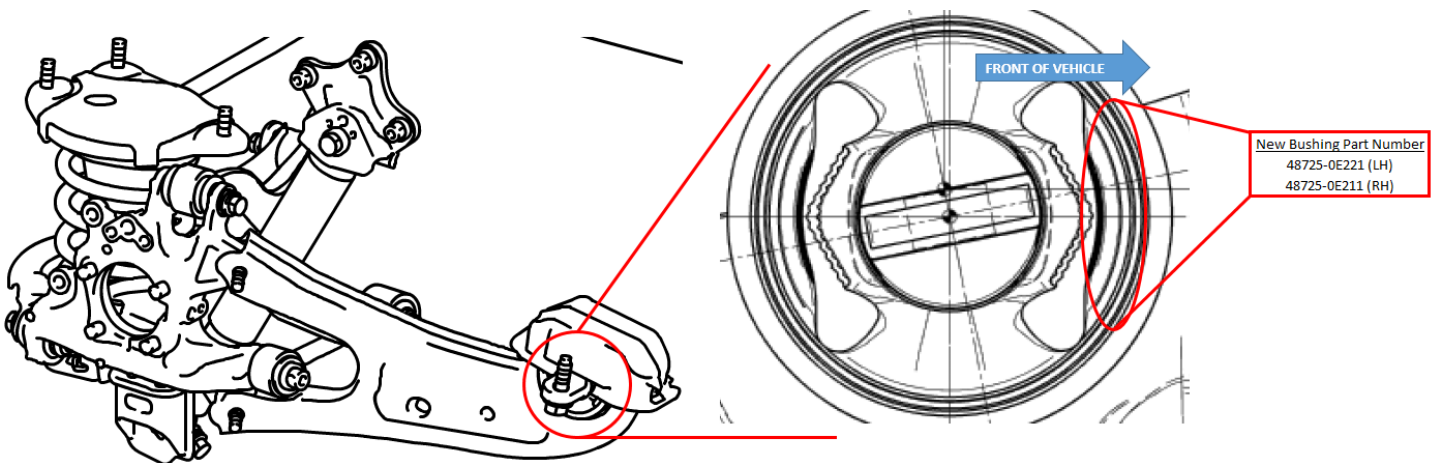
New Bushing Part Number
48725-0E221 (LH)
48725-0E211 (RH)
