MIL "ON" DTC P0401 and/or Rattle After Cold Soak

YEAR(S)	MODEL(S)	ADDITIONAL INFORMATION
2011 - 2012	CT200H

The information contained in this bulletin supersedes SB No. L-SB-0028-13.

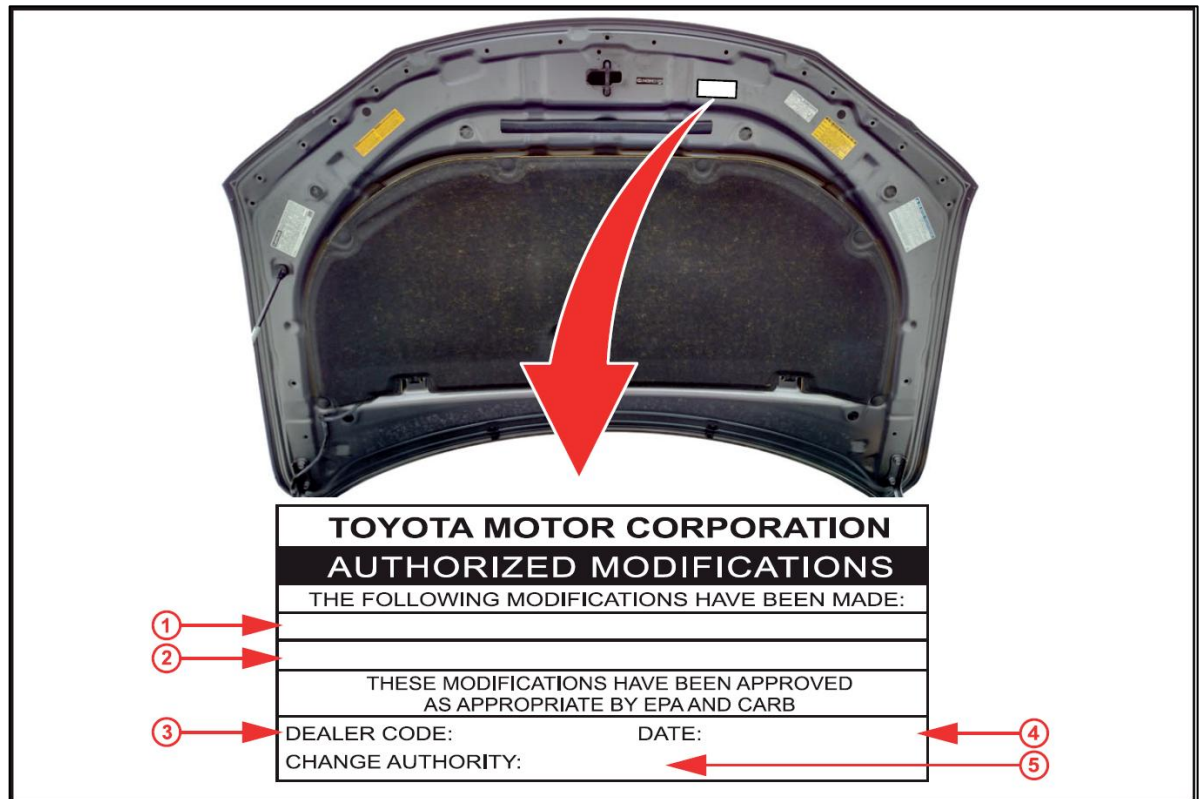
Figure 4. Location of Authorized Modification label for 2011 - 2012 CT 200h.

- Check for the Authorized Modifications Label affixed to the vehicle in the location shown in Figure 4 below. Confirm if the ECM (PCM) calibration has been updated. If the calibration ID listed is NOT the latest ECM (PCM) calibration — go to step 5. If the calibration ID is the latest, go to step 7.

6. Install the Authorized Modifications Label.
 - A. Using a permanent marker, enter the following information on the label:
 - ECM part number [*Refer to the **Parts Information** section for the **NEW PART NUMBER***]
 - Calibration ID(s) [*Refer to the **Calibration Information** section for the **NEW CALIBRATION***]
 - Dealer Code
 - Repair Date
 - Change Authority [**This bulletin number**]
 - B. Affix the Authorized Modifications Label to the vehicle at the location shown in Figure 4. The Lexus Authorized Modifications Label is available through the MDC, 00451-00001-LBL.
7. Confirm the repair.
