Service Bulletin

Bulletin No.: 17-NA-172

Subject: Rear Suspension Sagging or Sitting Low, Vehicle Not Level After Sitting Overnight

Brand:	Model:	Model Year:		VIN:		Engine:	Transmission:
		from	to	from	to		
Cadillac	XTS	2013	2018			All	All

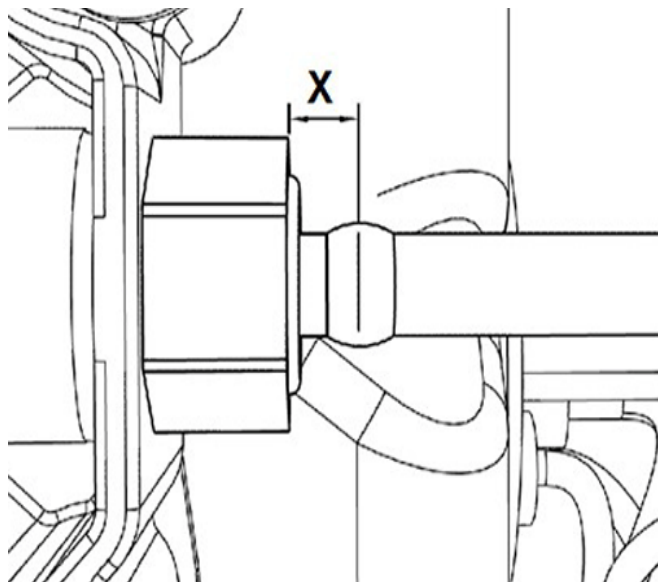
4799440

The air suspension system is very robust and if a vehicle is reported to have an air suspension failure in the first 5000 miles (8000 km), it is likely that the airline connections at the air springs were assembled incorrectly during the manufacturing process. The design of the airline does not allow for it to be partially inserted. It will either be fully seated or sitting loose in the fitting. There should be about 3-4 mm from the face of the valve to the notch in the airline (Dimension X above).
