Service Bulletin

Bulletin No.: 17-NA-334

Subject: Information on Diesel Engine Soot Deposits at the Variable Turbine Geometry (VGT) Pin

Brand:	Model:	Model Year:		VIN:		Engine:	Transmission:
		from	to	from	to		
Chevrolet	Cruze (Gen II - VIN B)	2017	2018			Diesel (RPO LH7)	
	Equinox						
GMC	Terrain	2018	2018

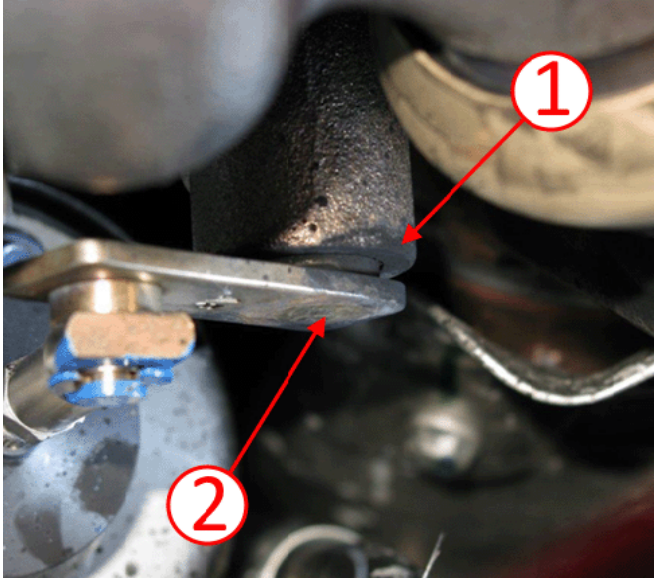
<p style="text-align: right; font-size: small;">4879702</p> <p>Some customers may comment that combustion deposits or soot (1) can be seen coming from the Turbo Actuator Pin/Arm (2).</p>
Information	<p>This is normal operation and will not affect the function of the Turbocharger. There is a small gap between the seal and the shaft to allow for proper rotation.</p> <p>Do Not replace the Turbocharger.</p>
