# Service Bulletin

**Subject:** Inspection and Repair Guidelines for Dust Intrusion into Passenger Compartment

**Models:** 2010-2013 Chevrolet Equinox  
2010-2013 GMC Terrain

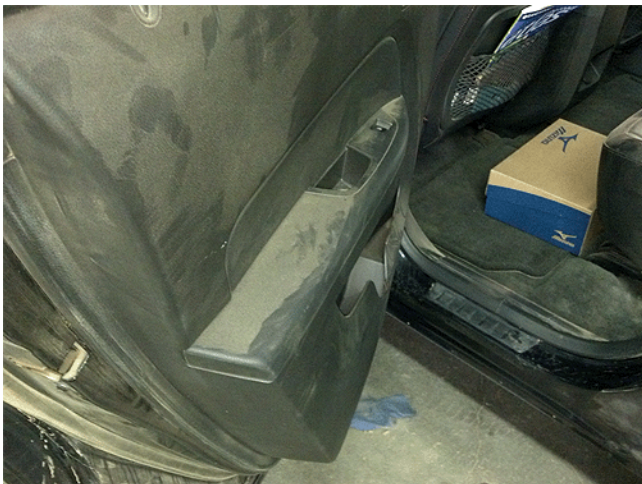
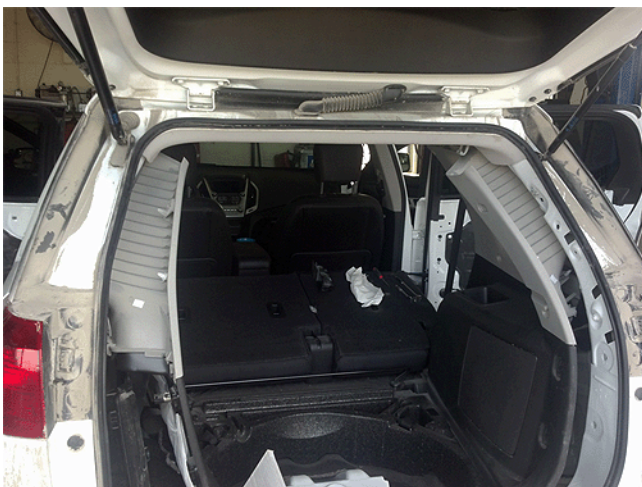
Some customers may comment that excessive dust is entering into the passenger compartment through the side doors or rear liftgate areas. This is usually found to occur when the vehicle is driven in high dust areas. Examples of this condition are shown in the graphics below.

The cause of this condition may be that the dust/debris is working past the side door or liftgate sealing surfaces.

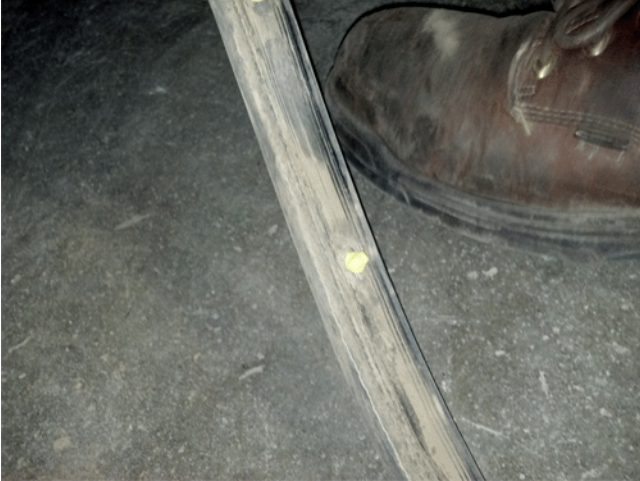
**Note:** A vehicle will sometimes show evidence of dirt/dust being pulled past the backside of the rocker moldings as shown above. A double sided tape is added to the moldings to help eliminate this condition.
