Service Bulletin

PRELIMINARY INFORMATION

Subject: Malfunction Indicator Lamp (MIL) On, Poor Acceleration, Throttle Body Freezing, Multiple DTCs Set, Ice Deposits and/or Oil Deposits Present in Air inlet Duct

Models: 2008-2011 Buick Enclave
2007-2011 Chevrolet Malibu
2009-2011 Chevrolet Traverse
2007-2011 GMC Acadia
2007-2010 Pontiac G6
2007-2010 Saturn OUTLOOK
Equipped with 3.6L Engine (RPOs LY7, LLT)

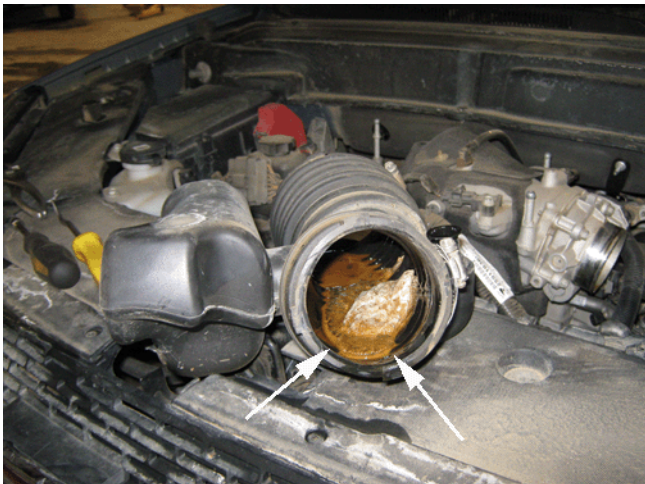
Technicians may find DTC s P0101, P0171, P0172, P0174, P0175, P1516, P2177, P2178, P2179, P2180, P2187, P2188, P2189 and/or P2190 along with either ice or oil deposits in the air inlet duct.

Ice formation is caused by condensation freezing at the base of the throttle body with additional collection of ice formation deposits in the air inlet duct. Freezing condensation forms after the vehicle has been driven and then parked in low ambient temperatures.

Oil deposits are the collection of the engine vapors, fuel dilution and oil mist at the base of the throttle body with additional formation collecting in the duct.

1. Remove both camshaft covers for servicing of the PCV system. Refer to Camshaft Cover Replacement Left and Right Side in SI.
2. Clean the PCV orifice with low VOC brake cleaner. Allow to air dry with compressed shop air.
3. Replace the bank1 camshaft cover gasket.
4. Reassemble the bank1 camshaft cover.
Tighten: Tighten the camshaft cover bolts to 10♦Y (89♦lb♦in).
5. Replace the bank2 camshaft cover and replace the camshaft cover gasket.
6. Reassemble the bank2 camshaft cover.
Tighten: Tighten the camshaft cover bolts to 10♦Y (89♦lb♦in).
7. Install the insulated PCV tube.
