Technical Service Bulletin

Mazda North American Operations
Irvine, CA 92618-2922

Subject: CONDENSATION / FOG IN FRONT AND REAR COMBINATION LAMPS (HEADLAMP AND TAILLAMP ASSEMBLIES)	Bulletin No.: 09-011/18
	Last Issued: 03/22/2018

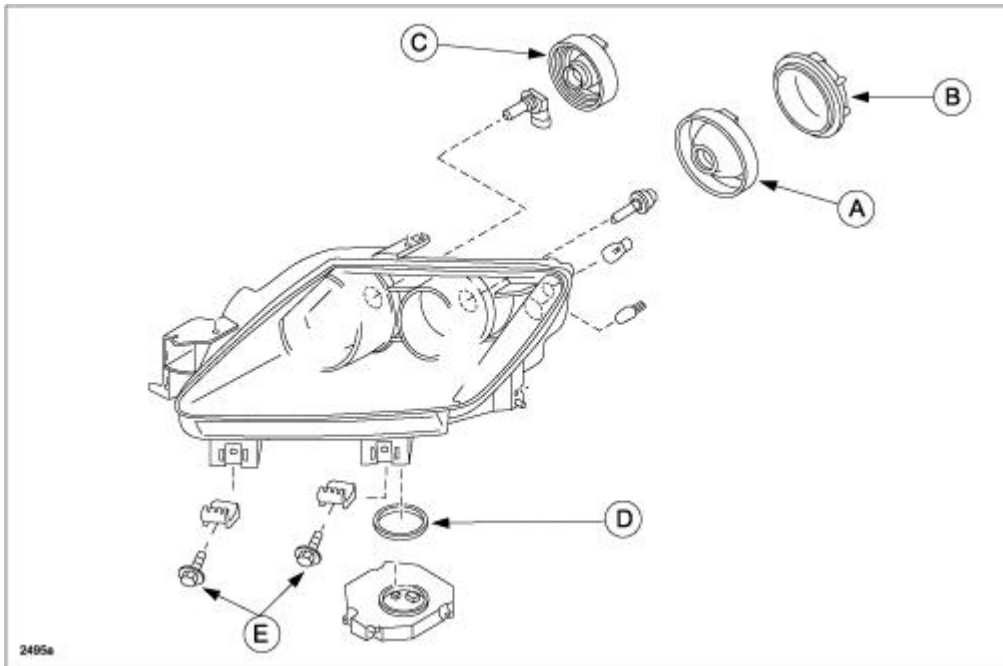
When dealing with customer complaints of excessive condensation and/or water within the headlamp unit, first determine if all the bulb sockets (including O-ring), seals and covers are present and correctly installed. In most cases you will find that the Bulb Seal No. 1 (A) or HID Bulb Seal No. 1 (B) and Bulb Seal No. 2 (C) socket covers have not been correctly installed or are missing due to improper prior repairs (i.e., customer replacing the headlamp bulbs or body shop not transferring them when replacing the headlamp unit(s) due to a collision). Any damage caused by missing socket covers, HID module seal (D), or missing bumper brackets (E) is not covered by warranty policy. If none of these issues exists, explain to the customer that this is a natural phenomenon and not a quality defect. DO NOT attempt repairs as this is considered normal, and is NOT covered under Warranty. Replacing the light unit will not correct this symptom.

NOTE: LED headlamp assembly with LED turn signal lamp replacement part include seals. Seal transfer is not required.

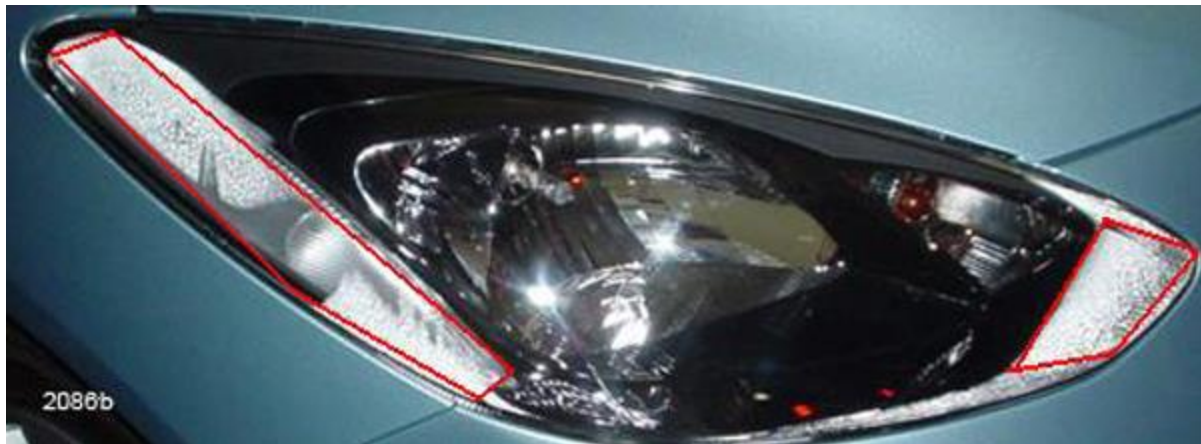
Condensation/fogging along the edges and in the corners is considered normal.

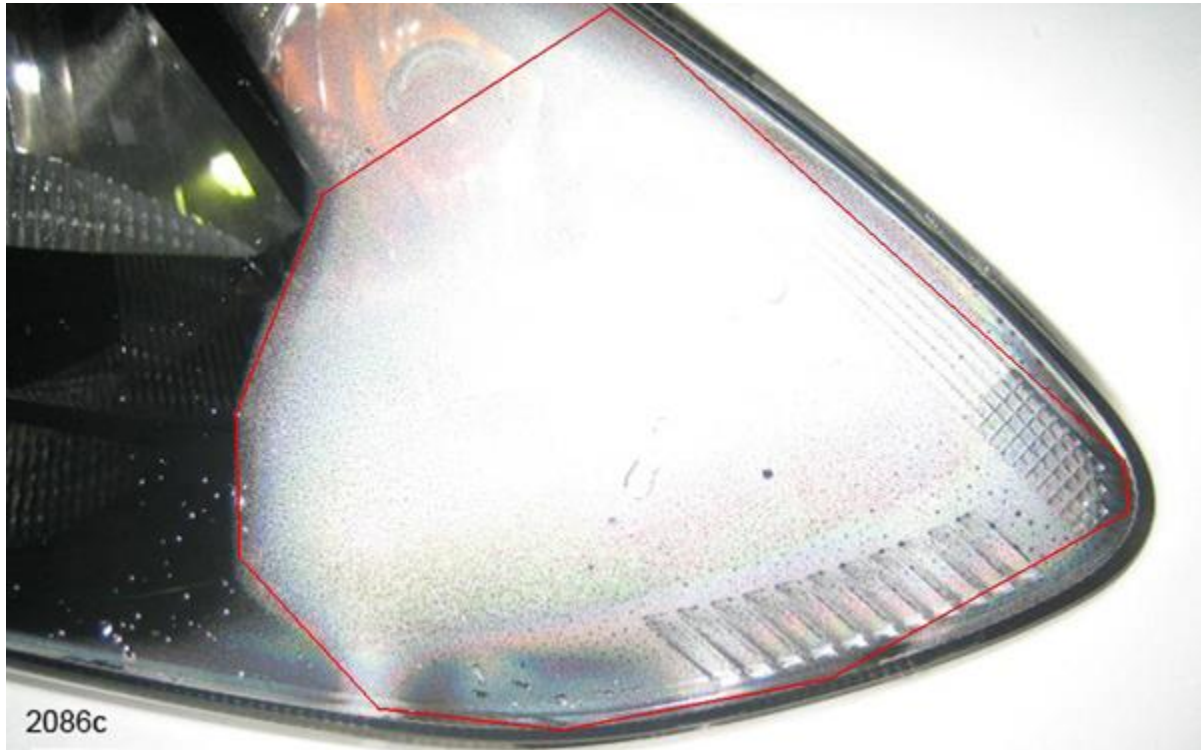
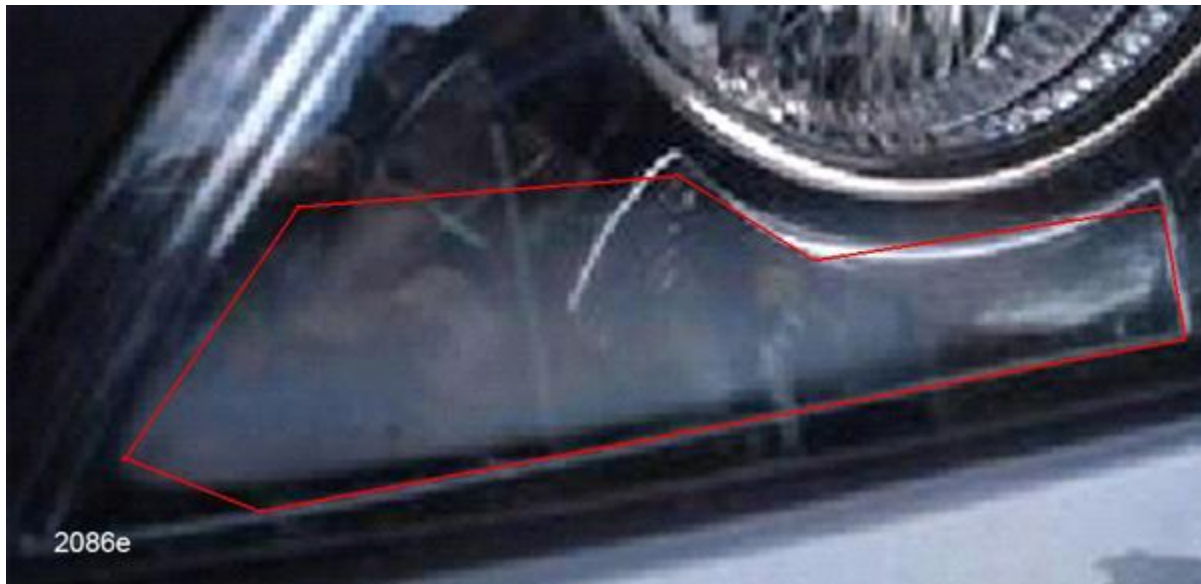
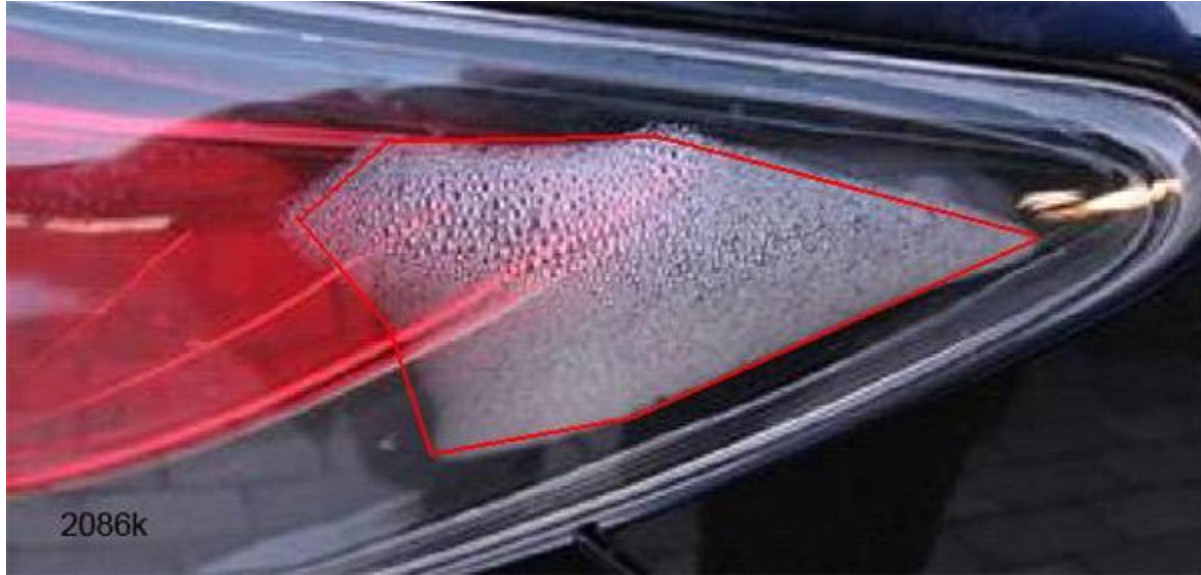
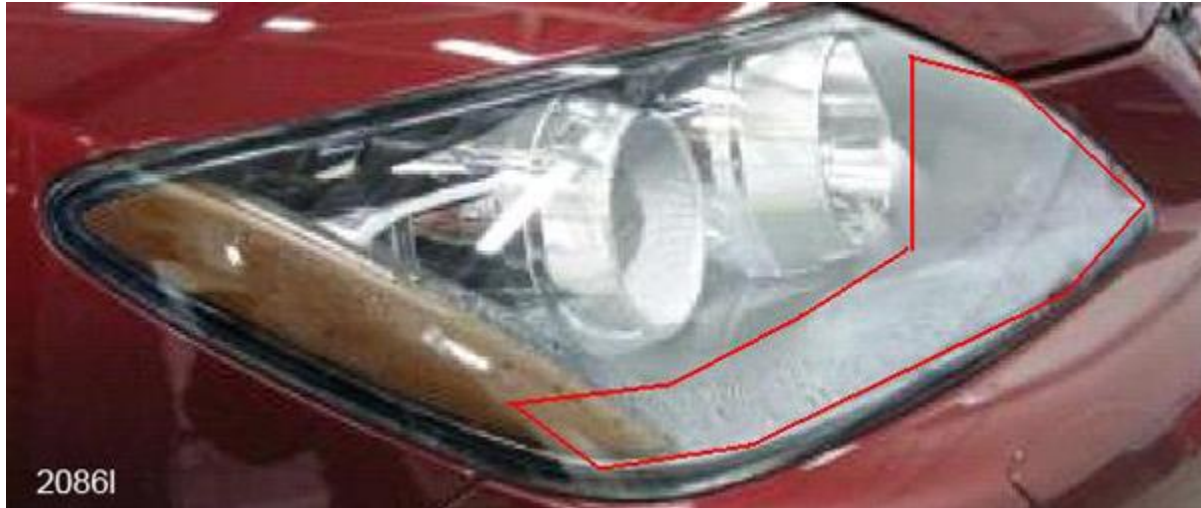
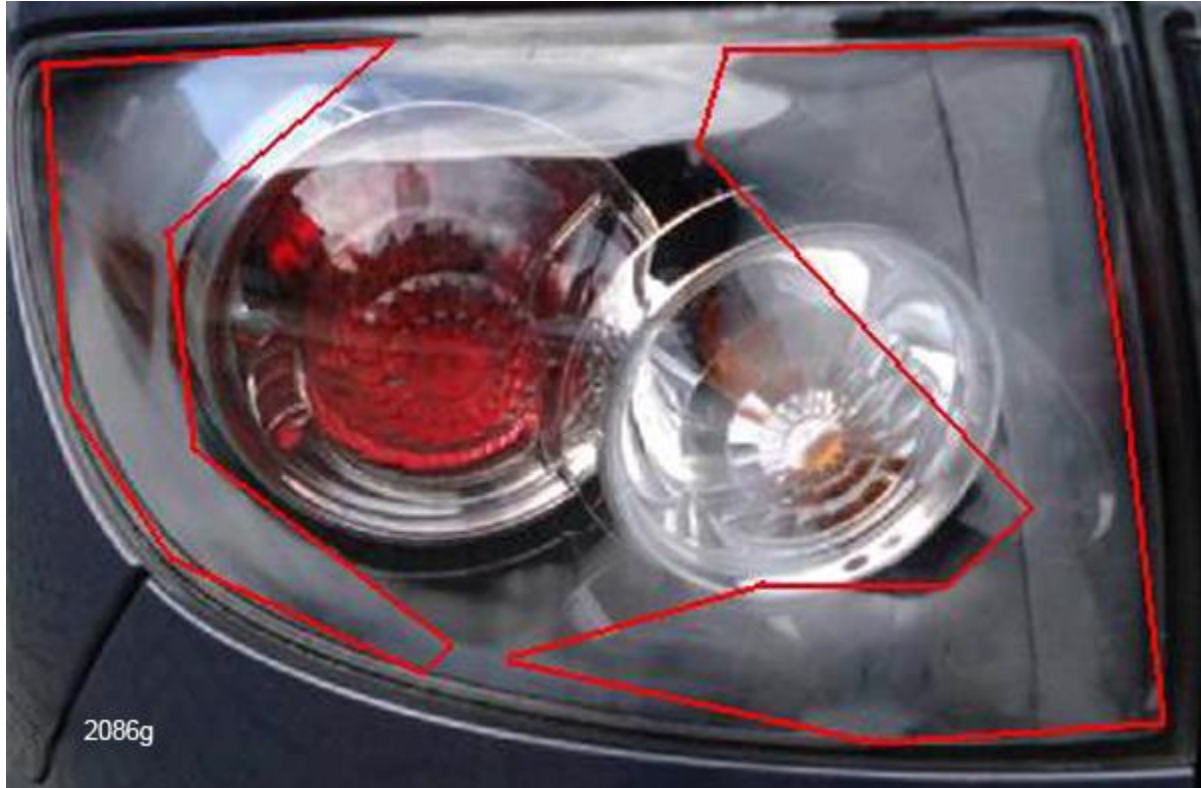
Examples of Light Units With Condensation/Fog That Should NOT Be Replaced

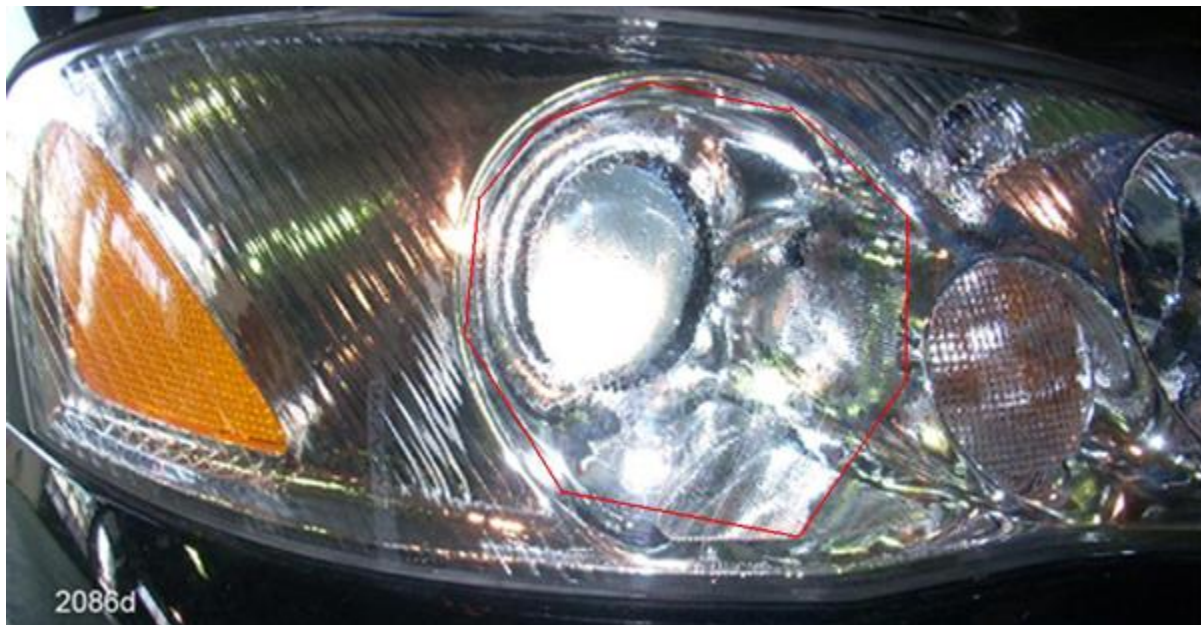
Some condensation/fogging on the lens is considered normal.

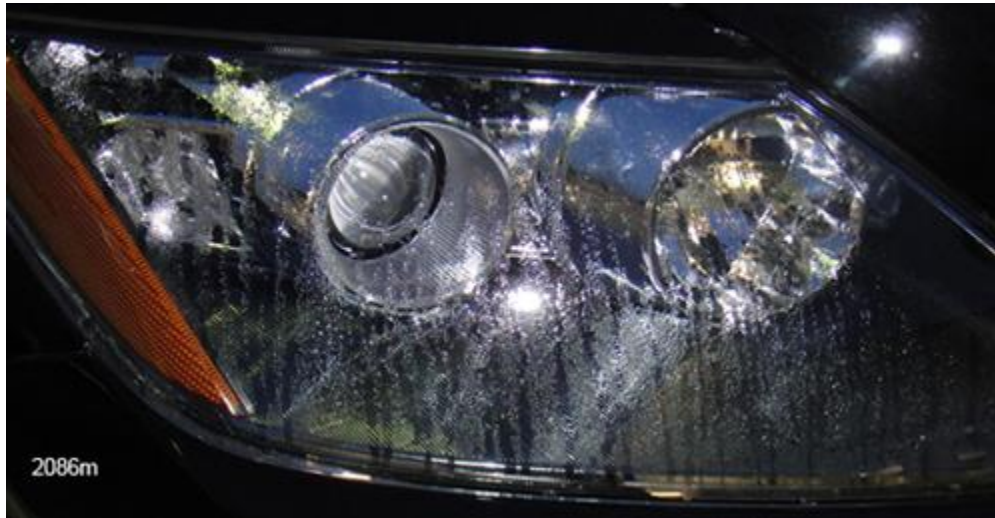
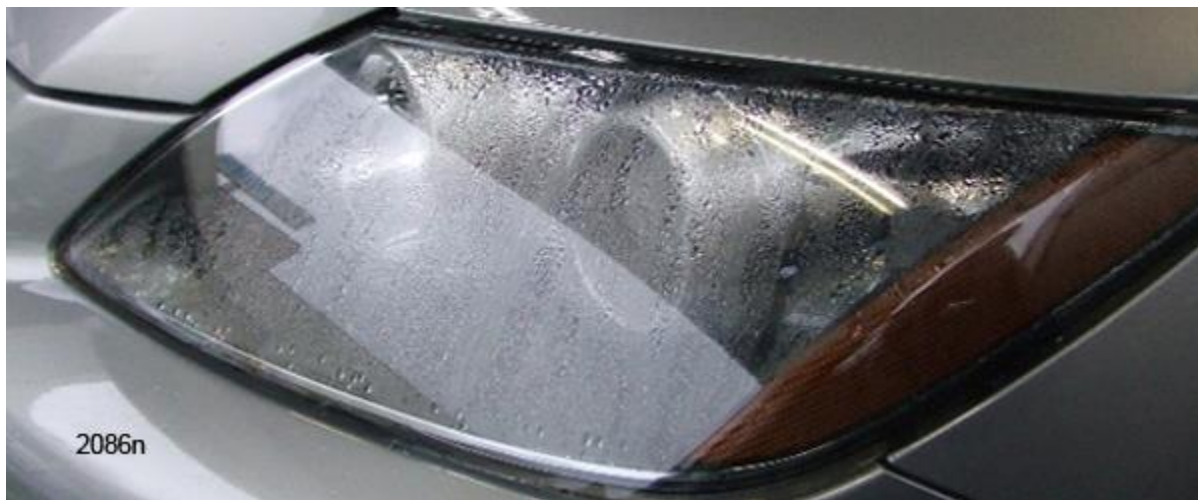
Heavy/large amount of condensation on the lens is not normal.

- The location where the bulbs are fitted has a high air volume with good air circulation, therefore, if a large or heavy amount of condensation appears here, the light unit should be replaced. A small amount of condensation here is considered normal and should clear after the lights have been on for some time and the light unit should not be replaced. Refer to the following pictures for examples.
- If the outside conditions are unfavorable (cold and damp), even fog (dew concentration) as shown in the following pictures will take some time to clear up. Therefore, be careful in making a decision. A picture will be required with every claim for Warranty. If a light unit is found with no problem, and no picture is sent in, the claim may be later debited. You can also perform the following test to determine if the light unit should be replaced.
