Service Bulletin

SUBJECT: Special Coverage Adjustment – Unable to Remove Ignition Key

MODELS: 2005-2010 Chevrolet Cobalt
2006-2011 Chevrolet HHR
2006-2010 Pontiac Solstice
2007-2010 Pontiac G5
2005-2006 Pontiac G4/Pursuit
2007-2010 Saturn Sky
2003-2007 Saturn Ion
Equipped with Automatic Transmission

Subject: 14632A – Special Coverage Adjustment
Unable to Remove Ignition Key
Part Information Revised

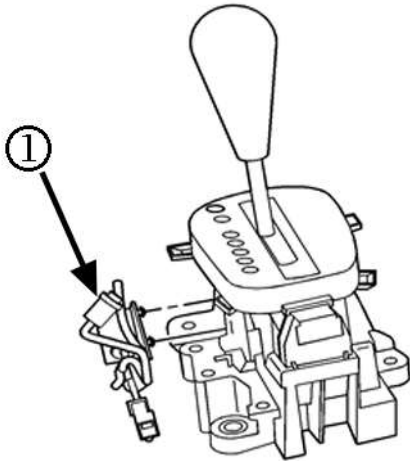
4043711

Important: For Ion models only, refer to *Diagnostic Starting Point - Automatic Transmission Shift Lock Control* and as necessary, *Shift Lock Control Solenoid (1) Replacement* in SI.
