Title (customer effect) Diagnostic Trouble Codes (DTC) P2080, P2084, P242B Lighting The Malfunction Indicator Lamp (MIL) - **US14+OBD13 And OBD15 Emissions (Commonly Model Years 2015 And 2016)**

Cause Diagnostic Trouble Codes (DTC) P2080, P2084, P242B can set due to incorrect calculation of " soak " time of ambient temperature after key off.

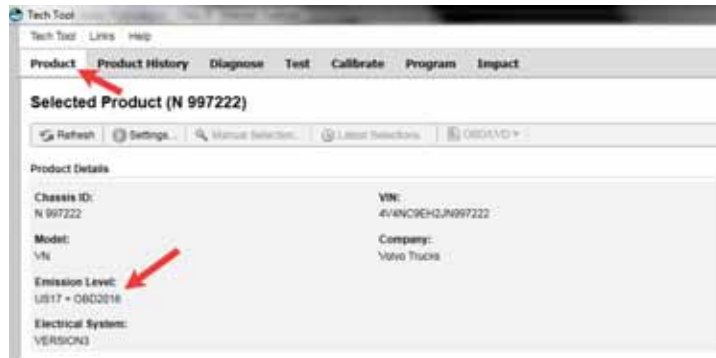
- Verify the chassis emissions level

- Details can be found in the Product Details box on the Product tab in PTT as seen below:

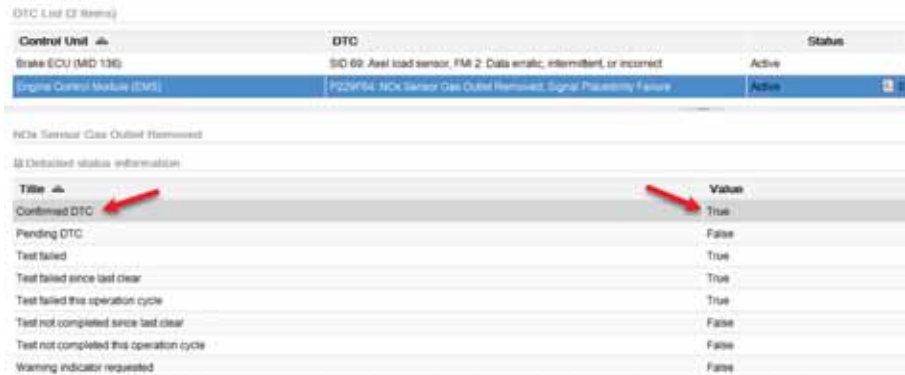
- Review the Detailed Status Information for the relevant code on the DTC Readout.

- If Confirmed DTC is **TRUE**: Proceed with diagnostics
- If Confirmed DTC is **FALSE**: Disregard and focus on other symptoms or DTCs relevant to the complaint.
