Audio 20: Surround sound setting with sound system (code 810) is not stored after an ignition cycle

Topic number	LI82.60-P-067426
Version	1
Function group	82.60 Radio, audio, video systems
Date	12-06-2017
Validity	MODEL 205, 253 with code: 520/522, 154, 810
Reason for change	
Reason for block

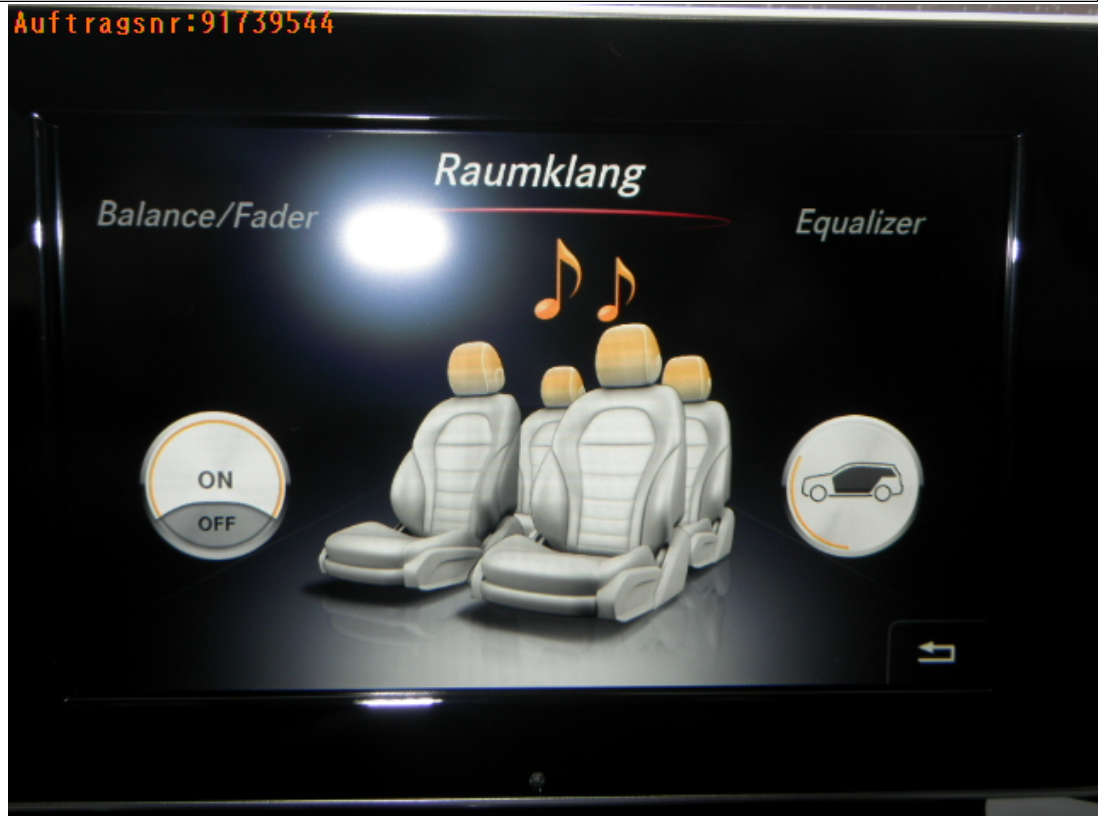
Raumklangeinstellung_zentral.jpg:

If a custom surround sound setting has been set, the central display shows the surround sound setting "Front" after an ignition cycle.

The surround sound setting is stored. The custom setting is shown incorrectly in the central display.

Possibly software release of Audio 20 control unit (A26/17).

Perform software update of Audio 20 control unit (A26/17) (the software is estimated to be available with Regio DVD 03/2018).
