LTB01148NAS1

# TECHNICAL BULLETIN

204-02: Rear suspension

Knocking Noise From The Rear Of The Vehicle

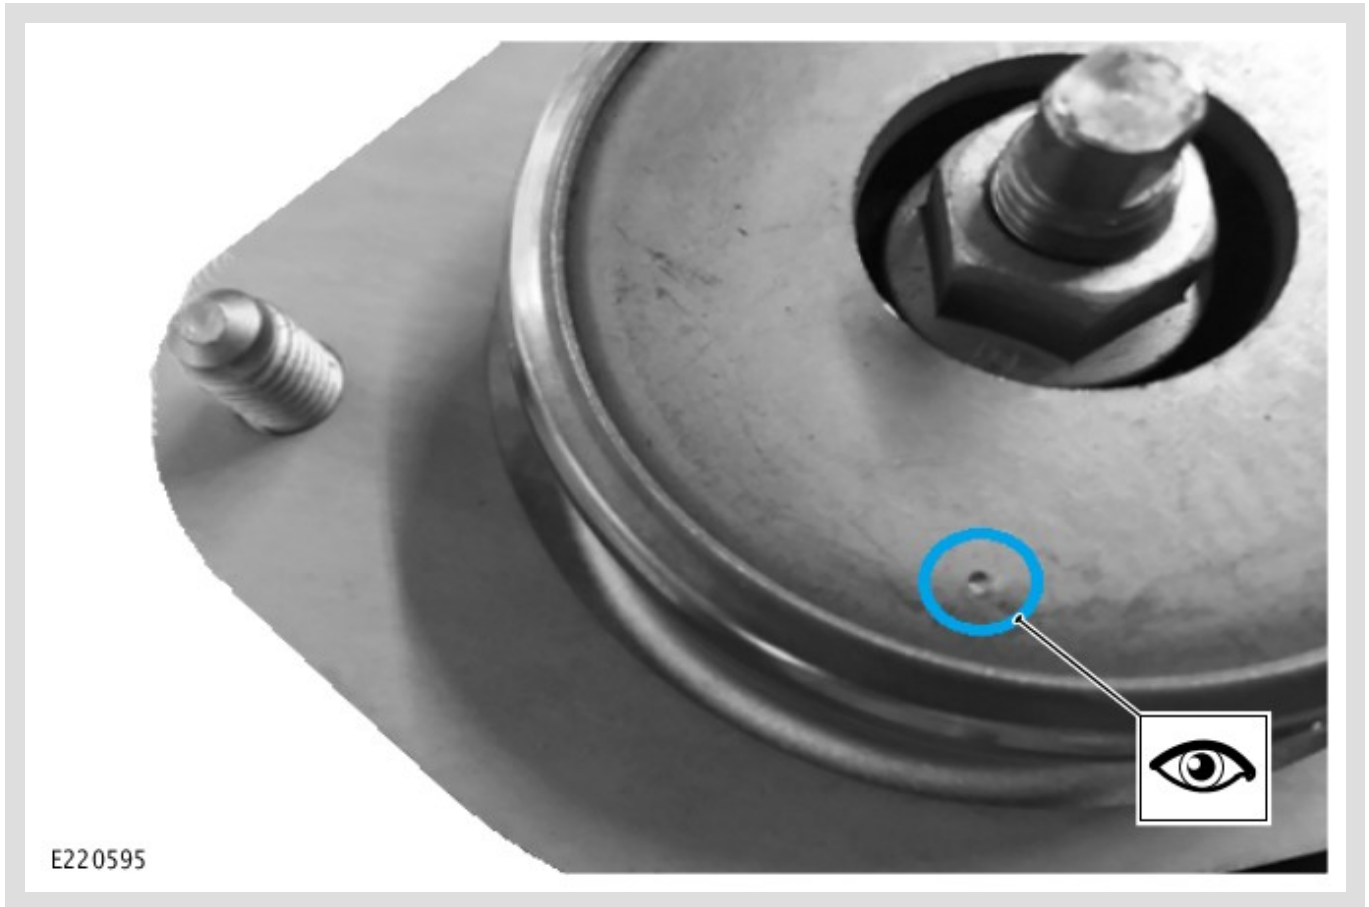
1

The new top mount should be identified with a 'dot' punch mark on the top plate.

Do not install a part that is not identified with a dot punch mark.
