# Service Alert

<b>Subject:</b> <b>CHECK ENGINE LIGHT ON WITH DTCs P2A04:00, P2272:00 AND/OR OTHER DTCs</b>	<b>Service Alert No.:</b> SA-004/18
	<b>Last Issued:</b> 02/06/2018

2007-2015 CX-9

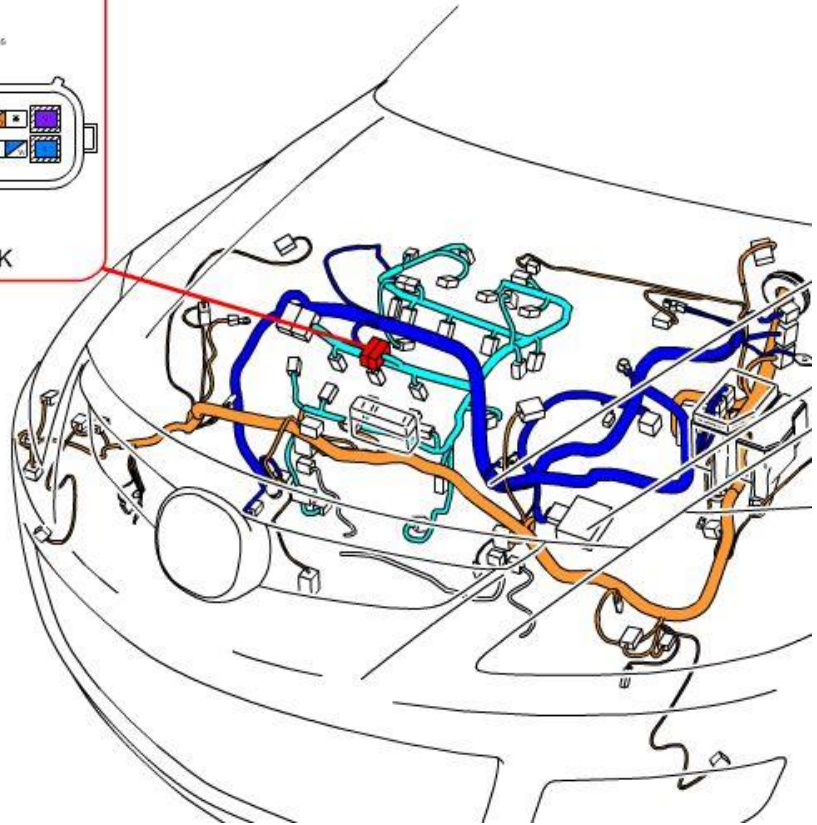
1. Verify the customer concern.
2. Inspect the C-34 connector (shown below) for engine oil contamination.

- If oil contamination is not present, this repair is not applicable. Diagnose DTCs according to the instructions on MGSS online.
  - If oil contamination is present in the C-34 connector, perform the following steps:
    - a. Inspect the engine oil pressure switch for external leaks.
    - b. If external leak is found, replace the engine oil pressure switch.
    - c. Clean the C-34 connector and harness of oil contamination, then go to step 3.
3. Inspect the related O2 sensors according to the instructions on MGSS online.
- If the related O2 sensors are operating correctly, go to step 4.
  - If the related O2 sensors are not operating correctly, replace the affected O2 sensor(s) according to the instructions on MGSS online, then go to step 4.
4. Clear DTC(s) and test drive to confirm repair.
