Subject: MULTI-MODEL - ELECTRICAL CONCERN AND/OR MULTIPLE DTC'S DUE TO AFTERMARKET DEVICE	M-Tips No.: MT-004/18
	Last Issued: 03/28/2018

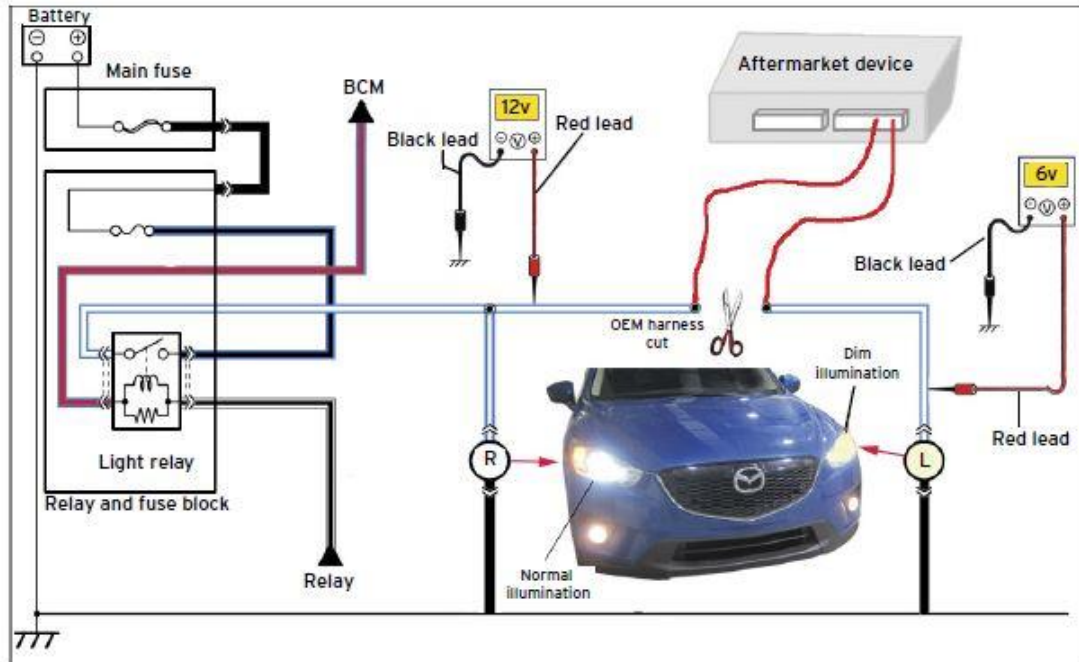
Example 2

Some aftermarket devices that are wired to the vehicles's wiring harness may create unusual electrical symptoms and/or store DTCs. Below is an example of a dim headlight. The aftermarket device changed the headlight circuit resistance, causing a dim headlight.
