JAGUAR LAND ROVER SHOP FOREMAN CONFERENCE CALL
MARCH 8, 2018

Safety Recalls N138 and H081

AJ20P 4 Cyl Gasoline Engines – Fuel Rail leaking

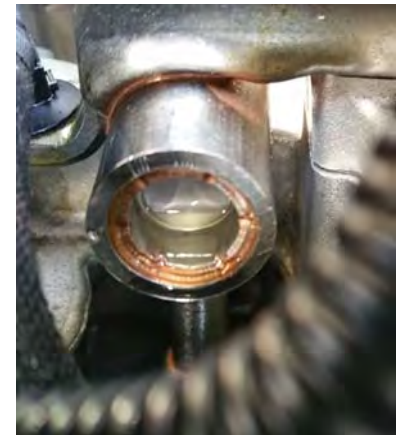
- Defect: The brazing of the engine fuel rail end caps is inconsistent and may not meet the design condition, thereby not sealing the fuel rail ends. Fuel vapor and liquid fuel leaks can occur over time.

- Prior to recall launch please submit EPQR's for any vehicle with a fuel rail leak and attach a short video clearly showing source of leak
- There are several reports of fuel leaks but there have been no reports of accidents, injuries or fires.

- Affected vehicles will need a replacement fuel rail plus 4 injector seal kits
- Parts and technical repair bulletins are expected to be available week of March 12th 2018. Initial parts shipments will be pushed to stores

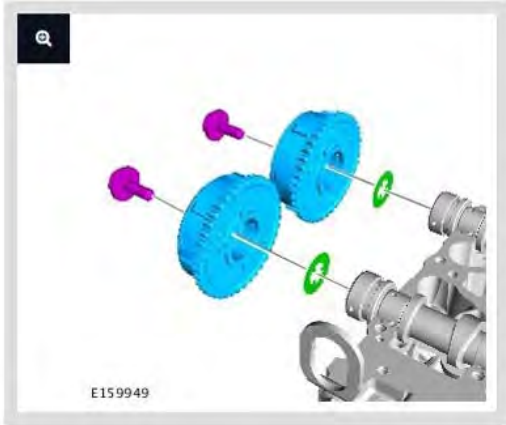
TOPIx Workshop Manual Section 303-01'X'

Vehicle	Customer Concern	Details and Status	Publication
Discovery Sport RR Evoque 18MY with Active Exhaust	A customer may complain of a Check Engine Lamp or Restricted Performance Message.	Diagnosis returns DTC P2170-11 "Exhaust Pressure Regulator Vent Solenoid Control Circuit Low - Circuit short to ground". If electrical circuit checks return no issue, place the active exhaust valve in the freezer for several hours then re-install and retest. If this allows for duplication of the fault, replace the valve and submit an EPQR with contact details so we can organize PRR of the original parts.	Under Investigation
Vehicles equipped with 2.0L GTDi Engines	Installation of Friction Washers after removal of VVT.	<p>Work instructions outlined in TOPIx reference installation of new friction washers. These friction washers are not installed during initial assembly of the engine, but MUST be added if service work is performed.</p> <div data-bbox="655 987 1157 1125" style="border: 1px solid #ccc; padding: 5px;"> <p>CAUTION:</p> <p>Make sure new washers are installed.</p> </div>

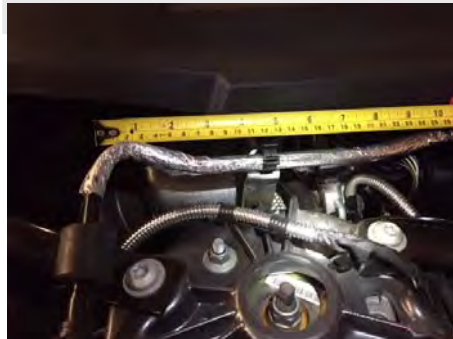
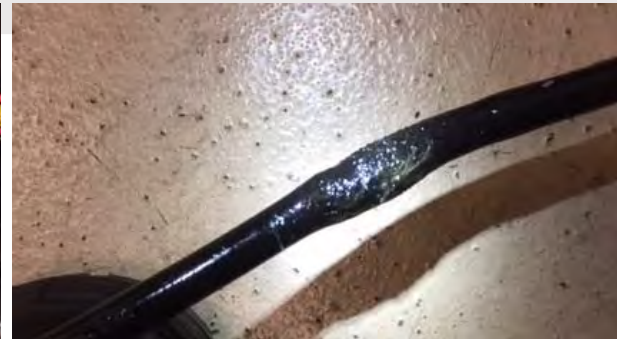
Vehicle	Customer Concern	Details and Status	Publication
Vehicles equipped with Flexray and 8HP Trans.	A customer may complain of a gearbox warning lamp, or restricted performance message.	Diagnosis finds DTC P0715-64 "Input/Turbine Shaft Speed Sensor "A" Circuit - Signal plausibility failure" stored in the TCM. Should you encounter this condition, please raise a TA for diagnostic assistance. Include in your submission a session file, adaptation data read out from the vehicle and a picture of a fluid sample.	Under Investigation
F-TYPE 18MY with Ingenium AJ20P	A customer may complain of a coolant leak from the vehicle.	If diagnosis leads to identification of the upper radiator hose breather pipe leaking due to damage to the pipe close to the turbocharger, please raise a TA. This topic is under investigation and repair guidance will be offered via the TA.	TBD

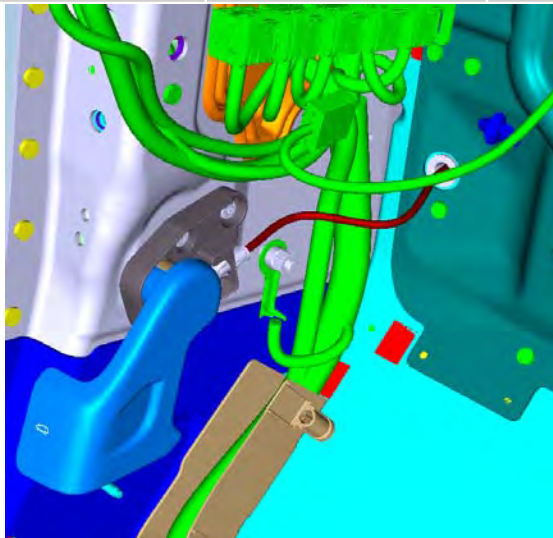
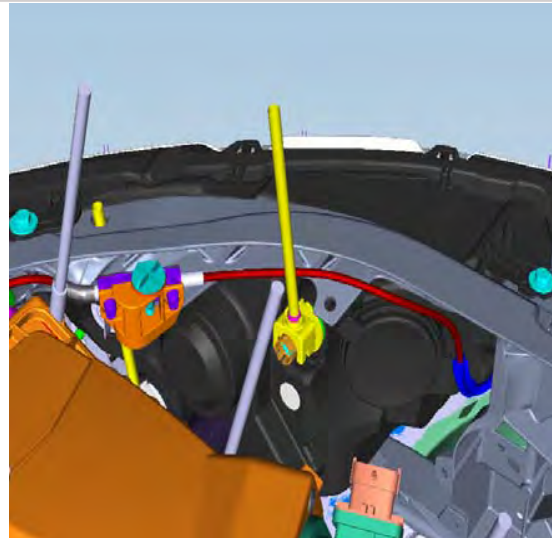
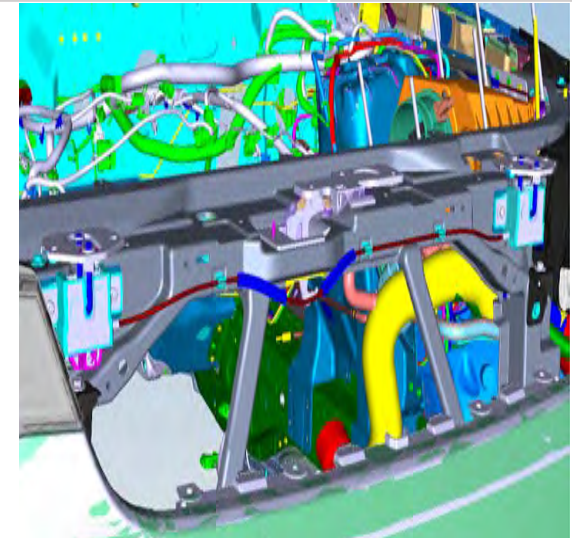
Vehicle	Customer Concern	Details and Status	Publication
Discovery 17 -18MY	Customers may report the hood is difficult to open.	Engineering is currently investigating a concern where the hood release level is pulled fully, but either one or both of the hood latches does not release. Further pulling of the release cable releases the latches. This may be caused by the hood cable routing. Engineering is requesting that the hood cable routing be inspected prior to removal or replacement of the cable. Specifically checking the radius of the cable bends. Should a customer express a concern, please submit an EPQR with pictures of the cable routing prior to any removal of the cable.	TBC

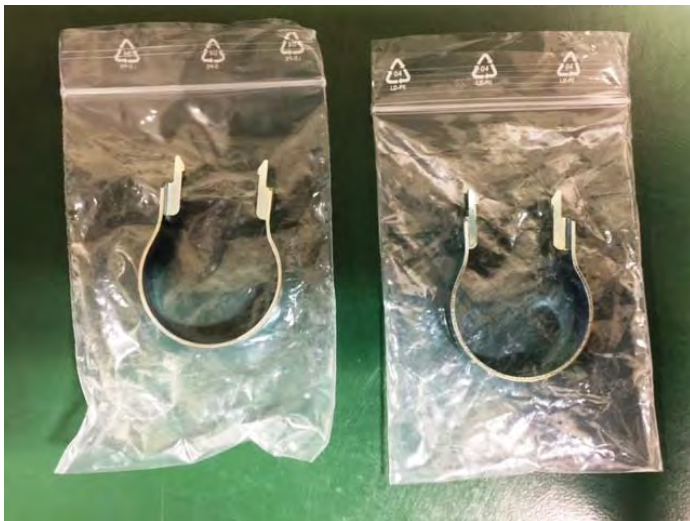
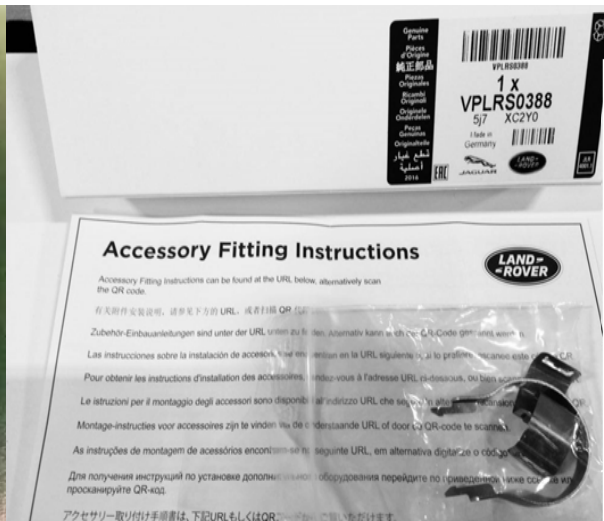
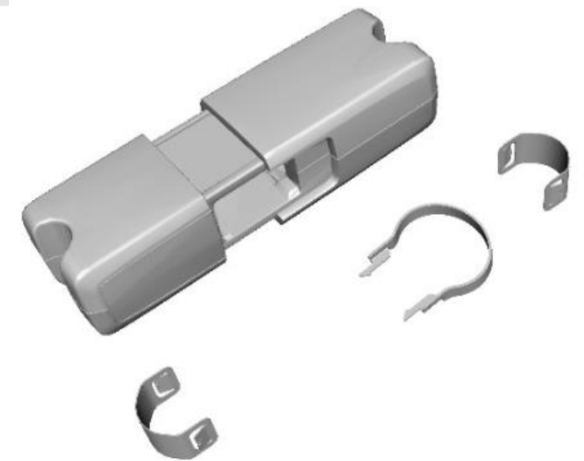
Vehicle	Customer Concern	Details and Status	Publication
E-PACE XCL	During PDI some vehicles come with two small tools in a baggie in the center console or glove box that we can not identify what it is used for.	The tool pictured in the baggies are the removal tools for the spring clips that retain the accessory convenience pack base mounting bracket to the front seat headrest bars. The convenience pack consists of a coat hanger or hooks that are easily removed from the base bracket. Port fitted convenience packs will have these removal tools provided in the vehicle.	SSM73747
