SI B54 01 18
Special Roofs

CONVERTIBLE TOP HEADLINER IS WORN ABOVE REAR WINDOW

F23 (2 Series Convertible)		
----------------------------	--	--

F23 CONVERTIBLE TOP HEADLINER WEAR REPAIR

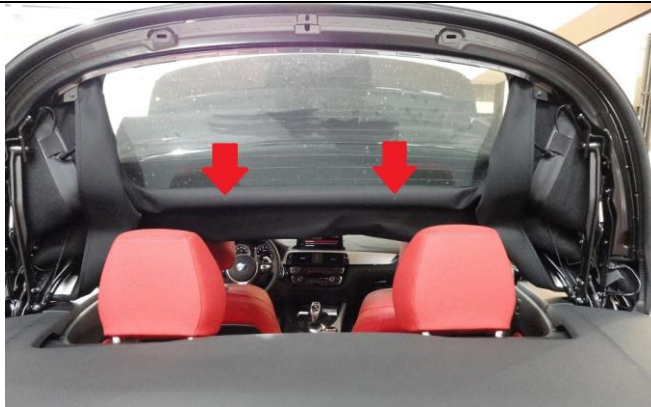
The convertible top headliner has holes worn through above the rear window.

Verify that holes have been worn through the headliner, above the rear window in the area shown to the left.

If holes are worn through, the convertible top headliner must be replaced. Adjust the position of the rollover protection system and rear window support.

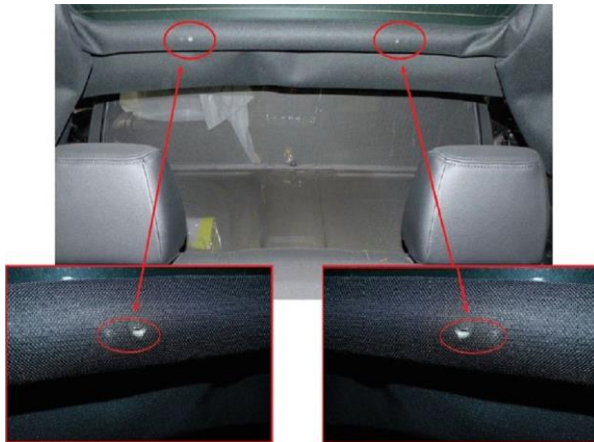
Note: Before replacing the headliner, a test must be performed to check the clearance of the headliner and the storage compartment when the top is in the stowed position. Refer to step 1 of this procedure for instructions.
