Service Bulletin

Bulletin No.: 08-08-57-007D

Subject: Excessive Midgate Closing Effort and/or Water Leak, and/or Tonneau Cover, Cargo to Midgate Water Leak

Models: 2006-2013 Cadillac Escalade EXT
2006-2013 Chevrolet Avalanche

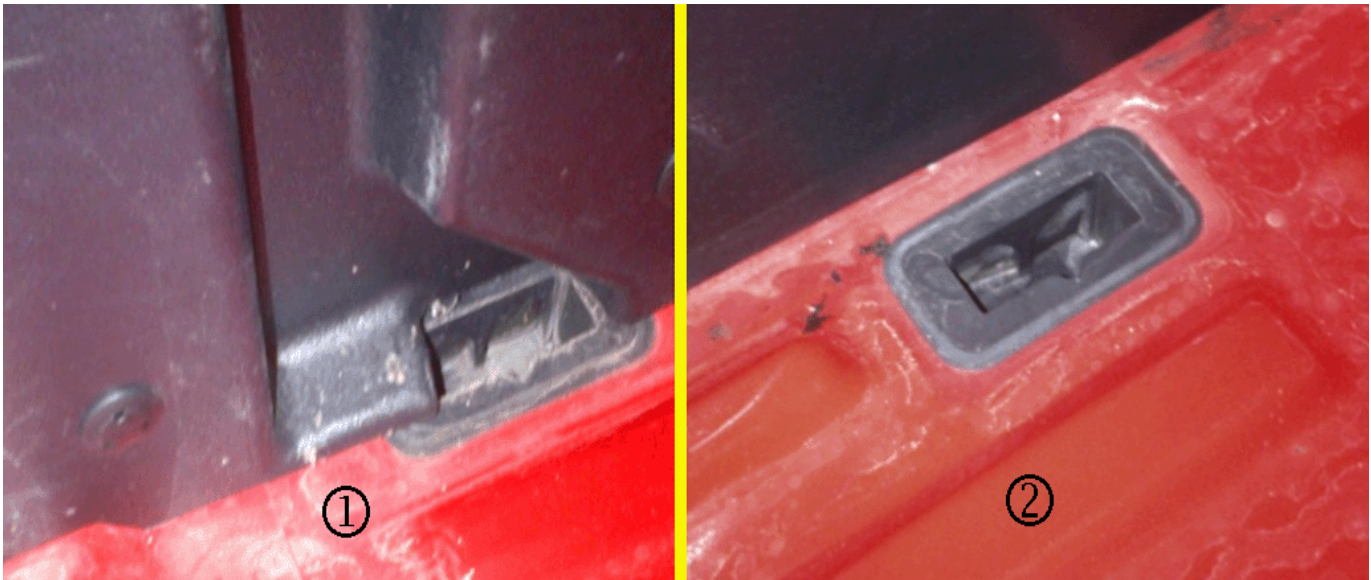
3807036

Note: The rear (1) and front (2) floor drains are shown in the graphic above.

2. Inspect the front, center and rear cargo floor drains on each side of the vehicle. Ensure the top side of the drains are not restricted by leaves or debris.

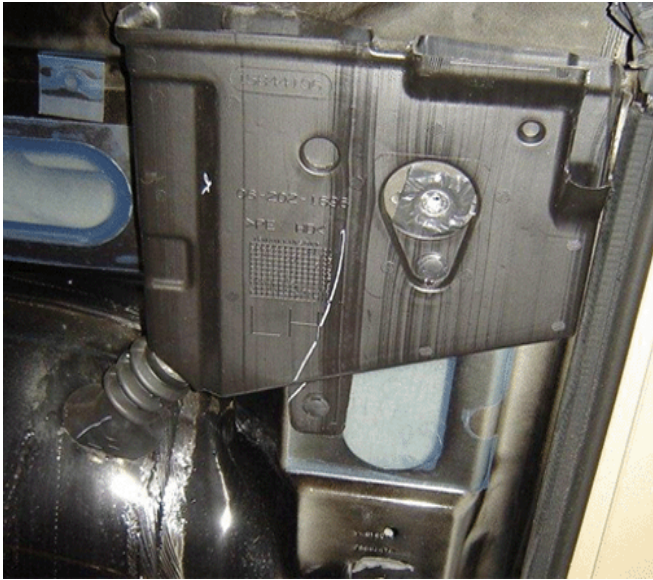
3807040

Tip: The body side rear drain duct is located underneath the cargo box storage lid and behind the cargo box storage box on each side of the vehicle.
