Service Bulletin

Subject: Mil On With DTC P0171 And / Or P1101

Models: 2013-2015 Buick Encore
2013-2015 Chevrolet Trax (Canada)
2015 Chevrolet Trax (US)
With 1.4L LUV

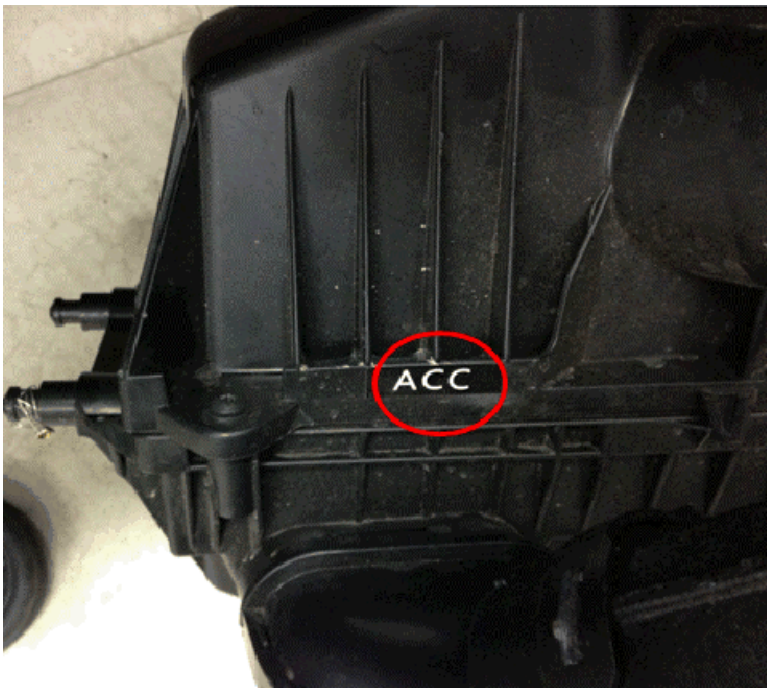
If SI diagnostics do not isolate the cause of the concern, inspect the ID code on the Air Cleaner Housing. (See photo below).

If the Hydro Carbon Absorber is missing, or the ID code is other than ACD, replace the Air Cleaner Housing with the latest listing in the Electronic Parts Catalog

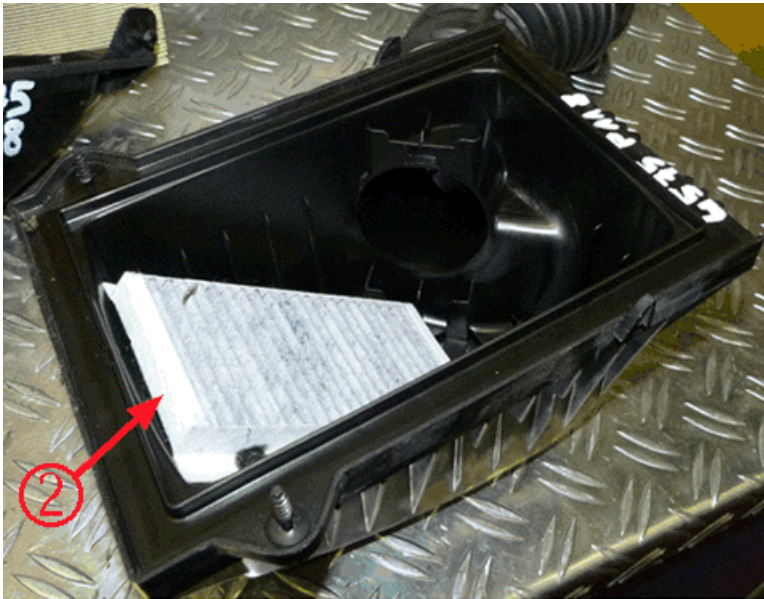
The correct application for the 2013-2015 Buick Encore and 2013-2015 Chevrolet Trax will have an ID code of ACD and will be fitted with a Hydro Carbon Absorber as shown below

If the Hydro Carbon Absorber is present and the ID code is ACD, refer back to current SI diagnostics.
