Instrument Cluster bevel and lens crack in cold weather

Topic number	LI54.30-N-067702
Version	1
Function group	54.30 Instrument cluster, display instruments, hazard warning device
Date	02-13-2018
Validity	906.xxx
Reason for change	
Reason for block

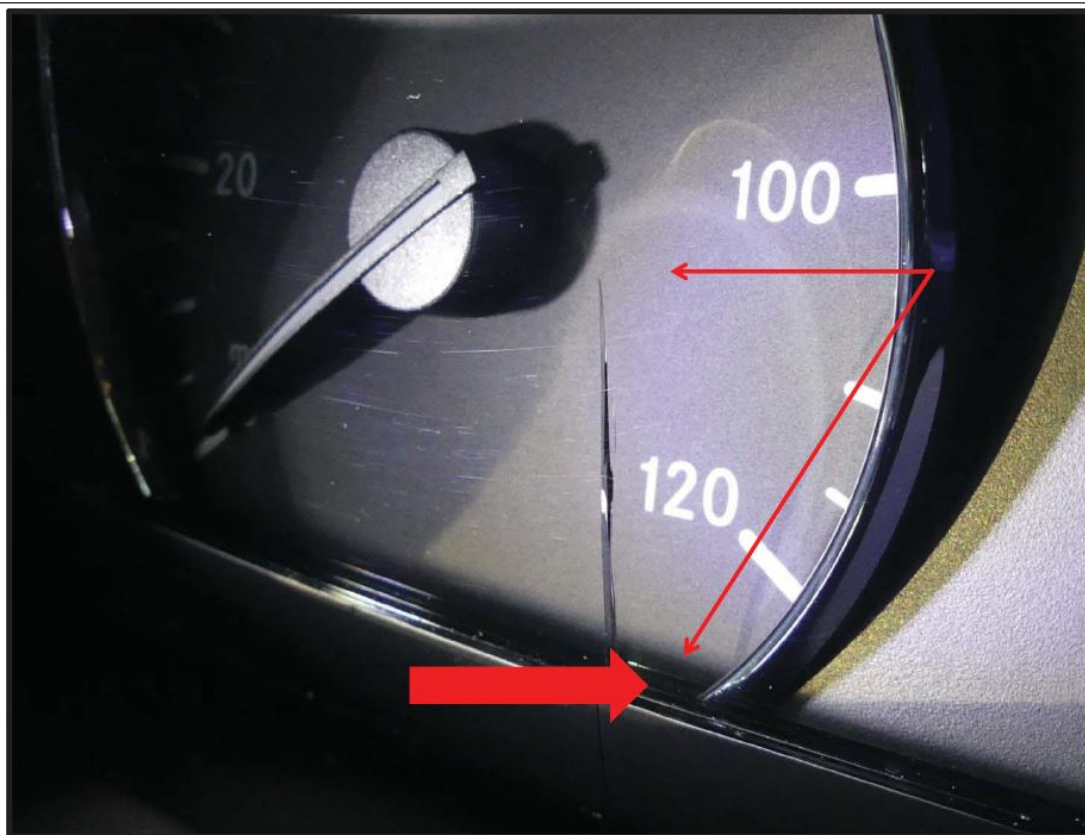
Cluster Cracking.JPG:

Customer complains the bevel surrounding the cluster face and/or the cluster lens is cracked

Note: See "Cluster Cracking" attachment for example

Possible impact damage or stress fractures

Carefully scrutinize the area of the crack for any visible signs of impact damage. If no impact marks are found replace the Instrument Cluster under warranty (if within the warranty parameters)
