Cooling Fan Broken / Breaks

Topic number	LI20.40-N-067705
Version	1
Function group	20.40 Fan, fan clutch
Date	02-22-2018
Validity	906.xxx
Reason for change	
Reason for block

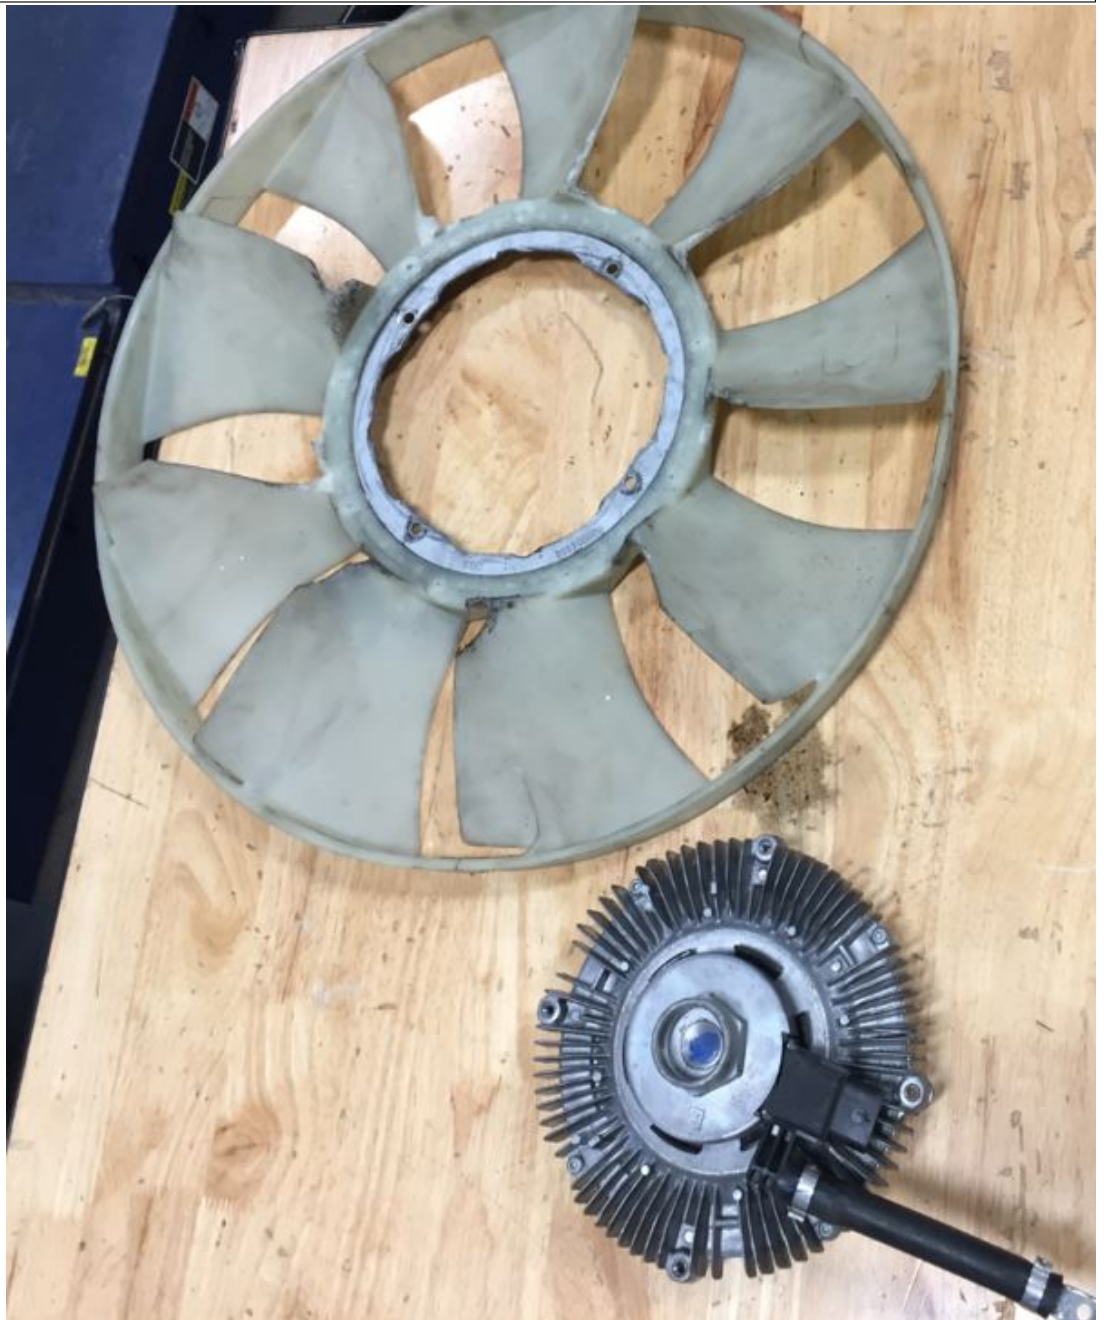
Cooling Fan.JPG:

Engine cooling fan assembly has sheared off from clutch hub

Attachments	
File	Description
Cooling Fan.JPG	Cooling fan broken

Possibly customer abuse / road damage

Before replacement of the cooling fan please gather the following information and create a PTSS case:

- (1) Picture of the entire vehicle (side profile)
- (2) Picture of auxiliary compressor, generator, etc in engine belt drive system (if applicable)
- (3) Photo of belt drive system (if different than OEM non aux setup)
- (4) Picture of upfitter label or name of upfitter (if applicable)
- (5) Belt part number and length/number of ribs
- (6) Part number on auxiliary A/C compressor / generator / alternator, etc (if applicable)
- (7) List of other devices within the belt drive system (if different than standard OEM)
- (8) Applicable Xentry data (fault codes, duty cycle from fan clutch (if applicable), etc)
