## Check Engine Light with multiple control modules exhibiting numerous CAN codes

Topic number	LI54.18-N-064032
Version	1
Design group	54.18 Cable harnesses
Date	05-10-2016
Validity	Model 906 with OM642 engine
Reason for change	
Reason for block

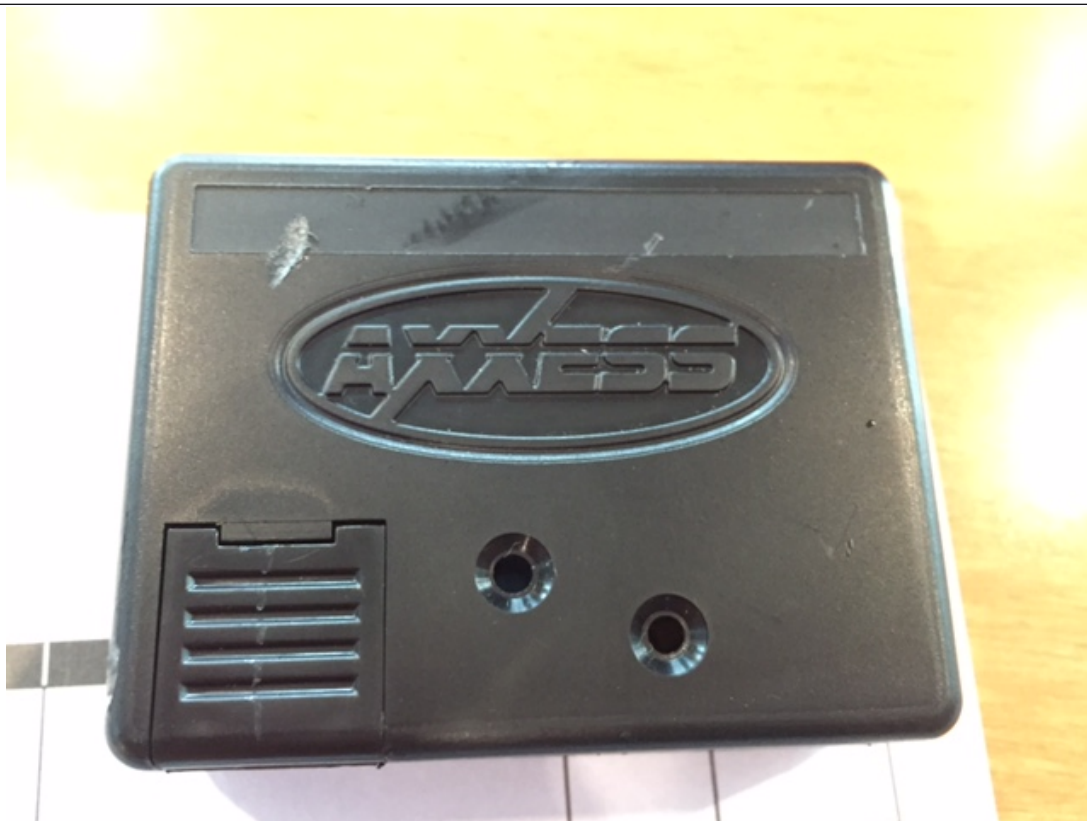
AXXESS control unit.  
JPG:

An after market system such could be installed by an upfitter in the vehicle.

If the control unit fails on the upfitted system this may lead to the interior CAN system becoming inoperative.

AXXESS control unit.JPG	AXXESS Control unit
WP_20160505_001.jpg	AXXESS Cable routing
WP_20160505_002.jpg	Cable and AXXESS control unit

Inspect the vehicle for upfitted device which may be improperly connected to the Interior CAN system and disconnect from the interior CAN system.
