OM651 Exhaust Bracket Cracking

Topic number	LI49.10-N-060969
Version	2
Design group	49.10 Exhaust pipes, catalytic converter, mufflers
Date	05-12-2016
Validity	Sprinter Model 906 with engine OM651
Reason for change	Part number change
Reason for block

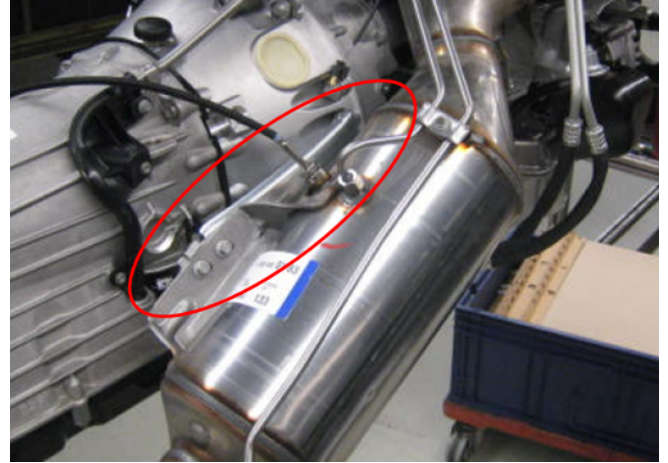
Pic 1.jpg:

Attachments	
File	Description
Pic 1.jpg	Mounting position of the DPF bracket
Pic 2.jpg	Mounting position of the DPF bracket - Transmission

Inspect and replace exhaust bracket (Pic 1 & 3) as needed with current part number (check EPC for latest part number). Inspect bell housing for damage replace as needed. There is a new redesign exhaust bracket in preparation at the supplier. When the new part is available this LI will be updated to inform you of the new part number.

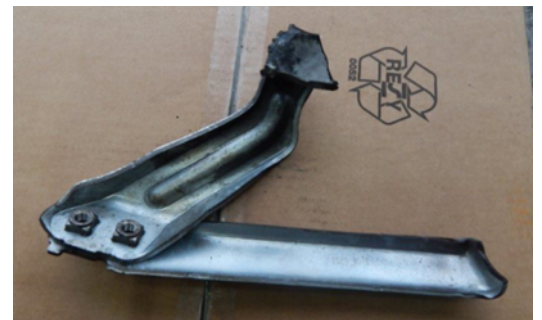
Pic 3.jpg:

Exhaust bracket cracking (Pic 3)

Attachments	
File	Description
Pic 3.jpg	Broken DPF bracket
