XENTRY TIPS

Model series 166 chafe mark on wiring harness - Bracket in center console is sharp-edged

Topic number	LI68.20-P-063996
Version	1
Design group	68.20 Center console
Date	04-29-2016
Validity	Model series 166
Reason for change	
Reason for block

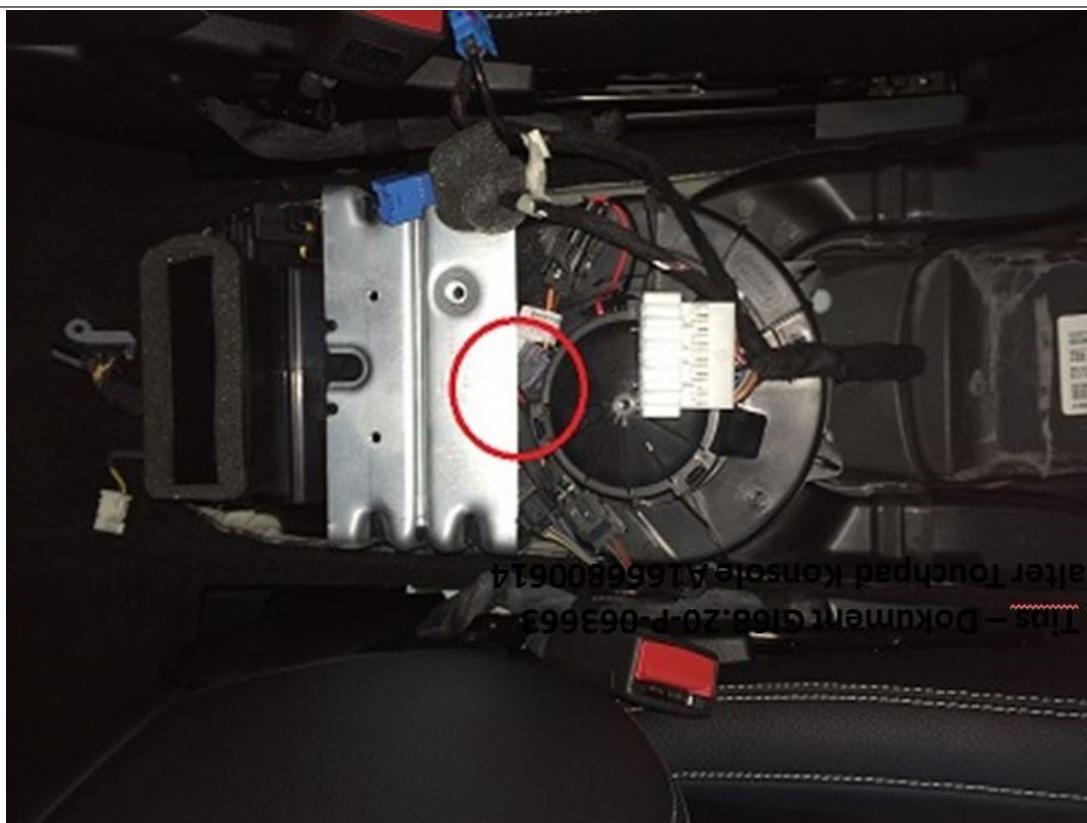
Pic 1.jpg:

Wiring harness on booster blower or rear air flap may contact the metal bracket for the center console and suffer chafing (Pic. 1)

Attachments	
File	Description
Pic 1.jpg	Area of damage
