Driver and front passenger seats make cracking noise when cornering

Topic number	LI91.10-P-054769
Version	2
Design group	91.10 Front seats
Date	01-10-2017
Validity	Model 220.### ## up to 420055
Reason for change	Damage code deleted
Reason for block

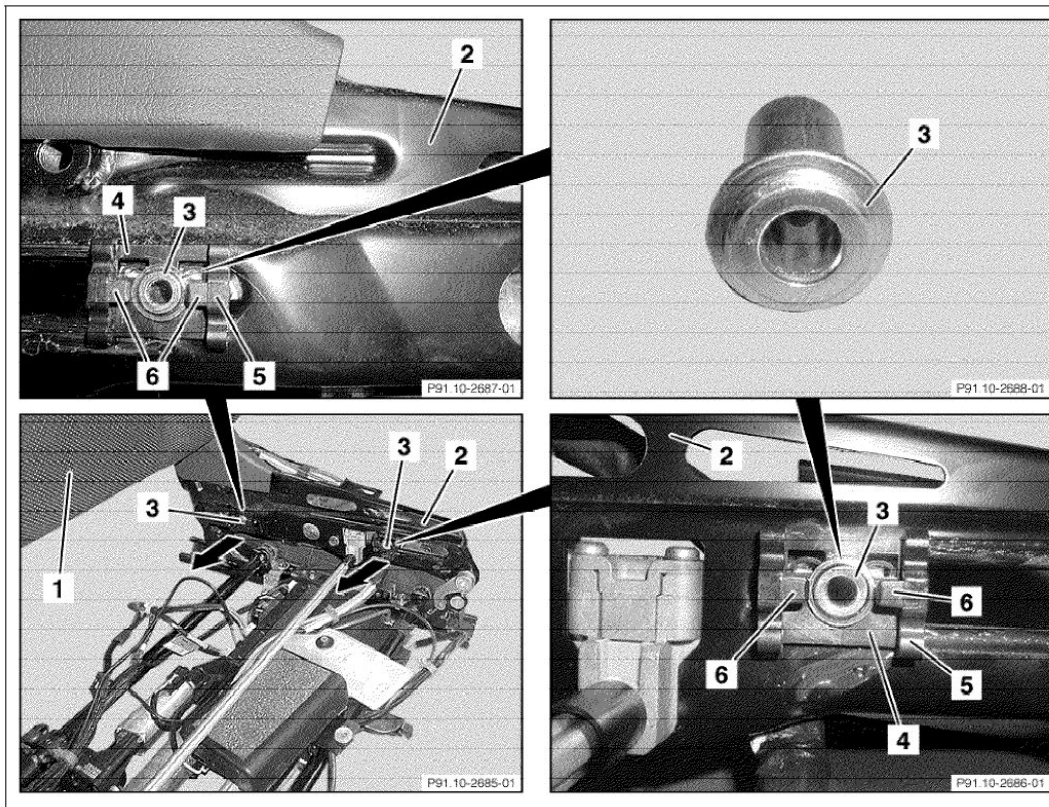
P91.10-P-1101DG.jpg:

Play in cushion shell bearing on door side

File	Description
P91.10-P-1101DG.jpg	Replacement of bushing on seat adjuster

3. Press bearing bushings (3) out of seat cushion guide (4) in direction of arrow.

Note: Only the bearing bushings on the rocker panel side should be replaced.

6. Push in bearing bushings (3) until they are behind the plastic lugs (6).

Note: The replacement part bearing bushing (3) is primed black.

Note: Grease the contact surfaces on the bearing bushings with multipurpose grease for metal (A 002 989 07 51).

Note: The plastic lugs must not be damaged when pushing in the bearing bushings.
