Noises from area of cross member of seat height adjuster at throttle lift-off and on rough roads

Topic number	LI91.10-P-048502
Version	2
Design group	91.10 Front seats
Date	01-12-2017
Validity	Model series 164 with SA code 241/242/275 up to VIN: # 211173 Model series 251 with SA code 241/242/275 up to VIN: # 051018
Reason for change	Damage code deleted
Reason for block

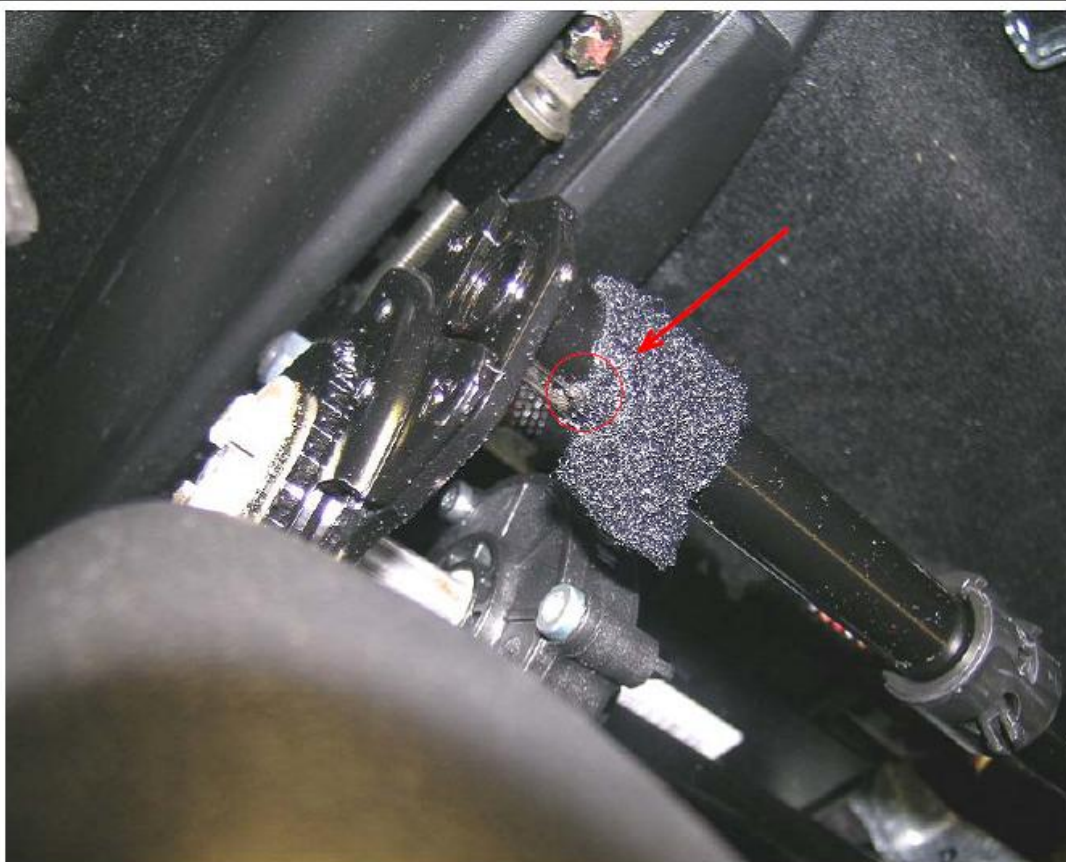
Falsche_Position_Filz_Beanstandung.jpg:

Positioning or detachment of the felt on the transverse pipe (door side).

6. Remove existing felt on transverse pipe and completely remove any adhesive residues using a suitable solvent (Picture 5).
