## Venting noises from dynamic seat

Topic number	LI91.00-P-049798
Version	3
Design group	91.00 General
Date	01-10-2017
Validity	Model series 216 and model series 221 with SA code 432 Model series 221 up to model refinement (- code 800)
Reason for change	Damage code deleted
Reason for block

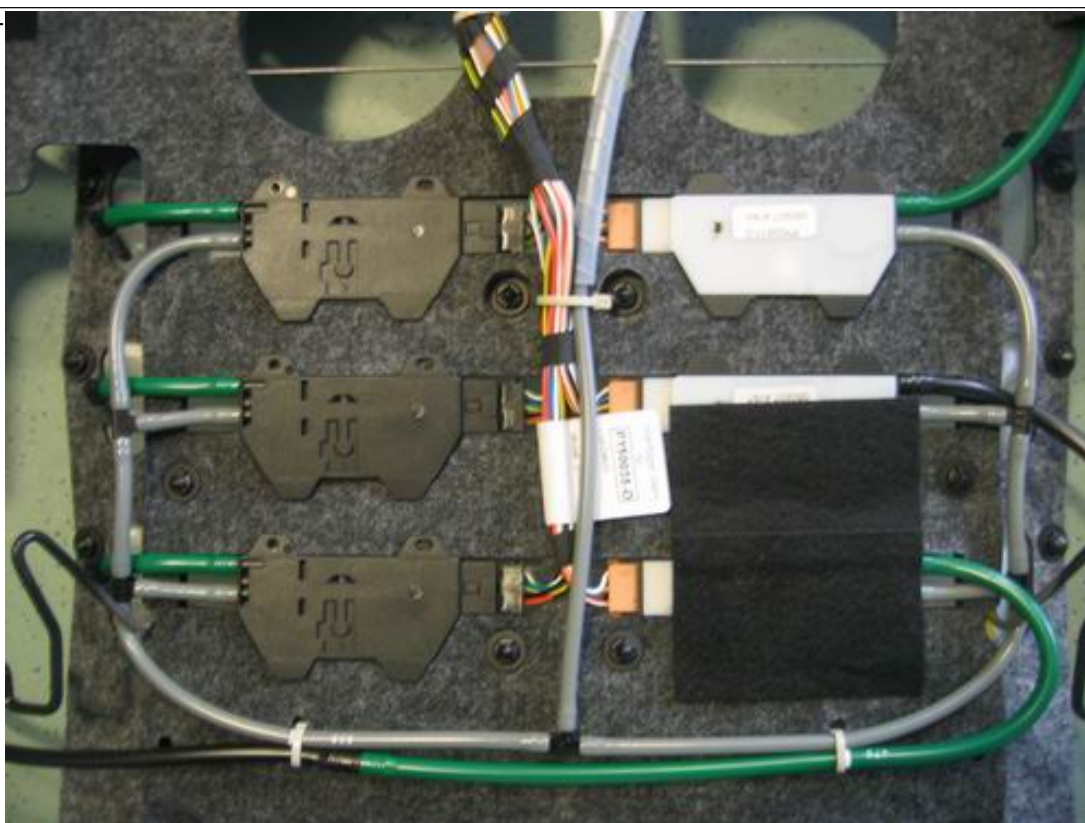
Ventile\_MKS\_FDS\_Einla-  
ge.JPG:

The noises are produced at the filter element in the air outlet of the valve units of the dynamic seat system modules (cf. Figure 1).

Attachments	
File	Description
Ventile_MKS_FDS_Einlage.JPG	(1) Valves of dynamic seat modules

Felt strips can be attached to alter the air stream such that the noises are significantly reduced. To do this, proceed as follows:
