Multicontour/dynamic seat, malfunctions

| Topic number | LI91.25-P-059392 |
| Design group | 91.25 Multicontour seat (MKS), dynamic seat |
| Validity | Model series W/V 221 with SA code 406 or 409 or 432 as of VIN 221...106647 up to VIN 221...134746 Model series 216 with SA code 409 or 432 as of VIN 216...002723 up to VIN 216...006715 |

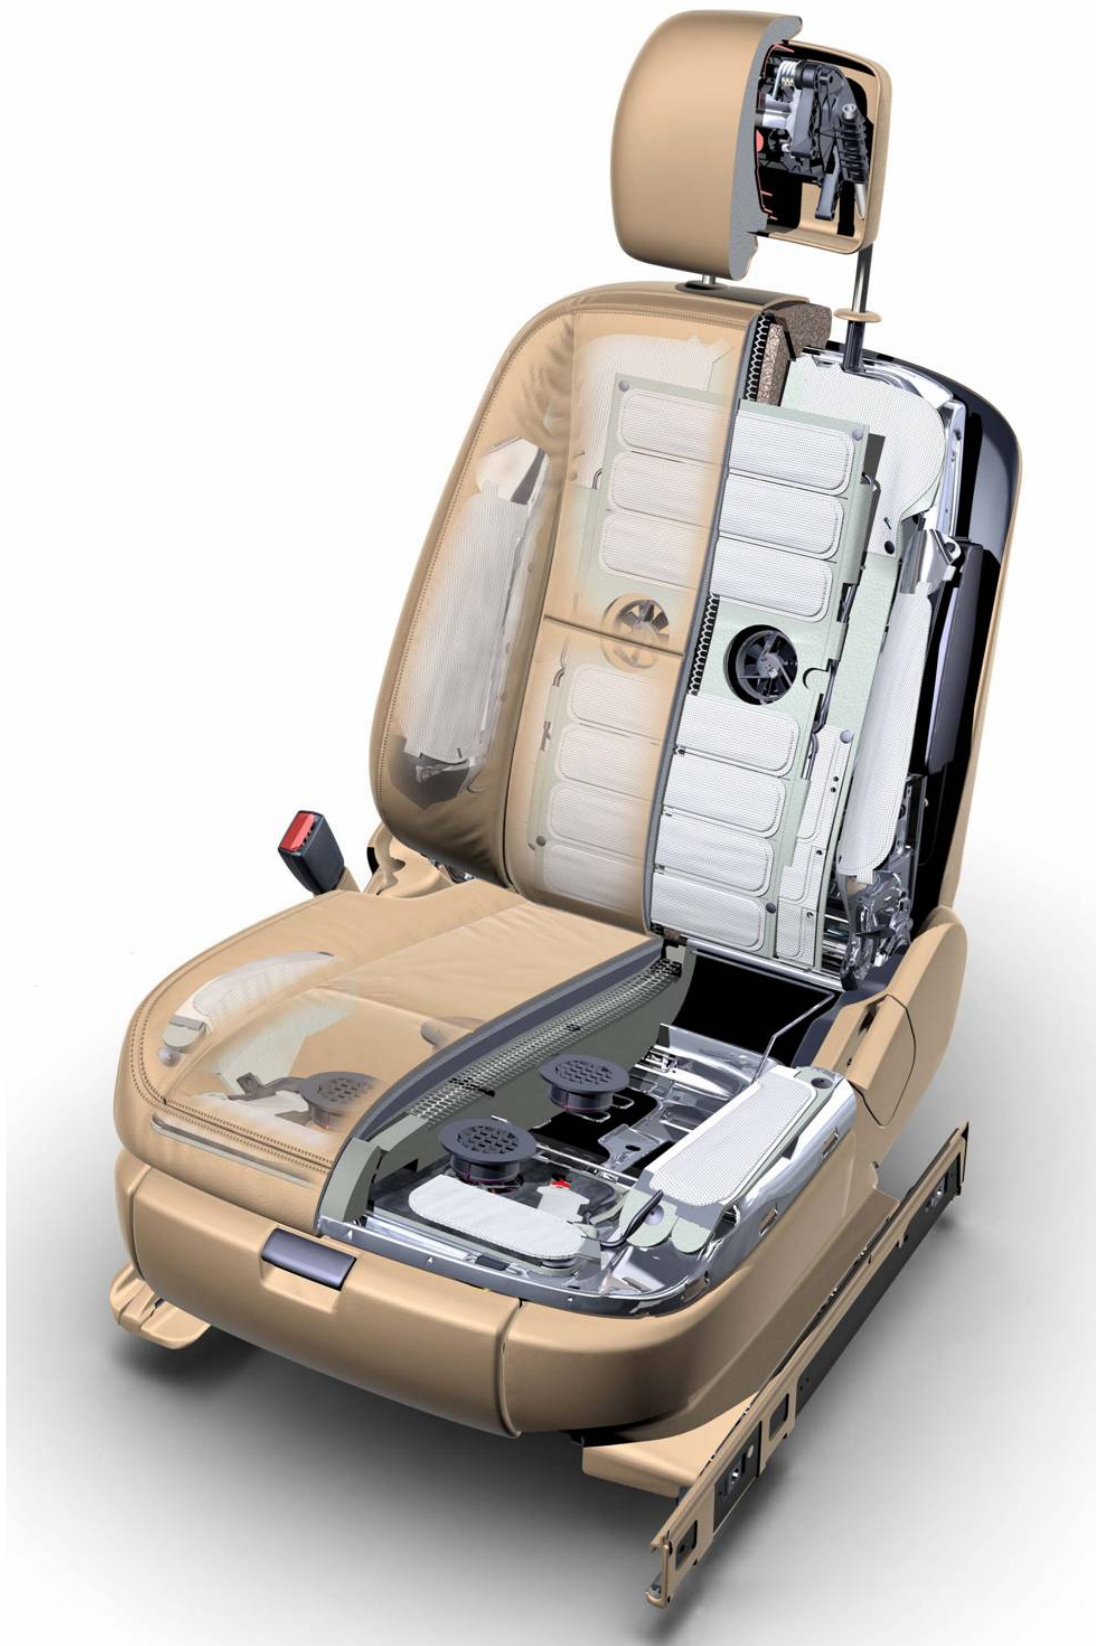
Schnittbild_221_Sitz_vorn.jpg:

| Attachments | |
|---|---|
| Schnittbild_221_Sitz_vorn.jpg | (1) 221 Sitz vorn Schnittbild - 221 Front seat cutaway view |

Please note: The massage pad in the front seats is permanently integrated in the backrest pad, so the entire backrest pad must be replaced (cf. picture 1 and 3). As mentioned above, the same applies for the massage pads in the rear seats (cf. picture 2).

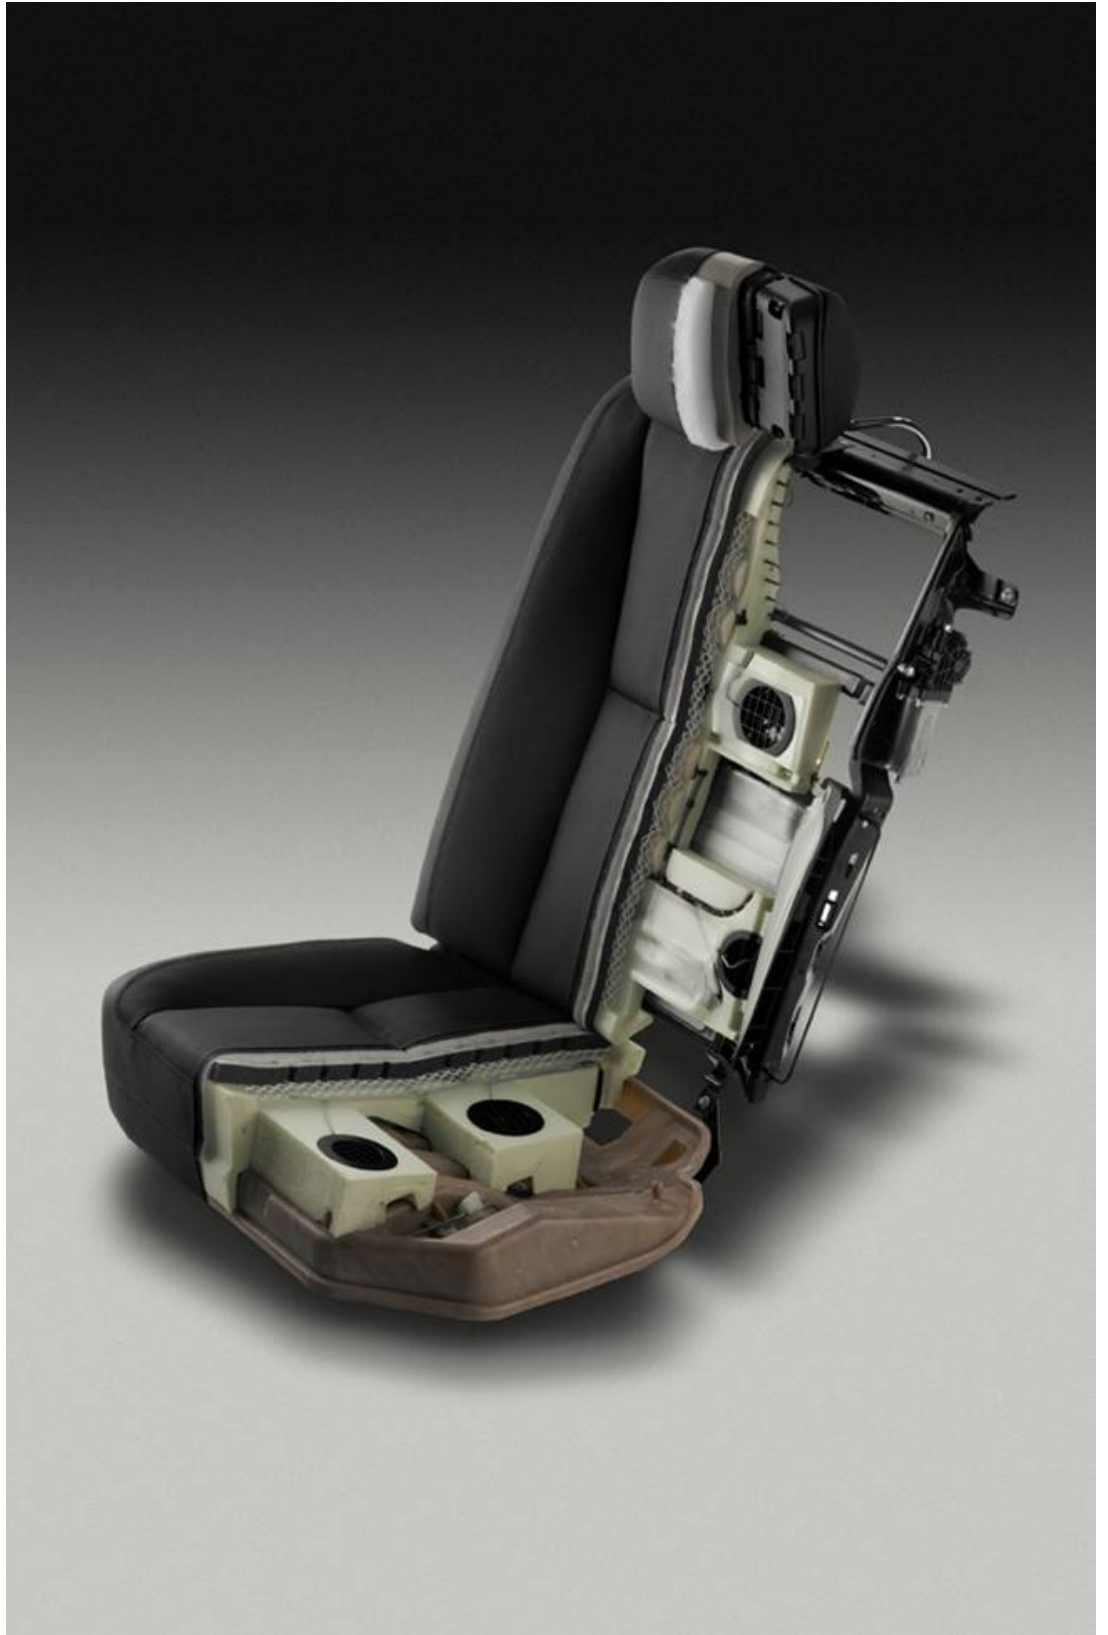
Schnittbild_221_Sitz_
Fond.jpg:

| Attachments | |
|---|---|
| Schnittbild_221_Sitz_Fond.jpg | (2) 221 Sitz Fond Schnittbild - 221 Rear seat cutaway view |

Please note: On the front seats, the pads (module carriers) in the backrest (pictures 4 and 7) and cushion (pictures 5 and 8) for the multicontour/dynamic seat function can be replaced separately. On the rear seat, however, the entire backrest pad (Figure 2) must be replaced because in this case the corresponding modules are permanently integrated.

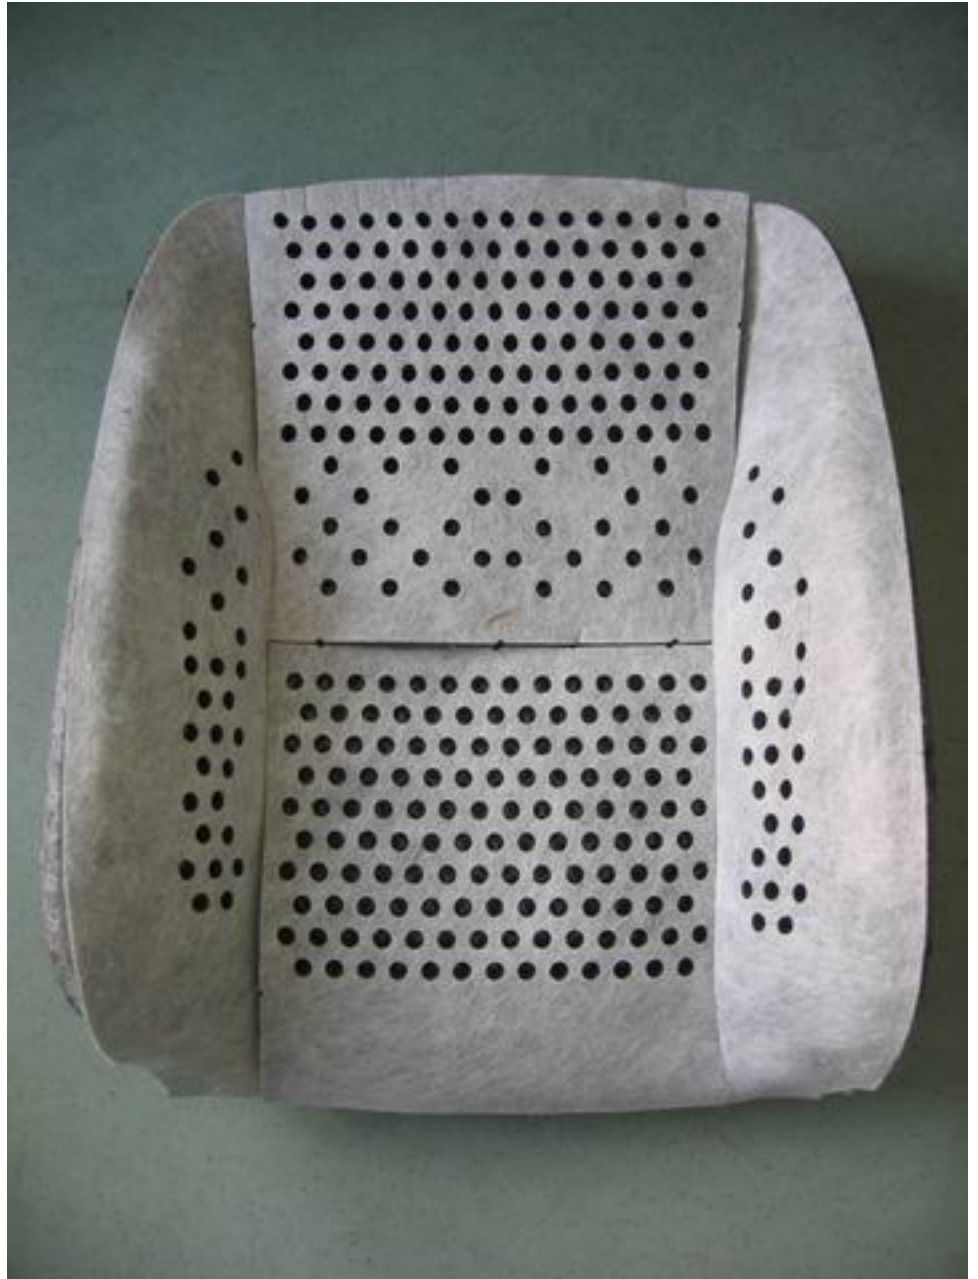
Lehnenauflage_Massageeinlage_221.JPG:

Faulty valves in the massage pads may cause the fault code 9202 "The module carrier for the massage function is defective" in the following control units:

| Lehnenauflage_Massageeinlage_221.JPG | (3) 221 Lehnenauflage mit optionaler Massageeinlage vorn - 221 Backrest padding with optional massage layer, front |

If these fault codes are found, the corresponding massage pads in the relevant seats must be replaced.

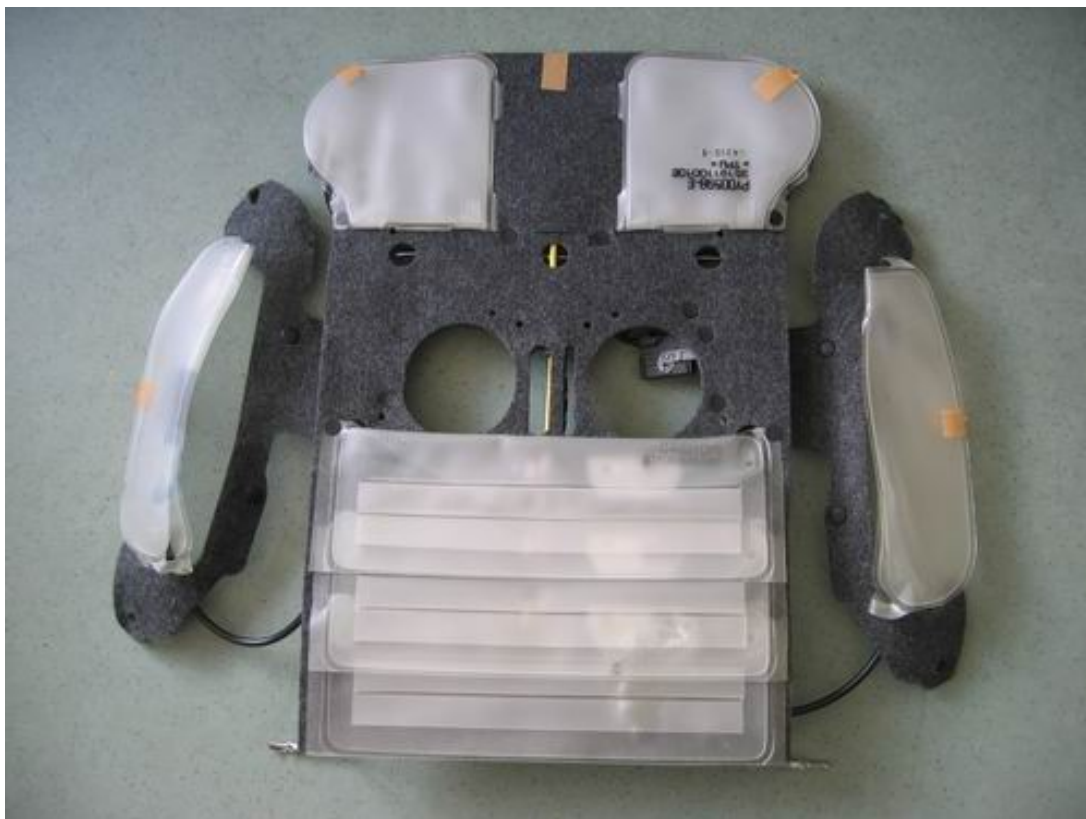
MKS_FDS_Einlage_Leh-
ne_221.JPG:

* 9210 "System failure of backrest module carrier" in the case of a defective multicontour/dynamic seat pad (module carrier) in the backrest

| MKS_FDS_Einlage_Lehne_221.JPG | (4) 221 Multikontur-/ Fahrdynamik-Einlage (-Modulträger) Lehne vorn - 221 Backrest multicontour / dynamic seat pad (module carrier), front |

If these fault codes are found, the corresponding multicontour/dynamic seat pads (module carriers) in the relevant seats must be replaced.

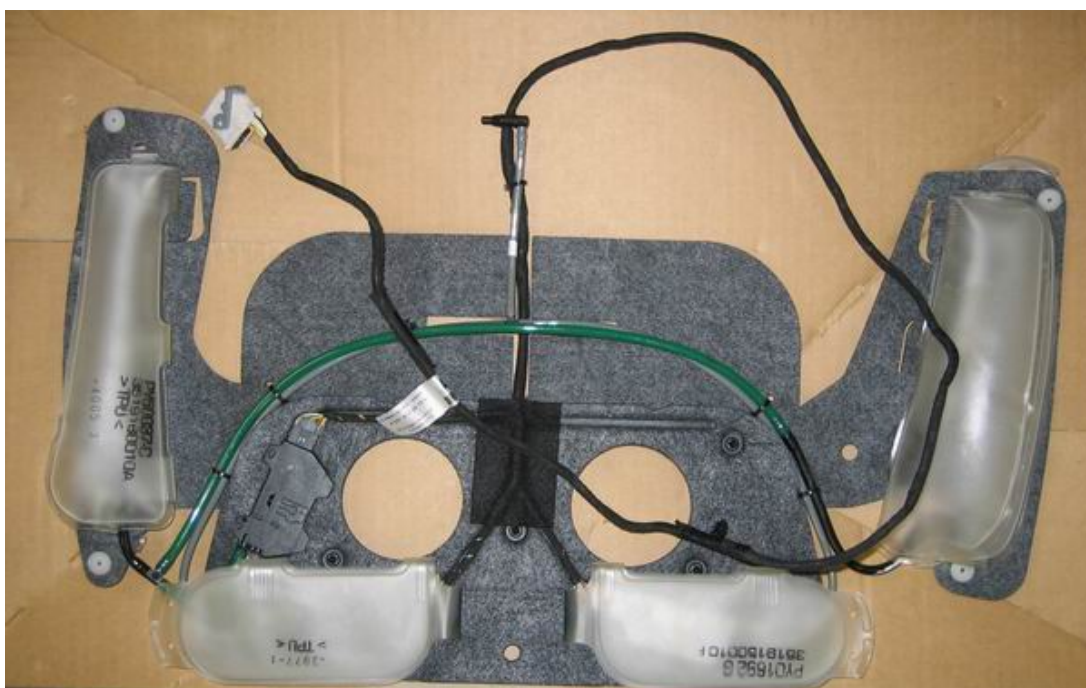
MKS_FDS-Einlage_Kis-
sen_221.JPG:

* 9211 "System failure of cushion module carrier" in the case of a defective multicontour/dynamic seat pad (module carrier) in the cushion

| MKS_FDS-Einlage_Kissen_221.JPG | (5) 221 Multikontur-/ Fahrdynamik-Einlage (-Modulträger) Kissen vorn - 221 Seat cushion multicontour / dynamic seat pad (module carrier), front |

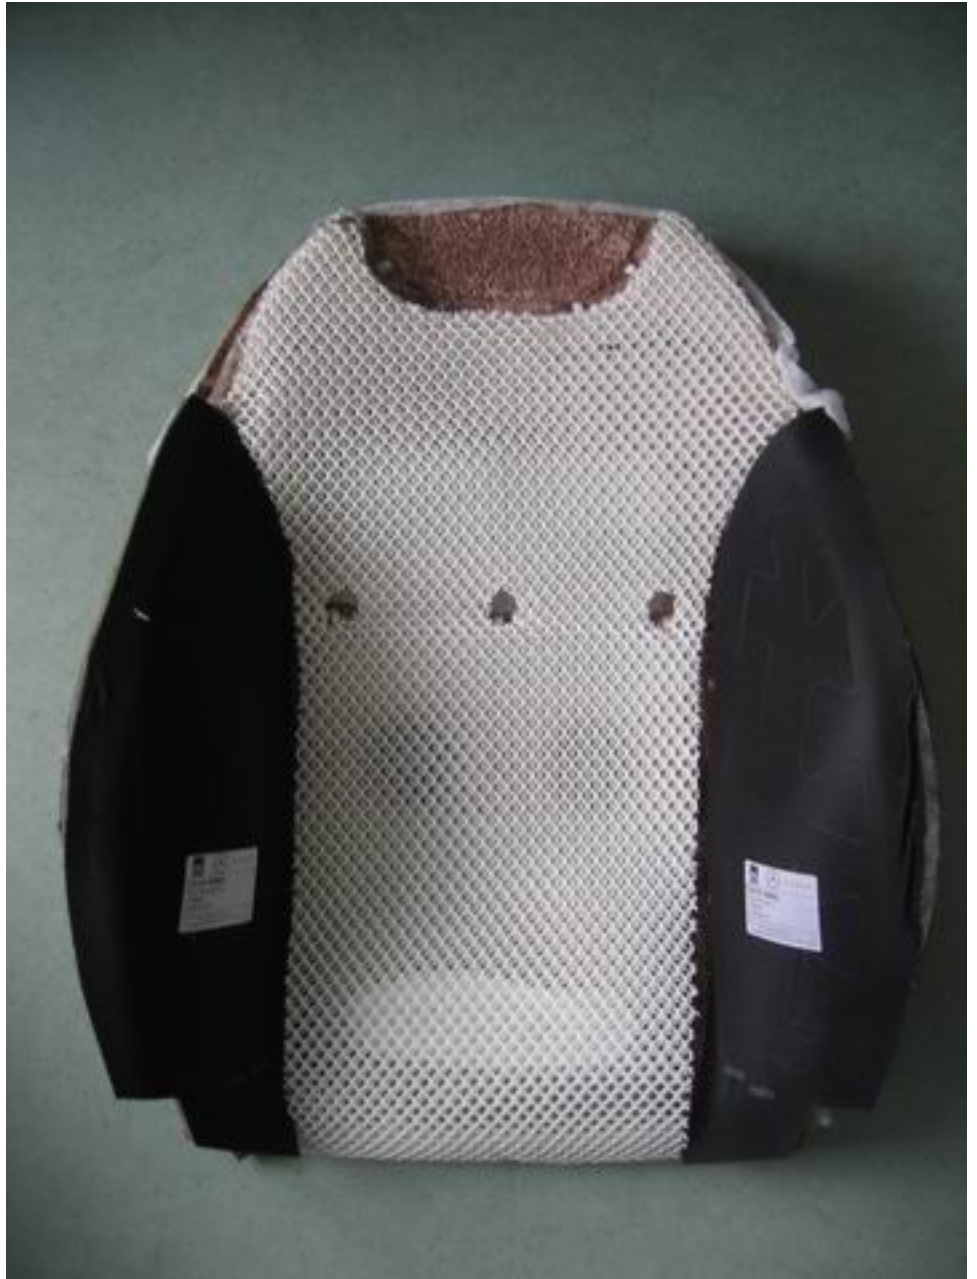
Lehnenauflage_Massageinlage_216.JPG:

| Lehnenauflage_Massageeinlage_216.JPG | (6) 216 Lehnenauflage mit optionaler Massageeinlage vorn - 216 Backrest padding with optional massage layer, front |

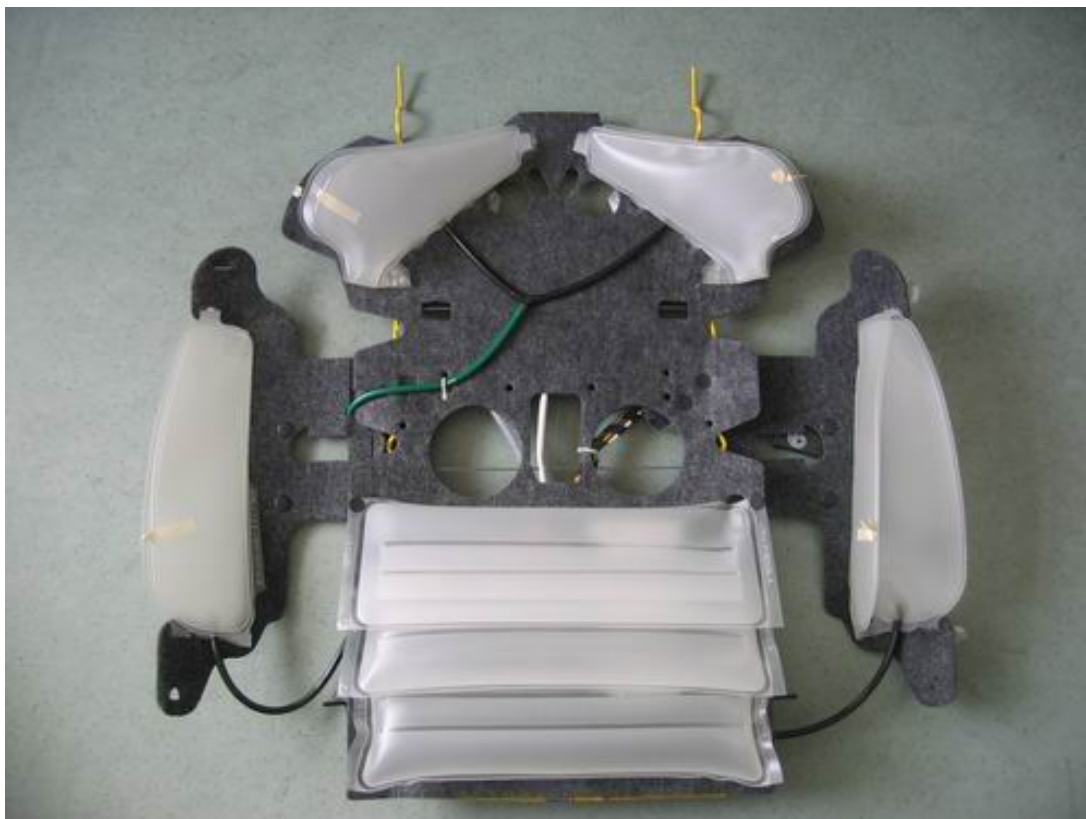
MKS_FDS_Einlage_Leh-
ne_216.JPG:

| MKS_FDS_Einlage_Lehne_216.JPG | (7) 216 Multikontur-/ Fahrdynamik-Einlage (-Modulträger) Lehne vorn - 216 Backrest multicontour / dynamic seat pad (module carrier), front |

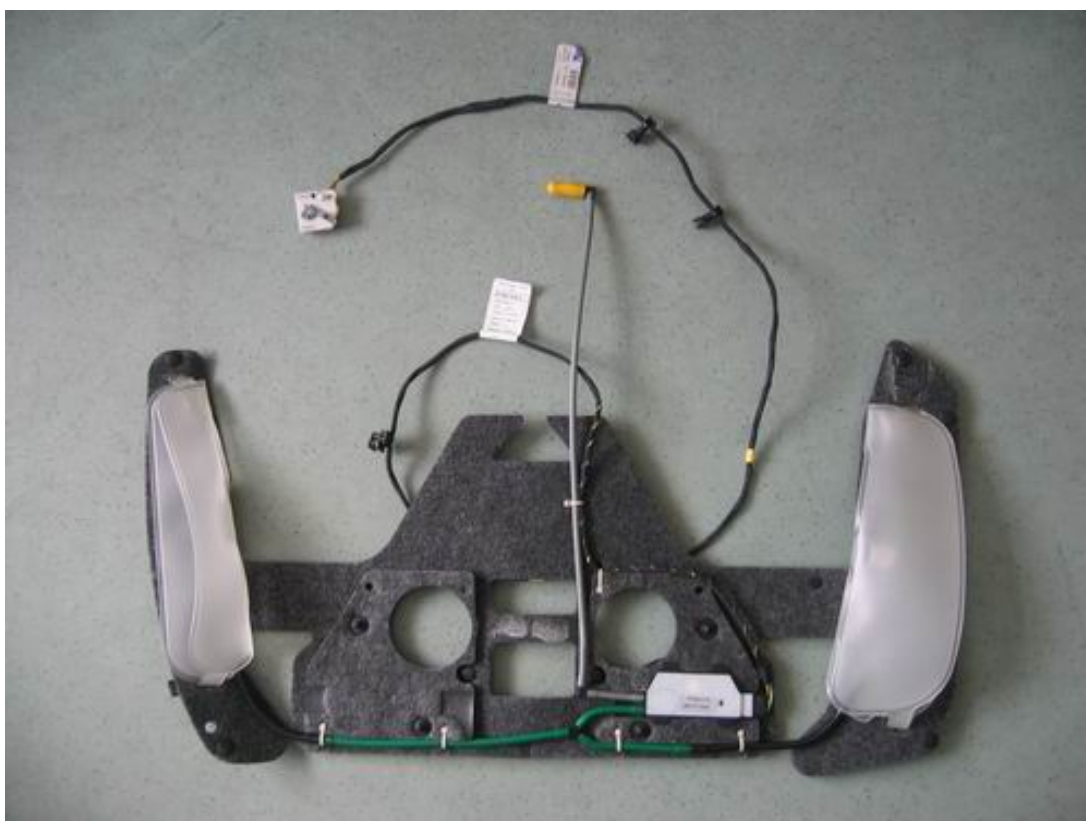
MKS_FDS-Einlage_Kis-
sen.JPG:

| MKS_FDS-Einlage_Kissen.JPG | (8) 216 Multikontur-/ Fahrdynamik-Einlage (-Modulträger) Kissen vorn - 216 Seat cushion multicontour / dynamic seat pad (module carrier), front |

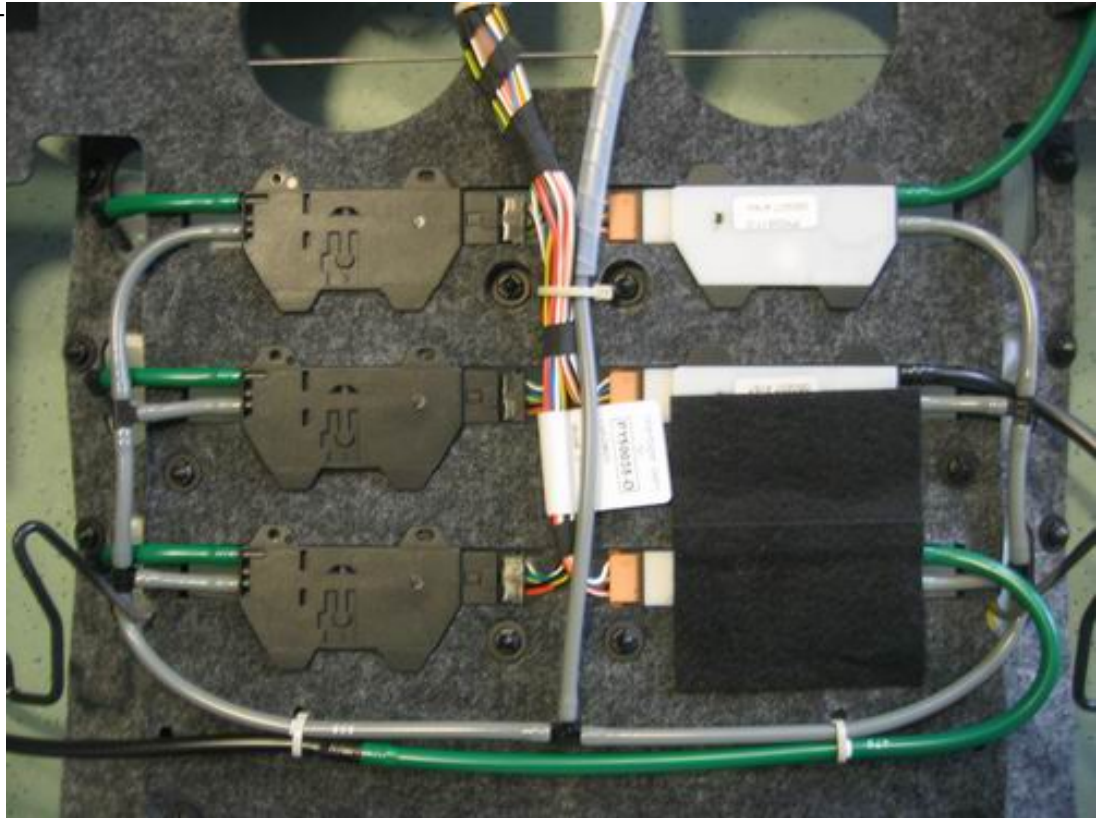
Ventile_MKS_FDS_Einla-
ge.JPG:

Valves (Figure 9) in the cushion/backrest pads can operate by themselves.

Depending on the switch position of the valve, this can result in either non-inflation or over-inflation of air cushions without any action by the driver.

| Attachments | |
|---|--|
| Ventile_MKS_FDS_Einlage.JPG | (9) Ventile der Multikontur/ Fahrdynamik-Einlagen - Valves of multicontour / dynamic seat pads |

The malfunctions to which this document refers (within the specified VIN range) are caused by the faulty transistors in the valves and not by the control units or the pneumatic pump.
