Seat belt height adjustment nonfunctional

Topic number	LI91.40-P-059364
Version	2
Design group	91.40 Seat belts, emergency tensioning retractors
Date	01-12-2017
Validity	Model series 221 with automatic seat belt height adjustment, up to VIN 199347
Reason for change	Damage code deleted
Reason for block

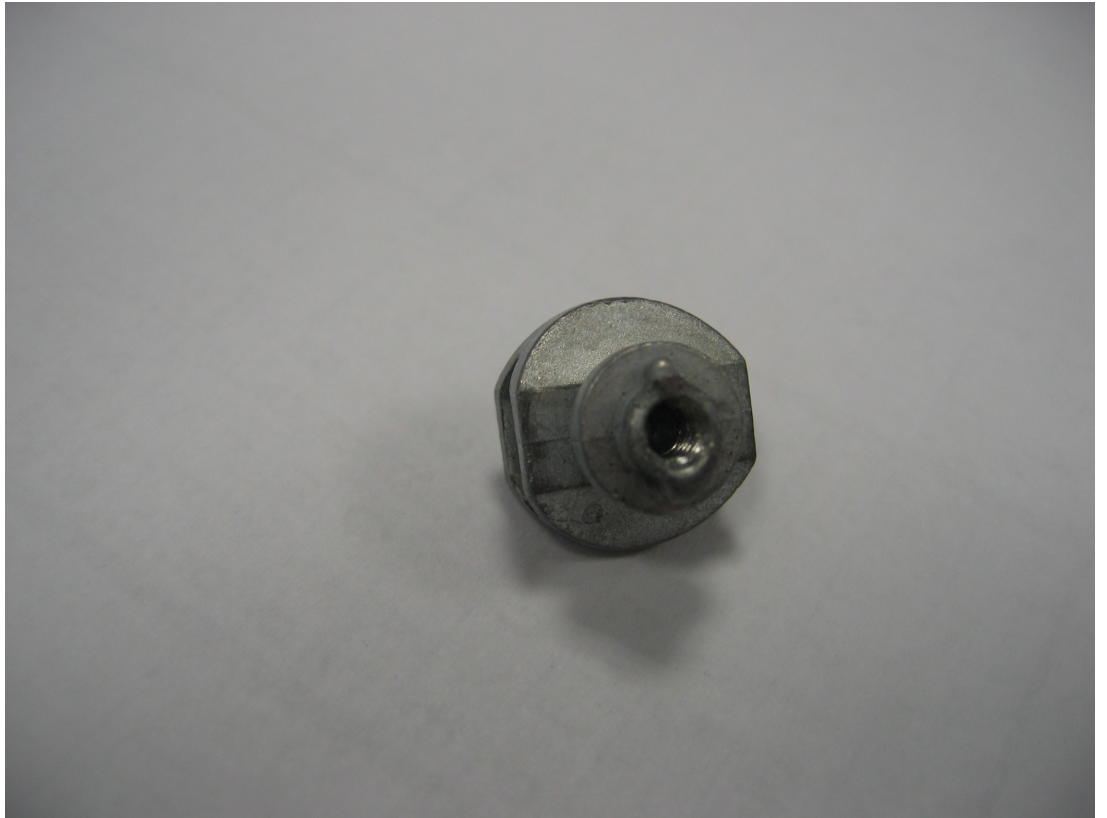
Bild1.jpg:

The pin for the seat belt height adjustment cable on the seat rail has broken out.

Cut an inside thread M4 that is 10 mm in deep in the center of the pin. (see Picture 1)
