## Variable rear spoiler occasionally fails to extend or retract.

Topic number	LI77.25-P-063997
Version	3
Design group	77.25 Wind deflector (spoiler)
Date	01-24-2017
Validity	MODEL 190.###
Reason for change	Part number added
Reason for block

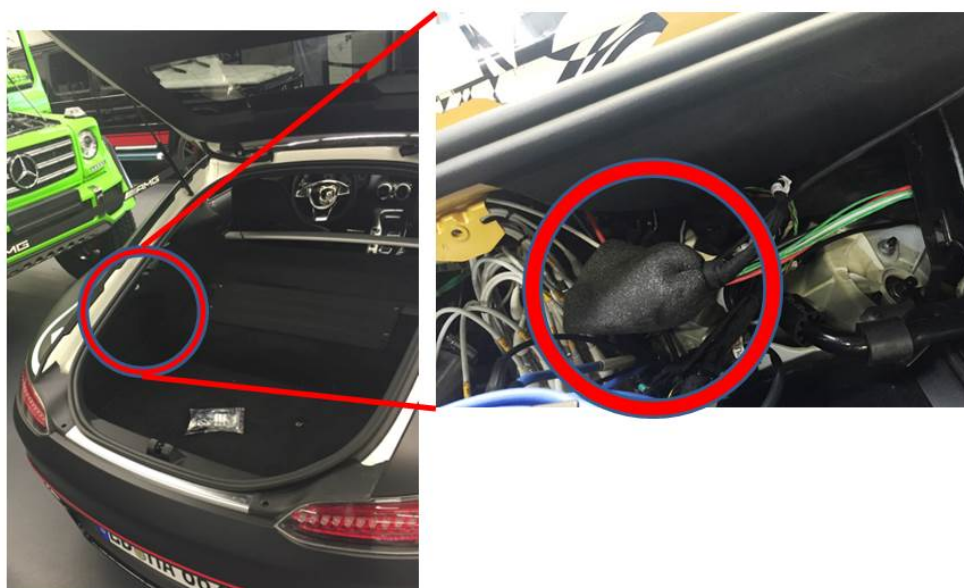
Position\_Relais.jpg:

Intermittent relay contacts.

Attachments	
File	Description
Position_Relais.jpg	Relay installation position

Note: Relay is not in relay slot but instead lying loosely in the wiring harness in a piece of foam material (see picture).

Check connection and rear spoiler relay (K115/1) in left rear trunk in rear SAM.
