Additional poly-V belt for roof air conditioning or front power take-off torn

Topic number	LI13.20-N-054722
Version	2
Design group	13.20 Belt drive, general
Date	03-26-2013
Validity	Model 906 with OM642 and high-performance A/C in passenger compartment (H08) or front engine power take-off with carrier for additional refrigerant compressor (N63)
Reason for change	The new brackets received in stock are Q02 and no longer have the color dot.
Reason for block

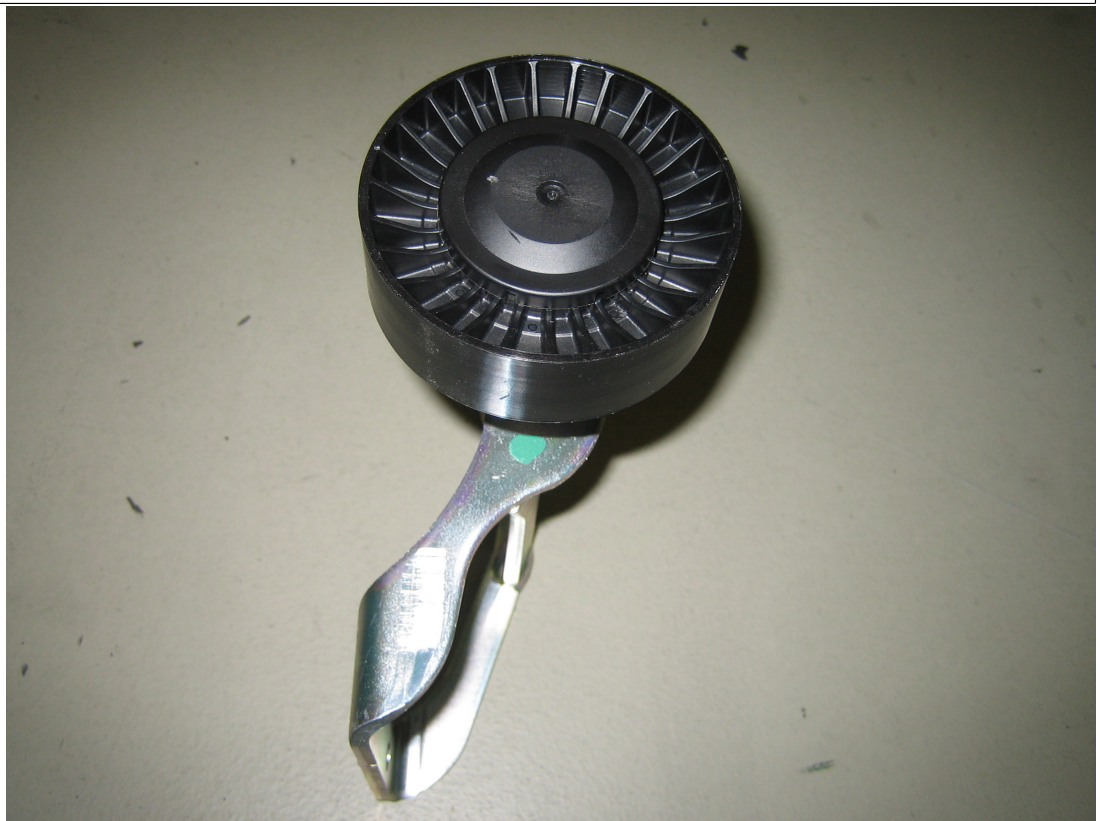
1.jpg:

The new brackets are Q02 and no longer have the color dot!

There still might be some stock with carriers with a green or blue dot and they may still be installed.

Attachments	
File	Designation
1.jpg	Color dot

Replace carrier of guide pulley and poly-V belt.
