## Cover of storage slot at front under roof liner (FF8) not fitting

Topic number	LI68.30-N-059117
Version	1
Design group	68.30 Coverings, trim
Date	05-27-2014
Validity	Model 906 with CODE FF8 (1 DIN slot at front under headliner)
Reason for change	
Reason for block

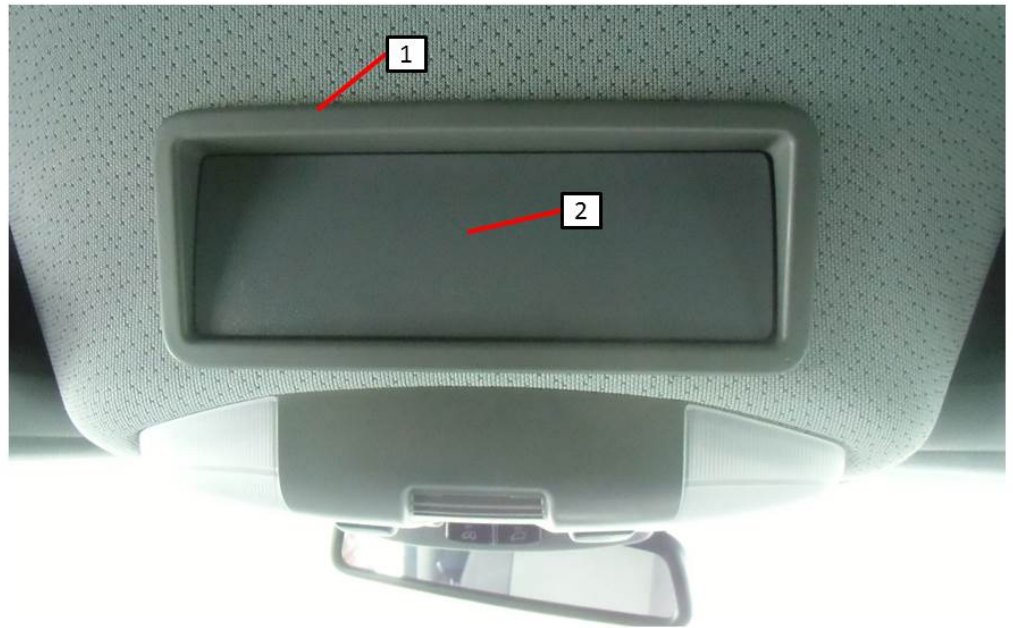
01.jpg:

Cover (1) of storage slot at front under roof liner (FF8) not fitting.

Minimum dimensions of the cutout in roof liner is too large leading to an insufficient overlap by the cover (1) (A 906 695 0130).
