Limp-home mode and delayed or non-existent upshift in combination with severe vibrations (in vehicles with automatic transmission)

Topic number	LI07.00-N-059118
Version	1
Design group	07.00 General
Date	06-03-2014
Validity	Model 906 with engine OM642
Reason for change	
Reason for block

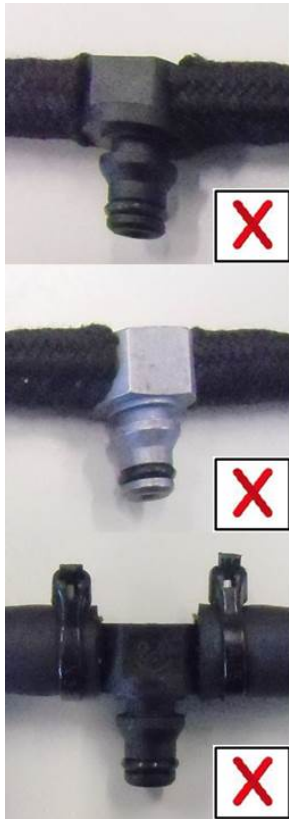
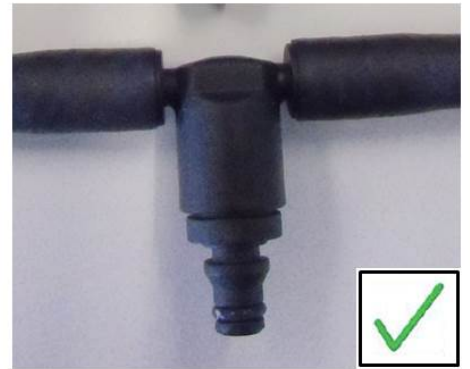
01 .jpg:

Incorrect T-piece due to prior incorrect repair (see Figure 01).

Note: An incorrect or incorrectly matched restrictor (T-piece) can result in power degradation, fault entries (rail pressure faults, boost pressure faults) and limp-home mode (see Figure 01).

Attachments	
File	Description
01 .jpg	Restrictor (T-piece)

1. Perform guided tests for the individual fault codes and process the faults if there are fault entries in the control unit. If all guided tests pass, proceed to Step #2.
2. Visual inspection of leak oil line and restrictor.
3. If there is a fault in the leak oil line or restrictor (T-piece) or if the wrong restrictor is installed, replace the leak oil line.

Note: The connections of the leak oil line must never be separated or replaced by other components! Always replace the entire leak oil line complete.
