Traces of oil in area around oil/water heat exchanger (inner V) on engine 642

Topic number	LI18.30-N-056338
Version	6
Design group	18.30 Oil cooling system
Date	07-01-2016
Validity	Model 639 with engine 642 Model 906 with engine 642
Reason for change	Corrected test step 3
Reason for block

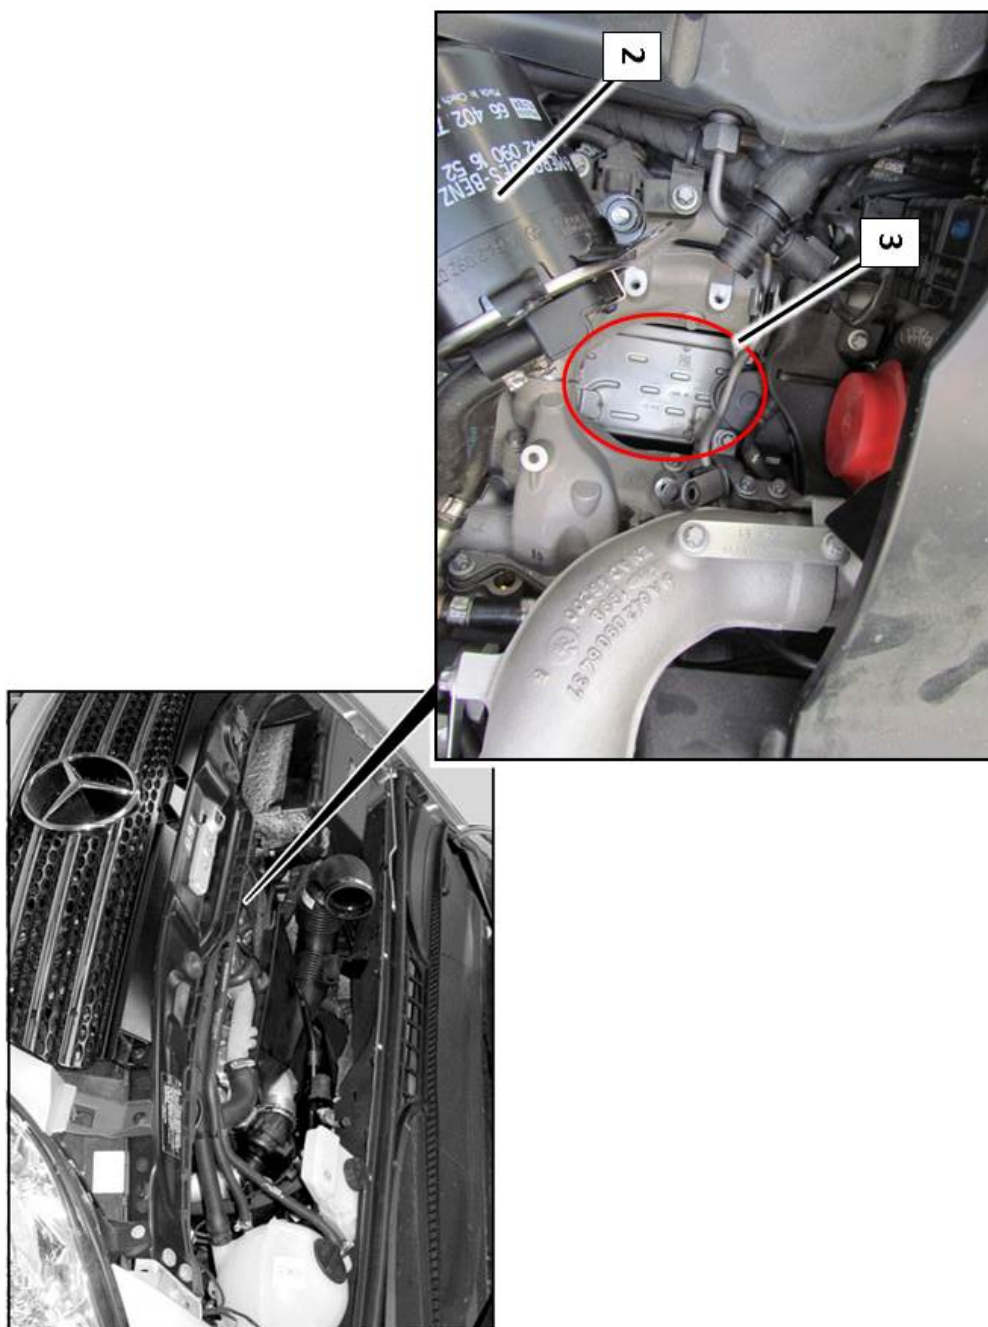
02.jpg:

- Traces of oil in area (3) around oil/water heat exchanger (inner V) on engine 642. See attachment "02.jpg"
- Traces of oil at drain points of inner V on engine 642.

Note: Do not disconnect the fuel hoses from the fuel filter (2).
3. Use a borescope (000 588 01 21 00) to check whether the traces of oil come from the area (3) around the oil / water heat exchanger.

Note: If the traces of oil come from the area (3) around the oil / water heat exchanger, continue with step 4. If the traces of oil do not come from the area (3) around the oil / water heat exchanger, ascertain the exact cause of the problem and initiate appropriate measures.
