Unusual handling characteristics caused by random sprung mass vibrations

Topic number	LI32.50-P-064467
Version	1
Design group	32.50 Active body control (ABC)
Date	07-14-2016
Validity	Model 222 and model 217 with code 487 (ABC)
Reason for change	
Reason for block

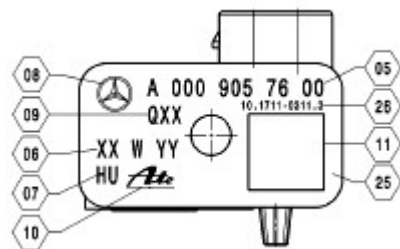
Beschleunigungssensor.
jpg:

Acceleration sensors may have been installed which could cause fault codes to be stored or unusual handling characteristics to occur. See the label on the sensor in the attachment.

File	Description
Beschleunigungssensor.jpg	Field 6 (XX W YY) on the sensor contains the affected batches. The following batches are affected: 16 W 16 16 W 18 16 W 19 16 W 20

1. Read out the fault code. If a fault code is displayed, replace only the affected acceleration sensor.
2. If complaint persists, change both acceleration sensors at the front axle and check the handling characteristics. If complaints persists, replace the acceleration sensor at the rear axle.
