Liftgate protective film wrinkled

Topic number	LI72.20-P-064479
Version	1
Design group	72.20 Rear door, tailgate
Date	07-11-2016
Validity	Model series 190 coupe
Reason for change	
Reason for block

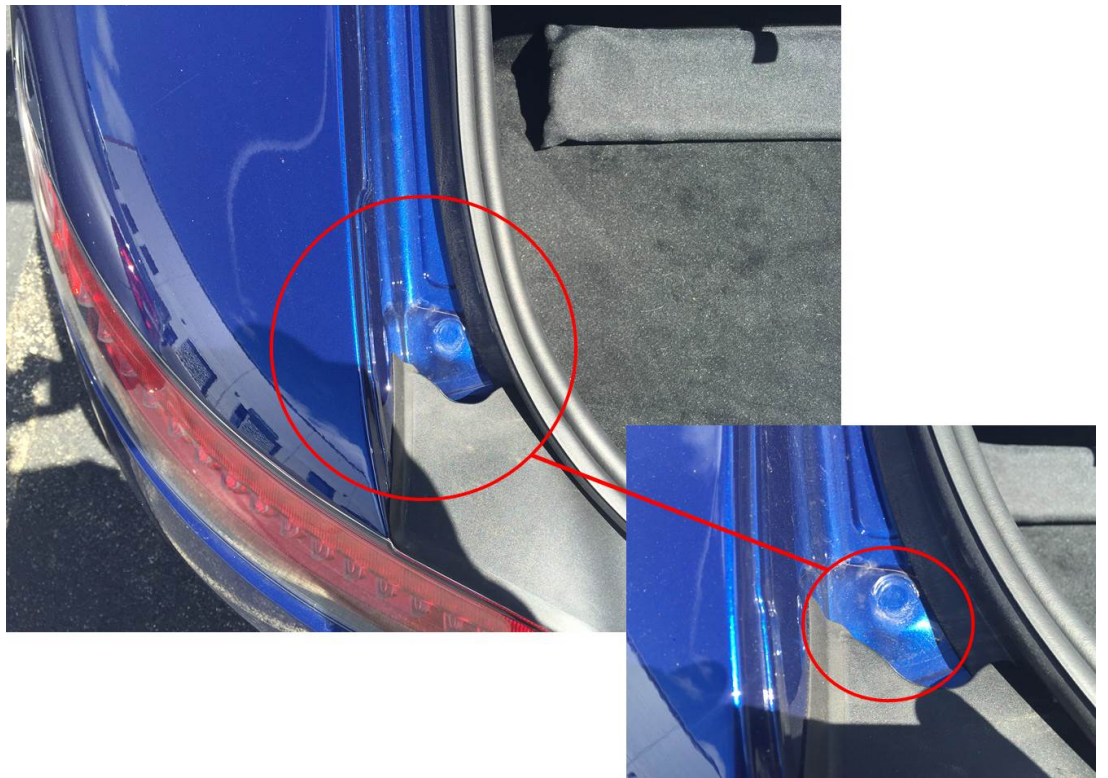
Picture1.jpg:

Body-side protective film for liftgate trunk lid lifter wrinkled, kinked, displaced, bubbled

Attachments	
File	Description
Picture1.jpg	Area of interest

Assembly error

Open liftgate and check left/right protective film for correct seating and clean bonding. Remove protective film if necessary. To do so, clean area with Teroson A0059891971 PU8550 and attach new film.
