Campaign No. 2016030011, April 2016

SUBJECT: Model 292, Model Year 2016 Replace Suspension Strut Electrical Harnesses

Service Campaign Bulletin

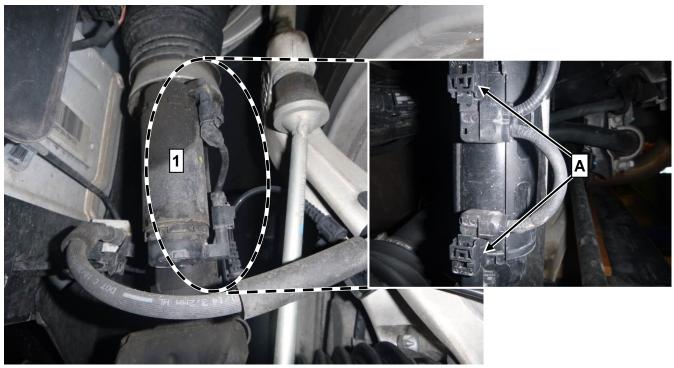
Figure 1 (Shown on left front axle)

This Service Campaign has been initiated because Daimler AG (DAG), the manufacturer of Mercedes-Benz vehicles, has determined that the electrical connector at the suspension struts does not meet specifications. It is possible that a leak may occur at the electrical connector and then the message "AIRMATIC fault" could illuminate in the display. To remedy this, an authorized Mercedes-Benz dealer will replace the electrical harness at the suspension struts on the affected vehicles as a precautionary measure.

- 1. Remove wheels.
- 2. Replace front air suspension strut (1 Figure 1) electrical harness (A):
- Remove front section of front wheel well lining to expose harness connectors.
- Replace front air suspension strut (1 Figure 1) electrical harness (A).
