# XENTRY TIPS

## Coolant / Vacuum / Temperature faults - Check Engine Light with DTCs P003313, P0299FA, P0299FB, P226100, P261F71, P012800, P012809

Topic number	LI07.09-N-063338
Version	2
Design group	07.09 Vacuum system
Date	04-26-2016
Validity	OM651
Reason for change	Updated remedy, pictures, cause, and parts
Reason for block

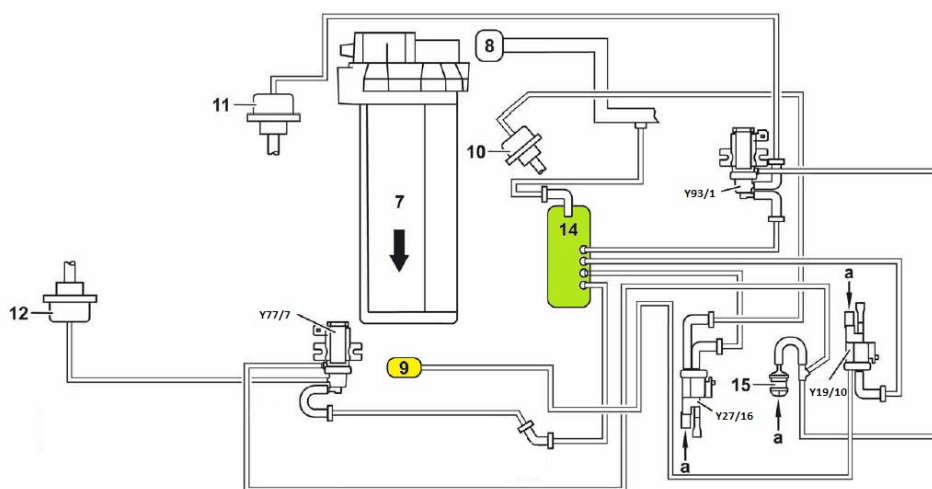
Sprinter OM651 vaccum diagram.jpg:

Vacuum system shown on engine 651.911

1- Inspect the vacuum system for loose connections or cracked hoses (See Vacuum Diagram)

-Yellow color -> part #9 --> connection point behind the coolant pump bracket

-Green color --> part #14 --> vacuum reservoir

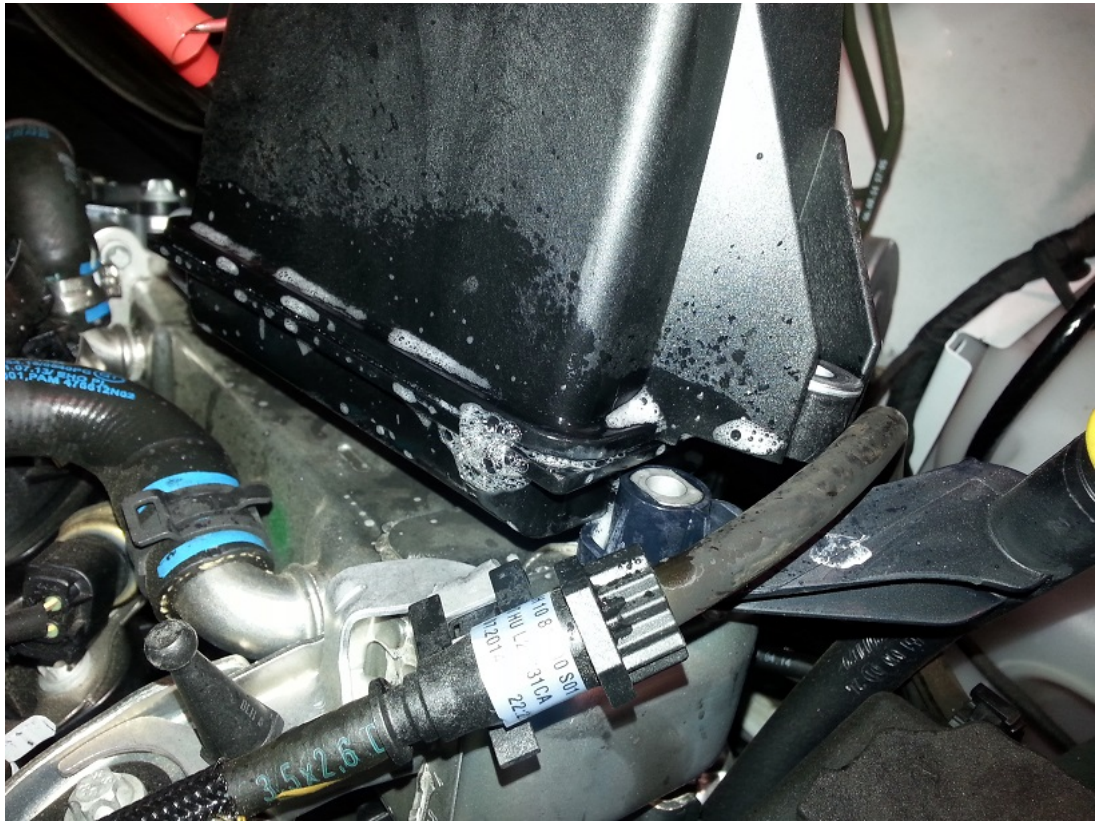
Leaking vaccum manifold.jpg:

-Vacuum manifold / Vacuum reservoir

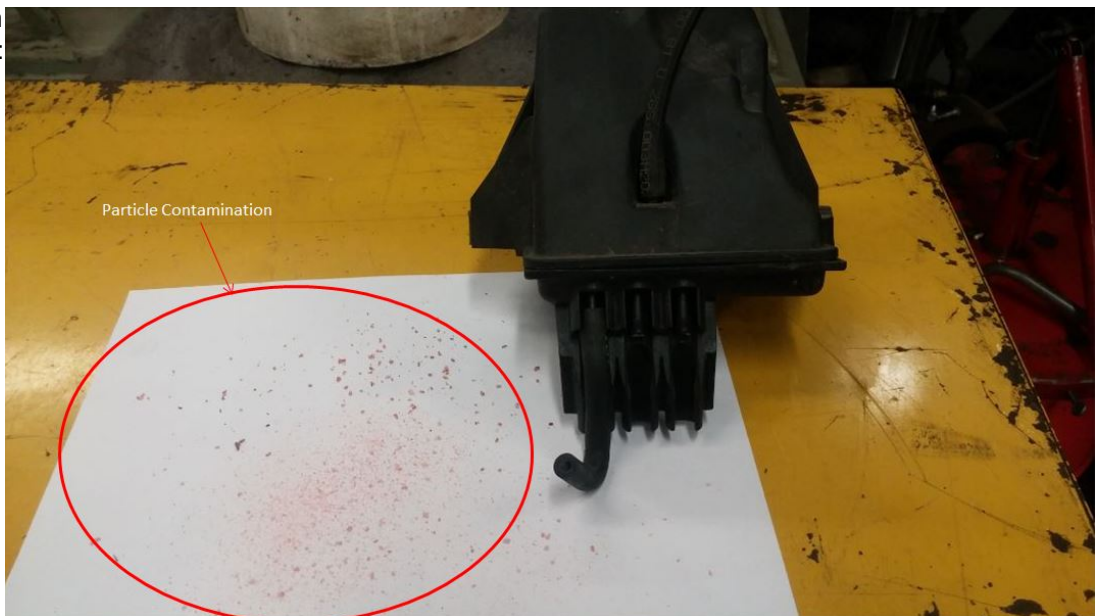
Particulate contamination of vacuum reservoir.JPG:

- Particulate matter

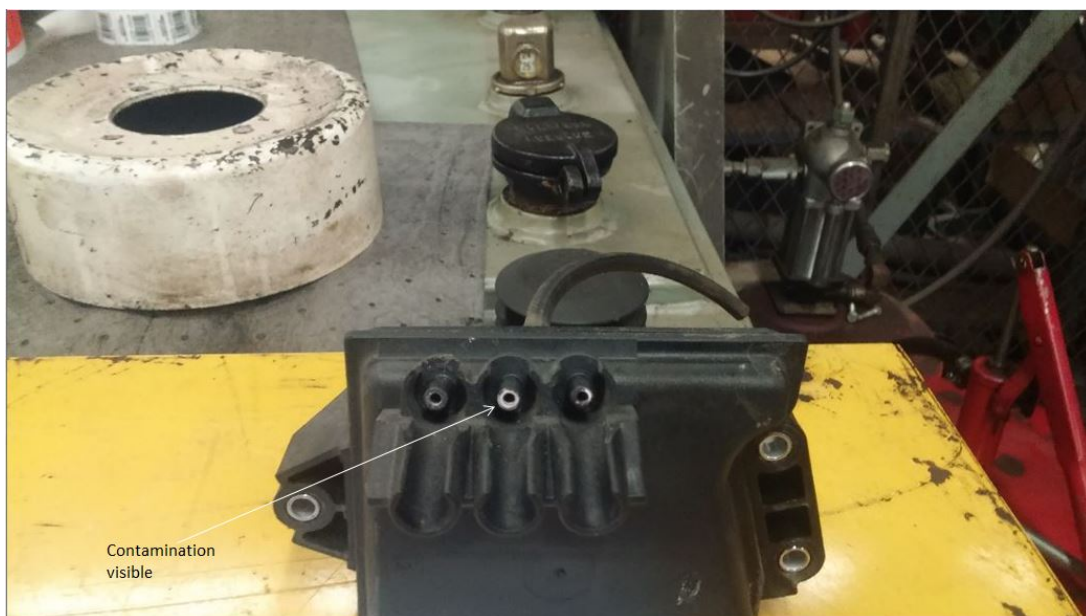
Vacuum reservoir contaminated output ports.jpg:

- Contamination of the inside of the vacuum connection

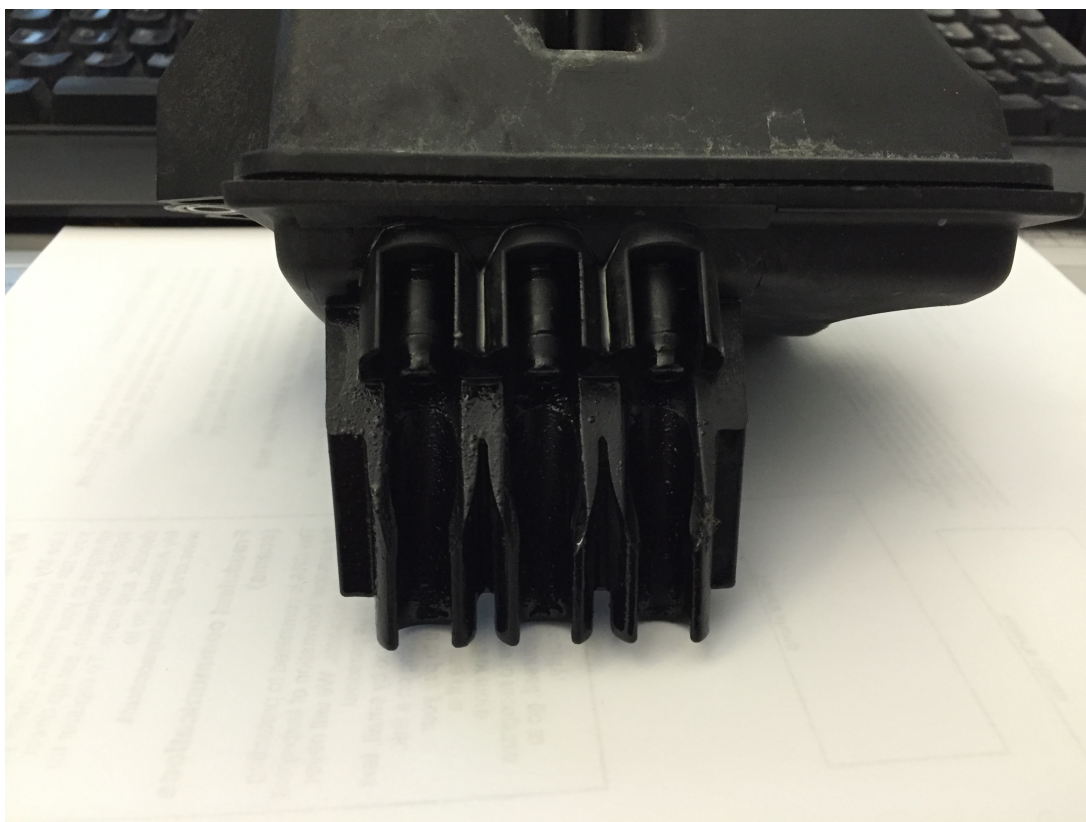
Liquid contamination vacuum reservoir.jpg:

- Any signs of coolant and/or oil on the inside of vacuum connections on the vacuum reservoir

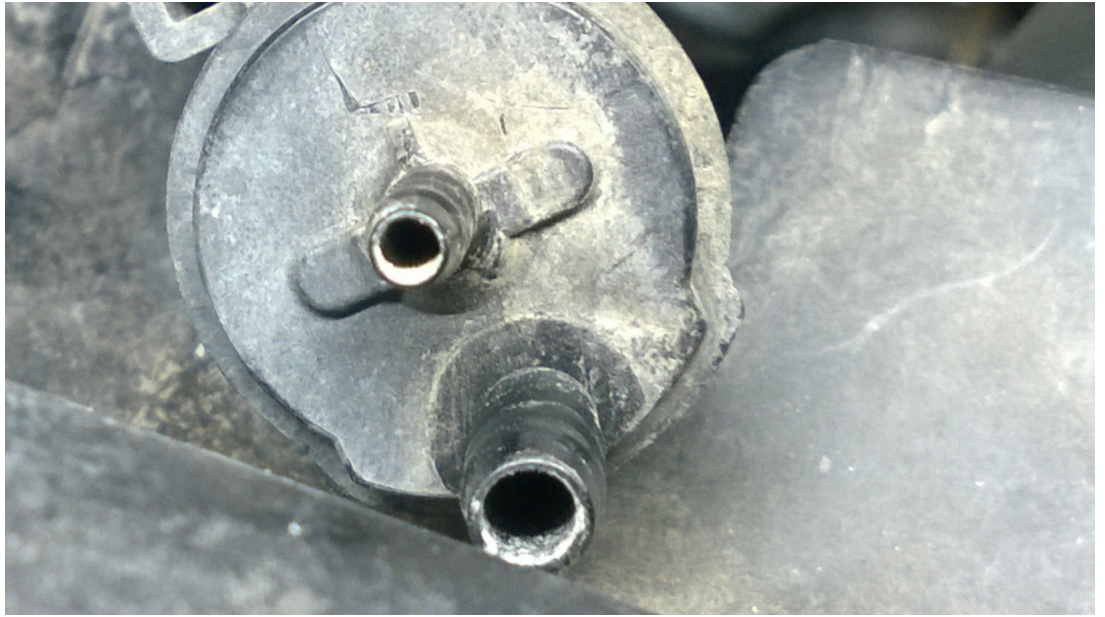
Contaminated EV Valve.  
jpg:
