MODEL
2018MY
Forte (YDm)
Rio (SC)

NUMBER
186

TECHNICAL SERVICE BULLETIN

SUBJECT: SERVICE ACTION: SPARK PLUG REPLACEMENT (SA342)

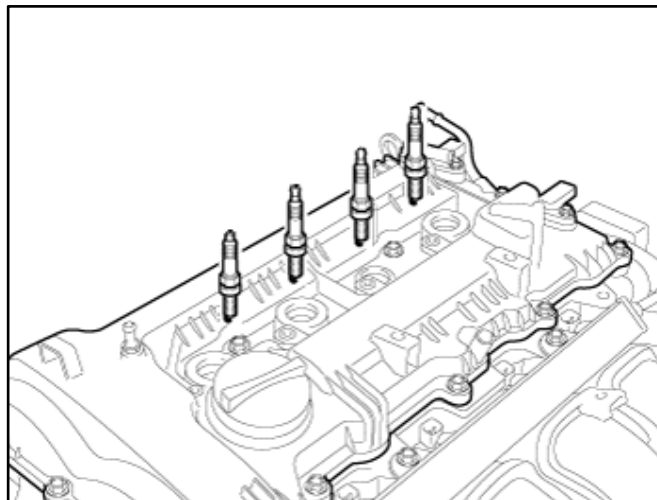
This bulletin provides the procedure to replace the spark plugs on some 2018MY Forte (YDm), produced from November 21, 2017 through April 12, 2018, and 2018MY Rio (SC) vehicles, both produced from November 22, 2017 through February 6, 2018, which may exhibit a malfunction indicator lamp (MIL) ON with DTCs P0300 through P0304 due to the spark plug porcelain cracking during manufacturing. Follow the procedure outlined in this bulletin to replace all four spark plugs, whether or not the MIL is ON. Before conducting the procedure, verify that the vehicle is included in the list of affected VINs.

DTCs P0300 – P0304: Random/Multiple Cylinder Misfire Detected
