Technical Service Bulletin: TSB170079	Released Date: 02-Apr-2018
Incorrect Aftertreatment Part Number Etching

- B6.7 CM2350 B121B
- L9 CM 2350 L116B
- X15 CM2350 X114B

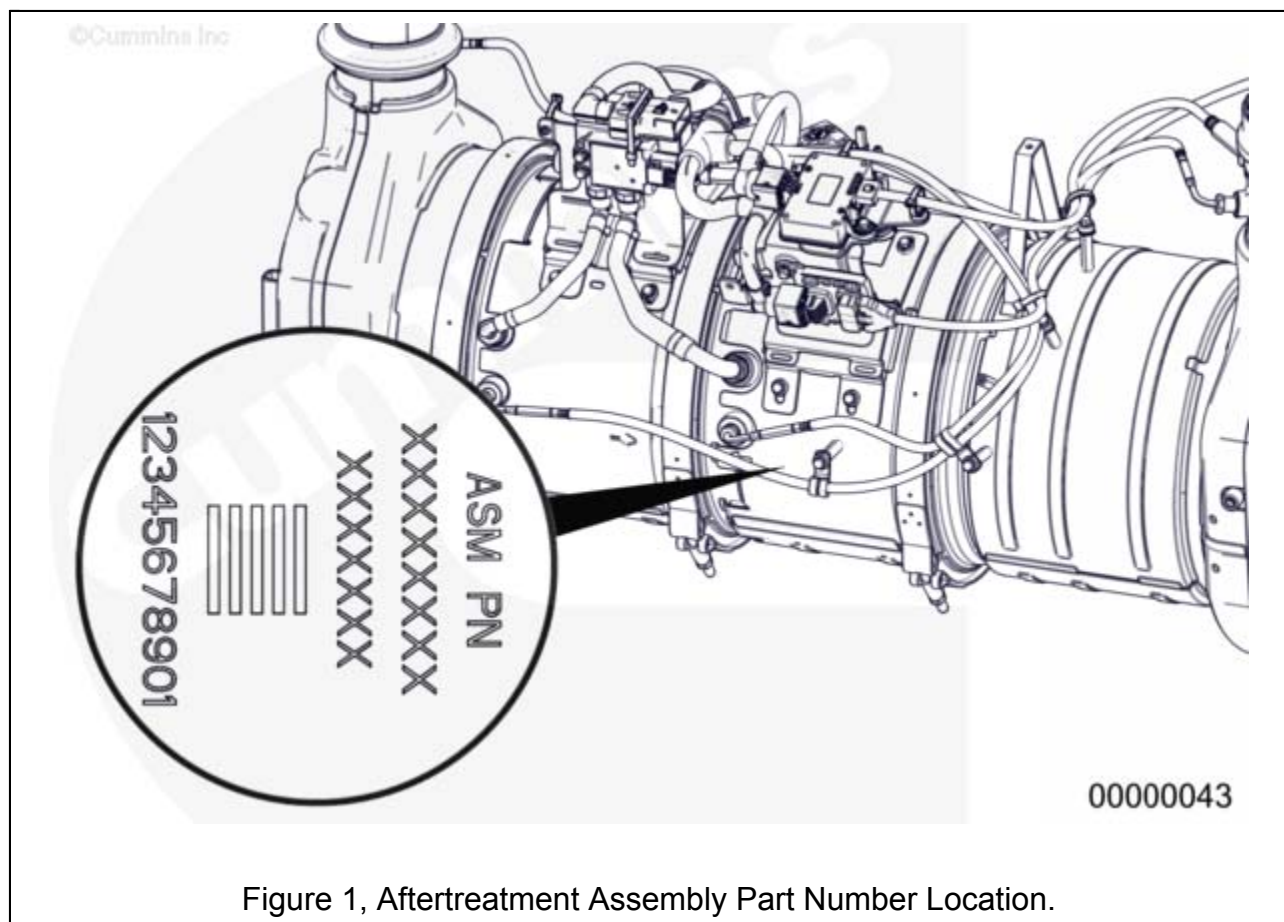
- Figure 1 below displays location of entire assembly part number, which can guide in further identification of needed individual parts.
- Figure 2 below displays location of E PN and C PN on aftertreatment DOC.
- More information about part number identification and location can be found in the corresponding service manual.
 - See B6.7 CM2350 B121B Service Manual, Bulletin 5411223. Refer to Procedure 100-001 (</qs3/pubsys2/xml/en/procedures/455/455-100-001.html>) in Section E.
 - See L9 CM2350 L116B Service Manual, Bulletin 5411330. Refer to Procedure 100-001 (</qs3/pubsys2/xml/en/procedures/459/459-100-001.html>) in Section E.
 - See X15 CM2350 X114B Service Manual, Bulletin 5411181. Refer to Procedure 100-001 (</qs3/pubsys2/xml/en/procedures/377/377-100-001.html>) in Section E.

- Before ordering an aftertreatment diesel particulate filter (DPF), aftertreatment decomposition tube (DRT), aftertreatment diesel oxidation catalyst (DOC), or aftertreatment selective catalytic reduction (SCR) catalyst, verify aftertreatment component part numbers are correct for the specific aftertreatment system. Use Tables 1, 2, 3, and 4 below to verify part numbers.
