# Technical Service Bulletin

SUBJECT:		No: <b>TSB-18-42A-001</b>	
<b>RUST ON QUARTER PANEL</b>		DATE: <b>April 2018</b>	
		MODEL: <b>2011-14 Outlander Sport/RVR</b>	
CIRCULATE TO:	<input type="checkbox"/> GENERAL MANAGER	<input checked="" type="checkbox"/> PARTS MANAGER	<input checked="" type="checkbox"/> TECHNICIAN
<input checked="" type="checkbox"/> SERVICE ADVISOR	<input checked="" type="checkbox"/> SERVICE MANAGER	<input checked="" type="checkbox"/> WARRANTY PROCESSOR	<input type="checkbox"/> SALES MANAGER

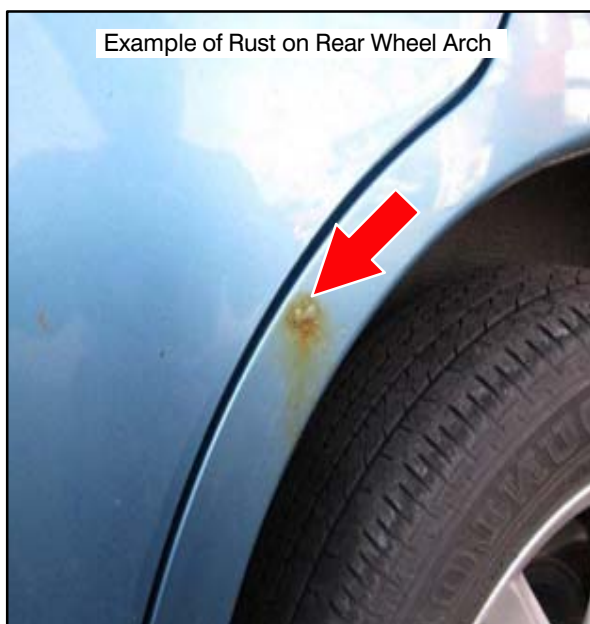
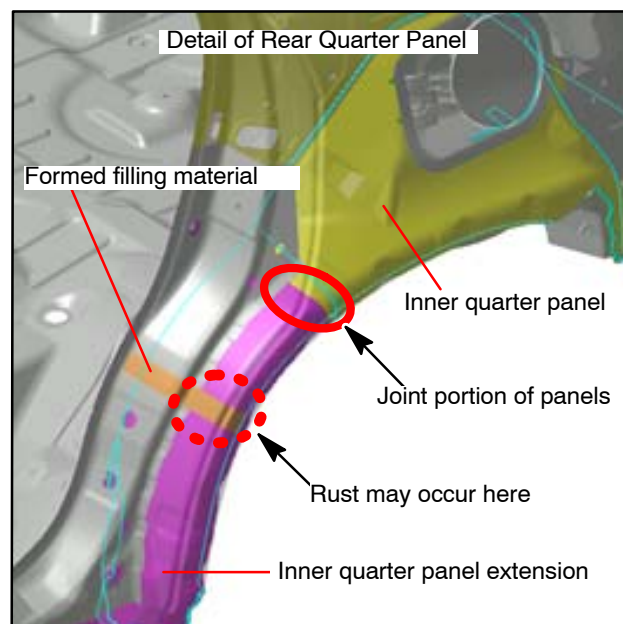
A customer may report a condition where rust forms on the outer side panel (see example in photo below). This may be a result of water penetrating into the joint portion between the inner quarter panel and the inner quarter panel extension where sealant was incompletely applied during manufacturing. If the vehicle has been washed with high-pressure water (such as a power washer), water may intrude and remain in the formed filling material, possibly leading to rust on the outer side panel.

In case corrosion repair on the quarter panel is required, this TSB instructs dealers to apply sealant to the joint area shown below, preventing recurrence of rust.

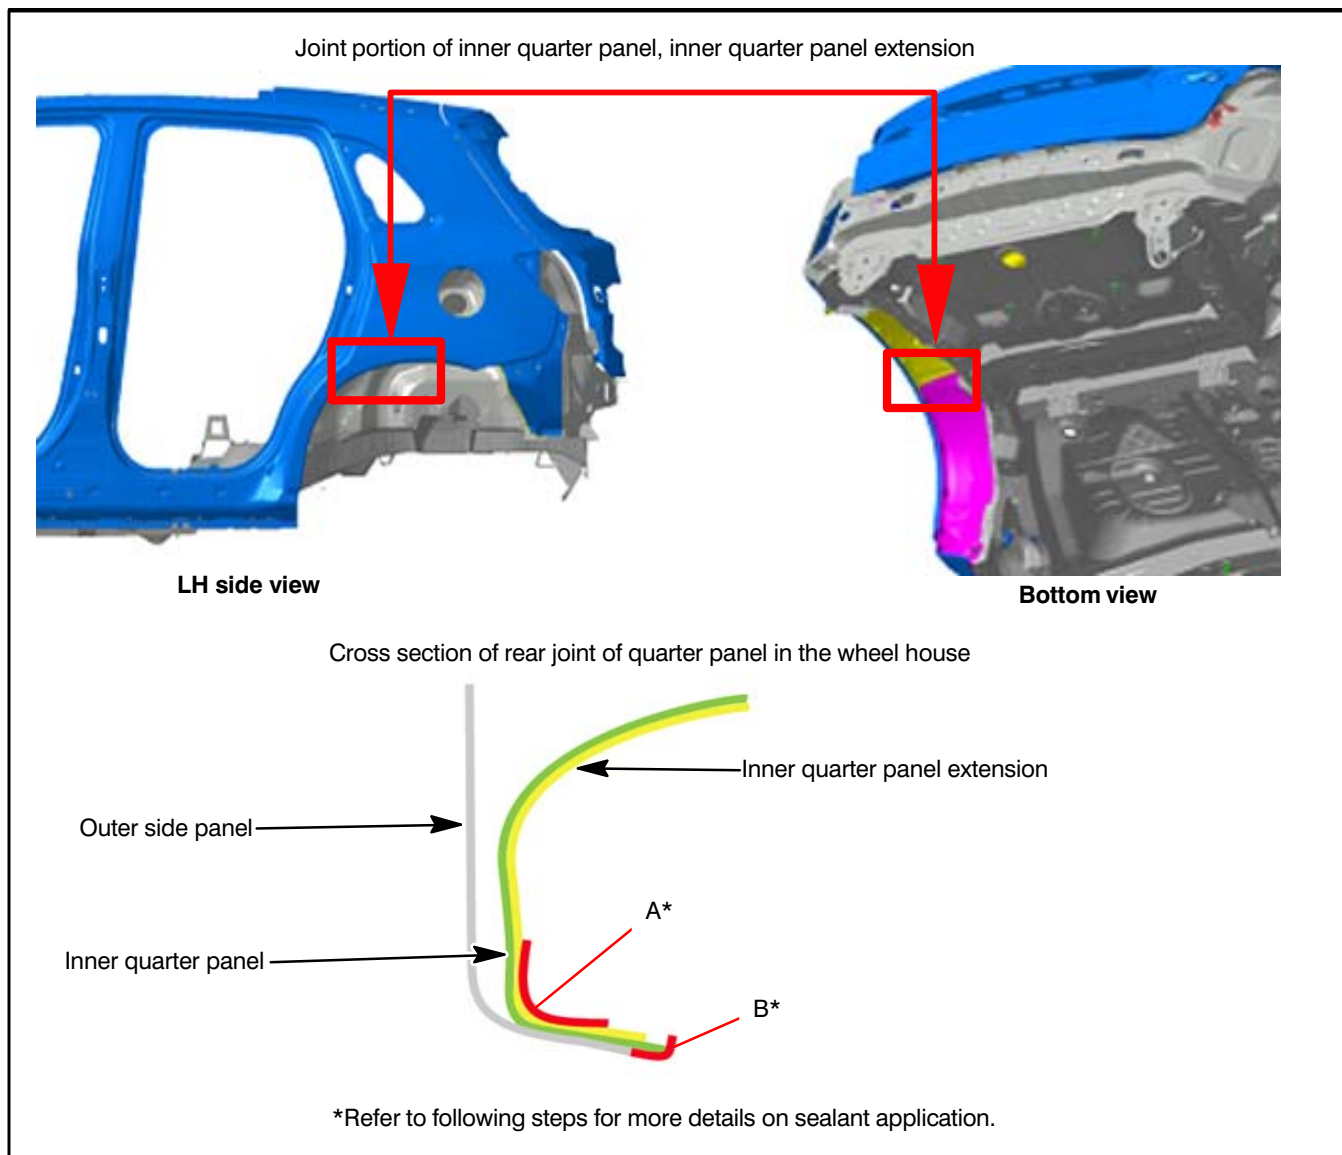
Rust recurrence can be avoided by applying sufficient sealant at the edge of the overlap/joint portion of the inner quarter panel to inner quarter panel extension [A] and outer side panel [B], after the panel is repaired.

1. Remove the rear wheel to gain access.
2. Take photographs of ALL rusted areas on the panels. See picture above for location of area(s) to be photographed.
