SI B52 02 17
Seats

SERVICE ACTION: CHECK PUMP FOR BACKREST WIDTH ADJUSTMENT

F80 (M3 Sedan)	F82 (M4 Coupe)
----------------	----------------

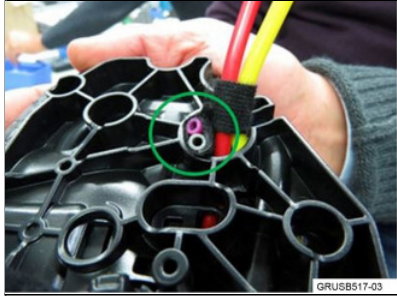
Note on Competition Seat</p> <p>Both the lines are not required, the competition seat does not have lumbar support, when replacing the air pump. The unused lines have to be cut off using a suitable tool. Pay careful attention to the correct line colors when cutting off. Use the removed part as a reference; see image.</p>
