SI B54 06 17
Special Roofs

WATER LEAK NEAR ROOF FUNCTION CENTER (FZD)

F25 (X3)

F25 PANORAMA ROOF DRAINAGE REPAIR PROCEDURE

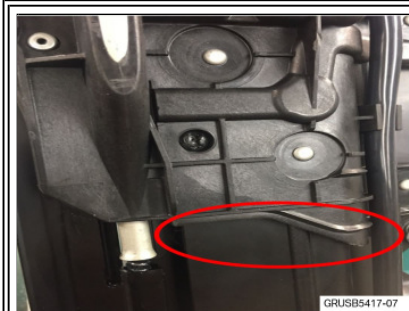
Water is leaking at front of sunroof cassette, at the front end frame at the plastic/aluminum junction point.

Apply additional butyl rope to reinforce transition point at the front end frame of the sunroof cassette.

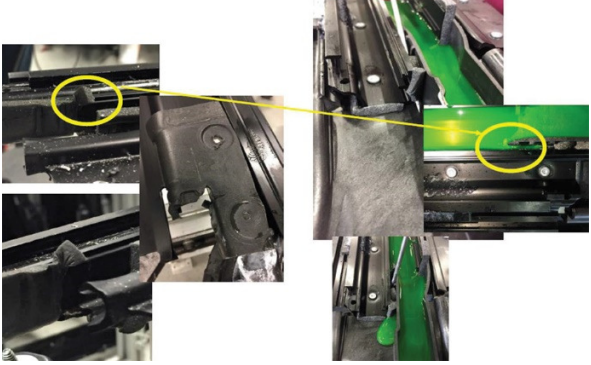
<ol style="list-style-type: none"> 1. Refer to Repair instructions "REP 54 10 260 Removing and installing panorama glass roof". With headliner removed, identify the affected area and water test to confirm leak location. Note: In the picture at left, the water is dyed green for clarity.

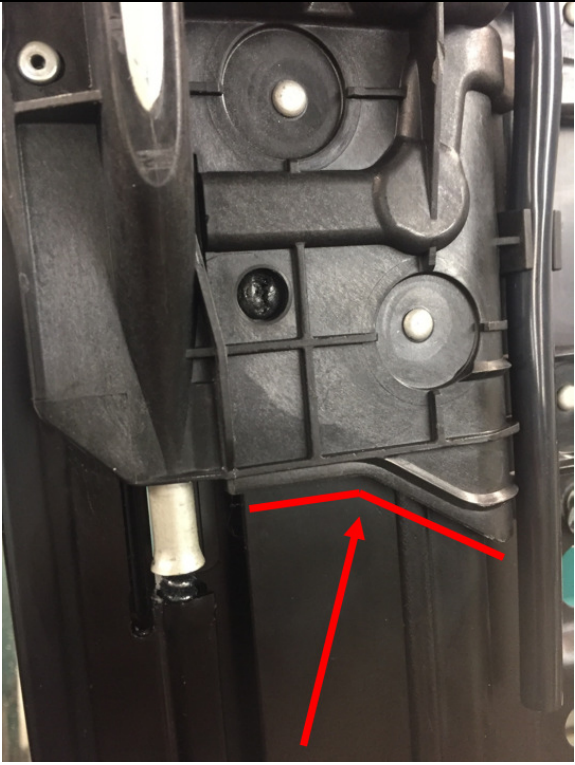
<ol style="list-style-type: none"> 2. If the water is leaking in this area (junction between aluminum and plastic end frame of the sunroof cassette), remove all water from cassette and prepare to perform repair. Continue with sunroof cassette removal.
