Service Alert

Subject: UPDATED - MAZDA CONNECT NAVIGATION CANNOT FIND STREET ADDRESS WITH VERSION 59.00.532 OR 59.00.540	Service Alert No.: SA-012/18
	Last Issued: 04/23/2018

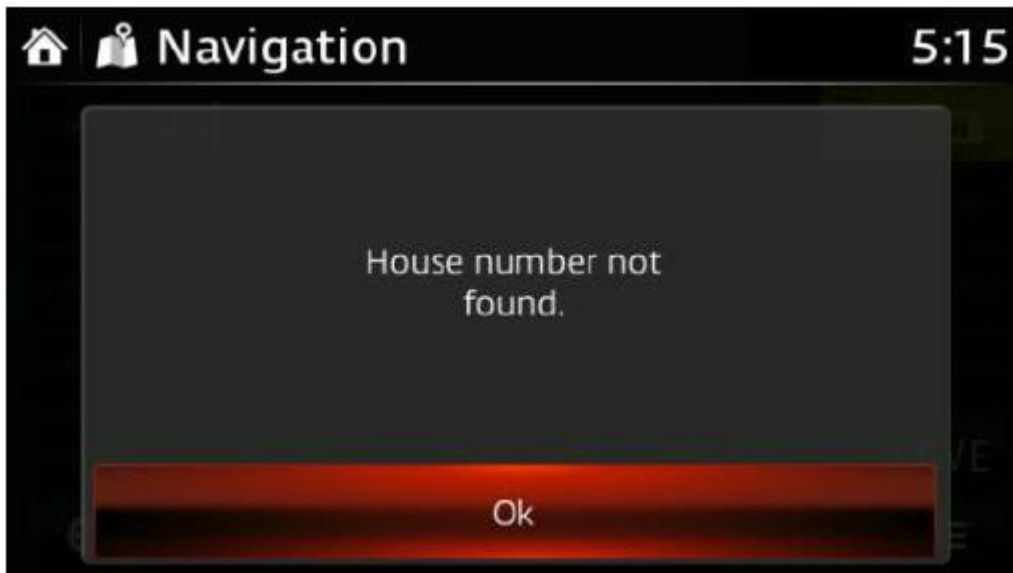
- A screen pops up that says "House number not found." After the user selects OK, the system finds the address or a nearby address.

This only occurs with MAZDA CONNECT software version **59.00.532** or **59.00.540**, which started being installed into vehicles in January 2018. The concern can be eliminated by installing MAZDA CONNECT software version **59.00.545** now available on MGSS.

1. Check to see if the vehicle has MAZDA CONNECT software version **59.00.532** or **59.00.540**.

- YES - Use [AUDIO, NAVIGATION AND PHONE CONCERNS WITH MAZDA CONNECT INFOTAINMENT SYSTEM TSB](#) to change the MAZDA CONNECT software to version **59.00.545**.
- NO - Troubleshoot the Navigation system using the instructions on MGSS.

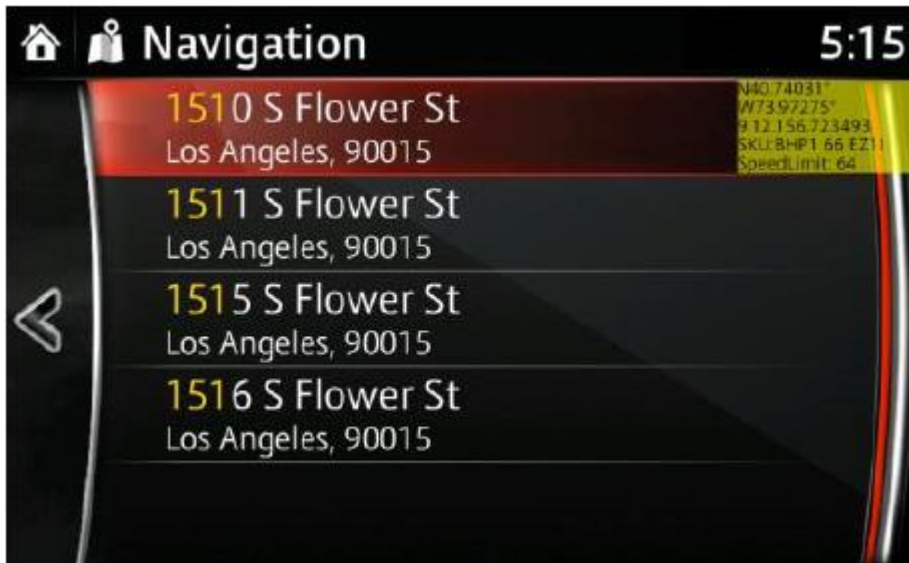
- Instead of finding the correct address number the system adds a digit to the end of the number.

Example: You enter 151 and the system comes back with 1510, 1511, 1515, 1516, etc.
