NUMBER: 08-037-14

GROUP: Electrical

DATE: March 29, 2014

RB4 Radio Enhancements

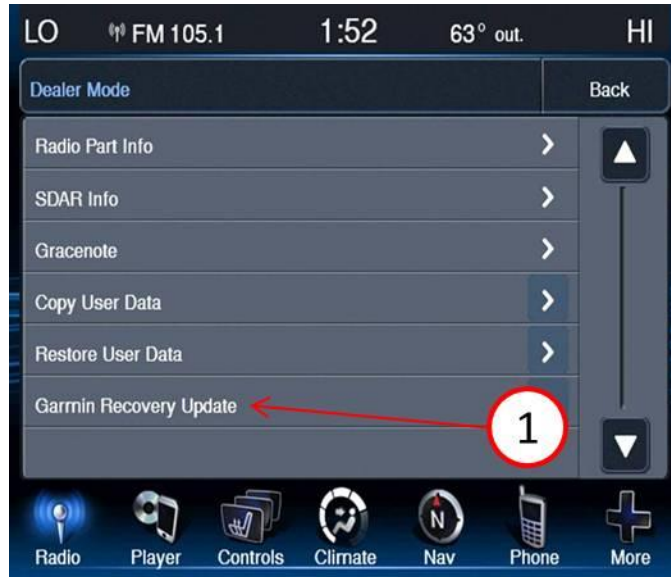
Fig. 1 Press Garmin Recovery Update to begin update

1 - Press soft key to begin

6. When the update is completed, the screen will read “Reflash Successful”. Touch the screen and the radio will reboot.
7. The screen will now show the old and new software, press “No” on the screen to eject the disc.
8. Put the radio into dealer mode by press the drives Temp up and down and the front defrost all at the same time until the dealer mode screen is displayed.
9. Press the soft key “Garmin Recovery Update” to begin the navigation update, see (Fig. 1).

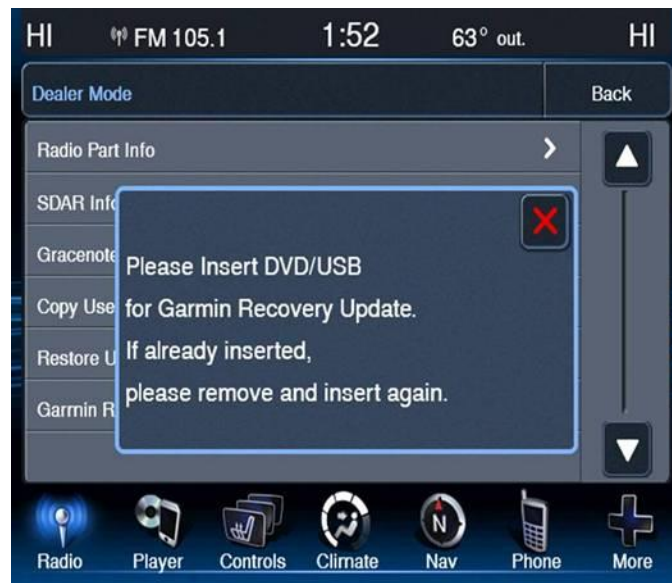
Fig. 2 Insert update when this screen is displayed

1 - Insert the update disc into the CD drive

-
10. To update the navigation system, insert the disc into the CD drive(Fig. 2).

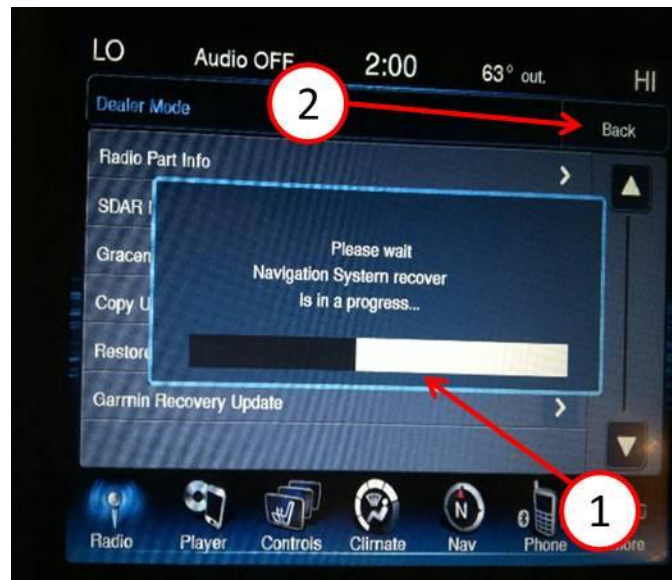
Fig. 3 This screen will be displayed next

1 - Pop up

2 - Soft key, back button

11. This is the first step in the update, System recover. When this part is done the pop up will no longer be displayed. This will only take a few minutes.
12. To continue press the "Back" soft key in the upper left hand corner of the screen (Fig. 3).

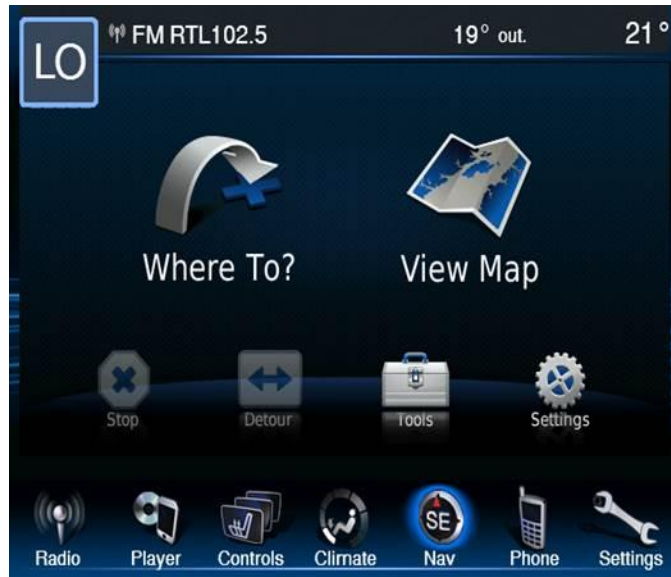
Fig. 5 Update has been completed

1 - Navigation has been updated

14. When the software has completed down loading, the screen will change to the Garmin main screen, see (Fig. 5).
