TECHNICAL SERVICE BULLETIN

Gearshift Selector Lever Bezel Door Binding, Skewed And/Or Not Latching

18-2088

Ford 2014-2018 Police Interceptor Sedan
2014-2018 Taurus

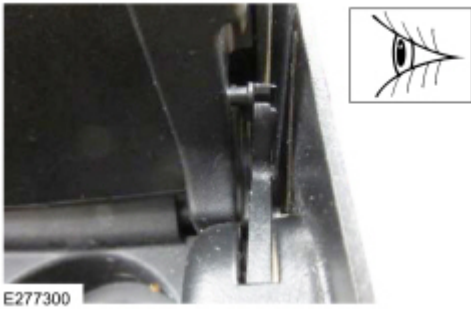
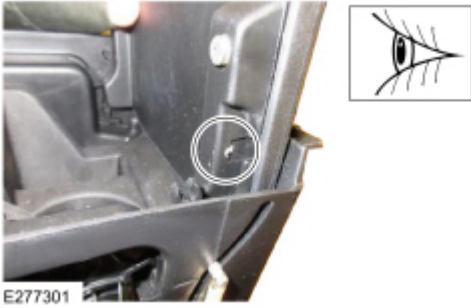
1. Inspect the door pivot pin and pivot pin linkage for damage. Is any damage present? (Figures 1 - 2)
 - (1). Yes - replace the gearshift selector lever bezel. Refer to Workshop Manual (WSM), Section 307-05.
 - (2). No - proceed to step 2.
