# TECHNICAL SERVICE BULLETIN

## 6.7L Diesel - Block Heater Inoperative And/Or Tripping Electrical Breaker/GFCI Outlet - Built On Or Before 24-Oct-2017

**18-2116**  
17 April 2018

<b>Ford</b> 2017 F-Super Duty
----------------------------------

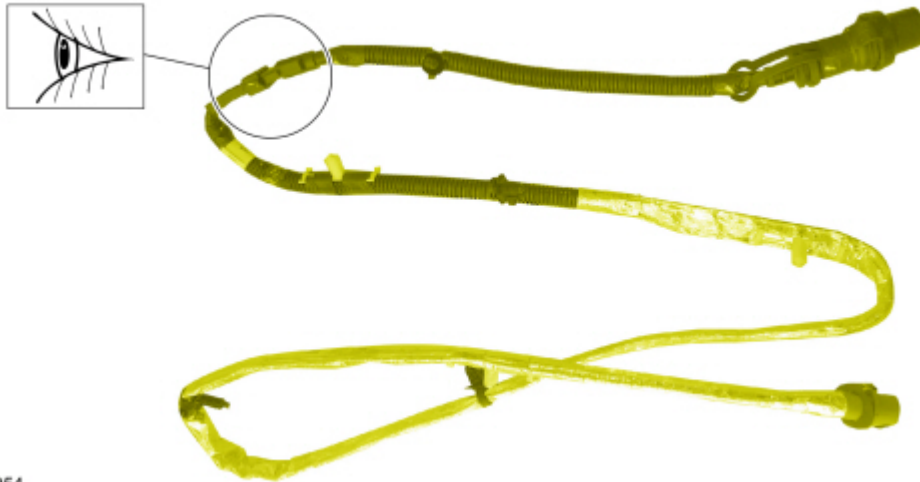
Figure 1

**Issue:** Some 2017 F-Super Duty vehicles equipped with a 6.7L diesel engine built on or before 24-Oct-2017 may exhibit an inoperative block heater. This can also result in tripping an electrical breaker or a ground fault circuit interrupter (GFCI) outlet. This may be due to water intrusion into the block heater power cord inline connector.

1. Inspect the block heater power cable inline connector for signs of water intrusion. The connector is located directly behind the right side bumper and can be accessed from under the vehicle. (Figure 1)

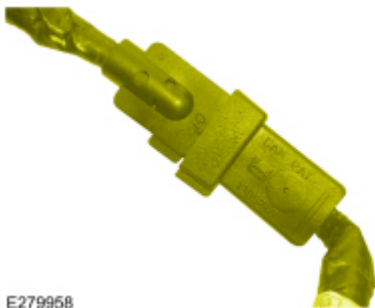
Figure 2

4. Replace the block heater power cable. Inspect the new block heater power cable for electrical grease within the inline connector. Is there electrical grease present? (Figures 2 - 3)

5. Fill the inline connector of the new power cable with Motorcraft® Electrical Grease or equivalent.
6. Install the new block heater power cable; following the routing of the old power cable.
7. To install the right front fender splash shield, reverse the removal procedure.
