Service Bulletin

Bulletin No.: 18-NA-051

Subject: TTY Phone Feature Icon Missing from Radio Display Setting

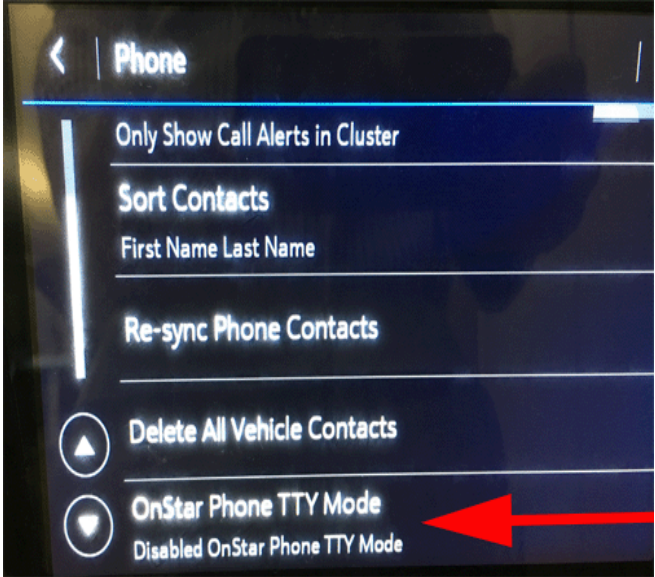
| Condition | <p style="text-align: right;">4889130</p> <p>Some customers may comment on the TTY phone feature icon missing from the radio display settings. The TTY feature helps people who are hearing impaired communicate on the phone. This feature is calibrated off and these calibrations will enable the menu and allow the driver to adjust the setting as they want.</p> |
| Cause | This may be due to a software calibration. |

| Correction | Update the radio with the latest calibrations available in TIS2WEB. |

If you encounter a vehicle with the above concern, SPS program the radio. Refer to *Radio: Programming and Setup* in SI. USB programming is not required.
