Service Bulletin

Bulletin No.: 17-NA-143

Subject: Clicking Noise from Front On Accel and Decel at Low Speeds

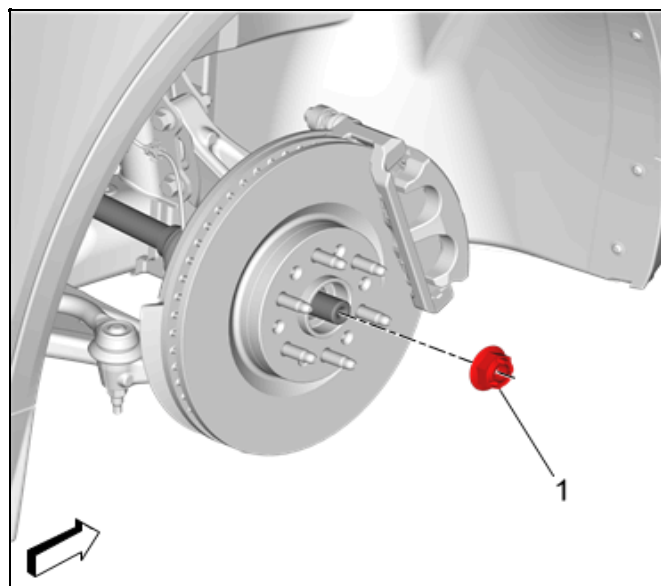
4296858

Caution: DO NOT use air tools to remove the wheel drive shaft nut. Damage to the wheel drive shaft threads could occur. Use hand tools only.

2. Remove the wheel drive shaft nut (1) and **DISCARD** the nut.
3. Separate the steering linkage outer tie rod from the steering knuckle.
