Service Bulletin

Subject: Diagnosis and Repair HVAC Blower Function

Models: 2008-2013 Cadillac Escalade Models
2007-2013 Chevrolet Silverado
2008-2013 Chevrolet Suburban, Tahoe
2007-2013 GMC Sierra
2008-2013 GMC Yukon Models
All Built Prior to November 1, 2012

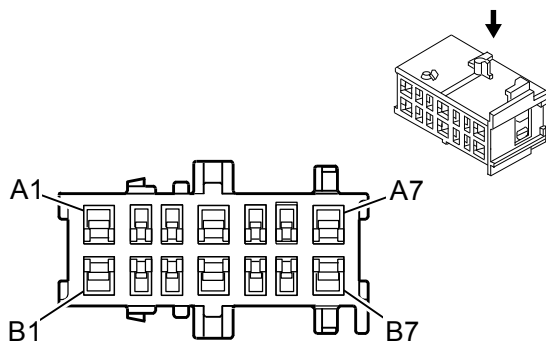
Junction Block X4 Correction

One possible cause of this condition may be the contacts in the HVAC junction block(s) located at the right side of the instrument panel.

2. Locate Pin A6, Circuit 754.
3. Perform a pin drag test using test probe J-35616-2A (GY).
4. If the terminal fails the pin drag test, replace the terminal for Pin A6. Refer to Junction Block - Right I/P X4 in SI.
5. Cut off the terminal between the core and the insulation crimp to minimize any wire loss.
6. To minimize wire loss, remove only the insulation required.
7. Position the stripped wire in the terminal.

8. Hand crimp the core wings first.
9. Hand crimp the insulation wings around the cable.
10. Solder the hand crimp terminal.
