# Service Bulletin

Bulletin No.: 18-NA-117

**Subject: Foam Visible Where Instrument Panel Meets Windshield**

Brand:	Model:	Model Year:		VIN:		Engine:	Transmission:
		from	to	from	to		
Chevrolet	Cruze	2017	2018

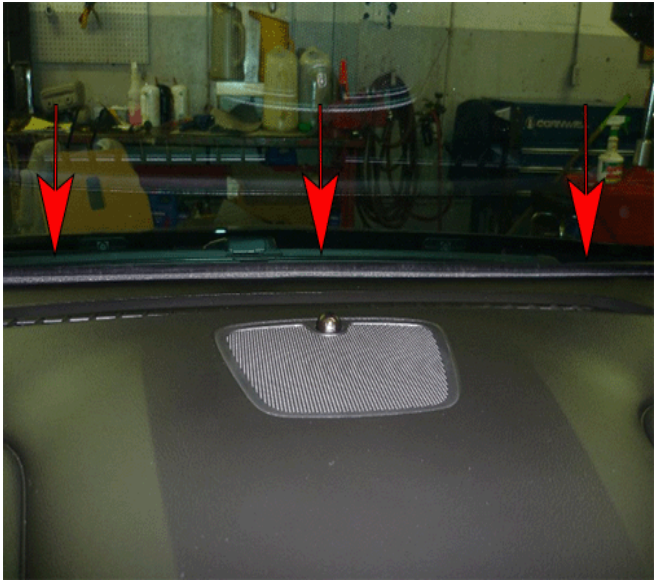
<b>Involved Region or Country</b>	North America and N.A. Export Regions
<b>Condition</b>

<p style="text-align: right; font-size: small;">5042338</p>
<b>Cause</b>	This condition may be caused by the foam that is installed on the instrument panel to aid with eliminating squeaks and rattles.
<b>Correction</b>	No repairs are to be attempted. The foam is visible to design intent.
