Service Bulletin

File in Section: 06 - Engine
Bulletin No.: 13-06-01-003E
Date: April, 2014

Subject: Excessive Oil Consumption – Perform Oil Consumption Test and/or Install Piston and Piston Ring Kit

Models: 2010-2013 Buick LaCrosse
2011-2013 Buick Regal
2012-2013 Buick Verano
2010-2013 Chevrolet Equinox
2012-2013 Chevrolet Captiva
2012-2013 Chevrolet Orlando (Canada Only)
2010-2013 GMC Terrain
Equipped with 2.4L Engine (RPOs LAF, LEA)

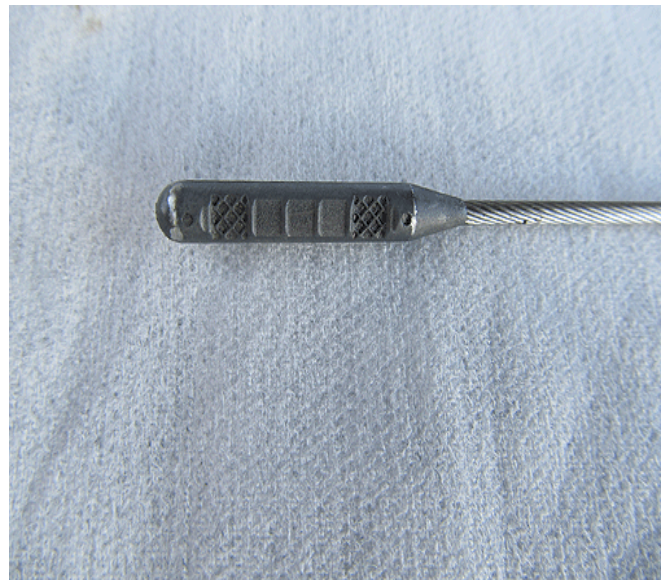
3339530

Important: When checking the oil level with the oil dipstick design shown below, please note that the oil volume per notch is not linear due to the shape of the block. The upper notches (relative to the top of the handle) equal 0.24 quart (0.227 L) between each notch while the lower notches only equal 0.14 quart (0.132 L) between each notch. As a result, no oil will appear on the dipstick if it is low on oil by approximately 1.25 quarts (1.18 L) or more. When determining the oil consumption rate, the oil volume added to return it to the starting location is the total amount of oil consumed. The consumption rate must be documented on a repair order.

Notice: Do not add too much oil. An overfill can lead to burn off of the excess oil. Advise the customer to wait until the oil is below the cross-hatched area at the tip of the dipstick before adding oil.

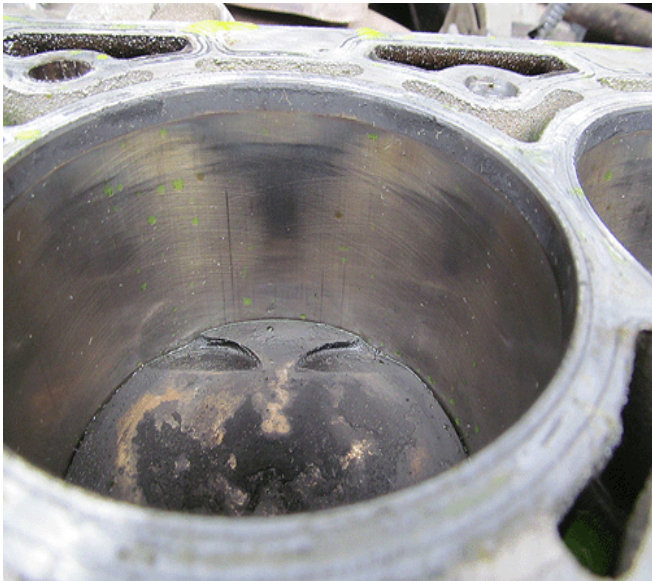
3339531

The repair is to replace the pistons and rings. In some cases the bore surface may not have a uniform look to the finish (zebra stripes) as shown below. As a result, some technicians may question whether the engine should be repaired or replaced. After careful evaluation, GM Powertrain has determined that the new pistons and rings will perform correctly in bores that have this appearance so engine replacement should not be necessary. The cylinder bores do not need any machine or honing work performed on them. Refer to the picture below for acceptable surface finishes.

Acceptable Cylinder that Does Not Appear Uniform (Zebra Stripes)

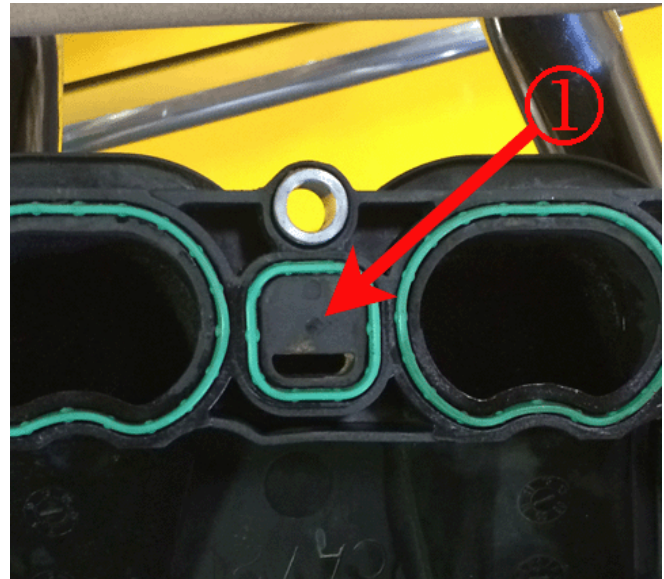
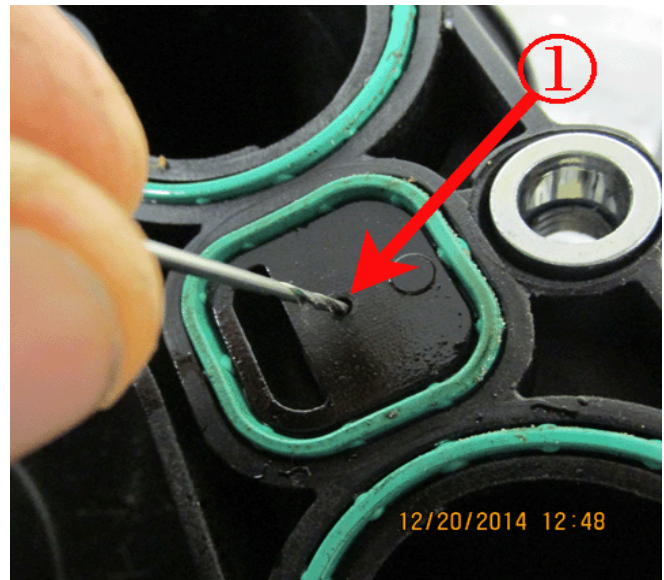
The oil consumption may have clogged/ reduced PCV flow. The PCV system should be serviced.

(1) PCV orifice in the intake manifold

Clean any ice/sludge/water/carbon out of the PCV pipes/hoses, the PCV nipple on the cam cover, the PCV orifice between the #2 and #3 intake runners (use a 1/16 inch drill bit as illustrated below).

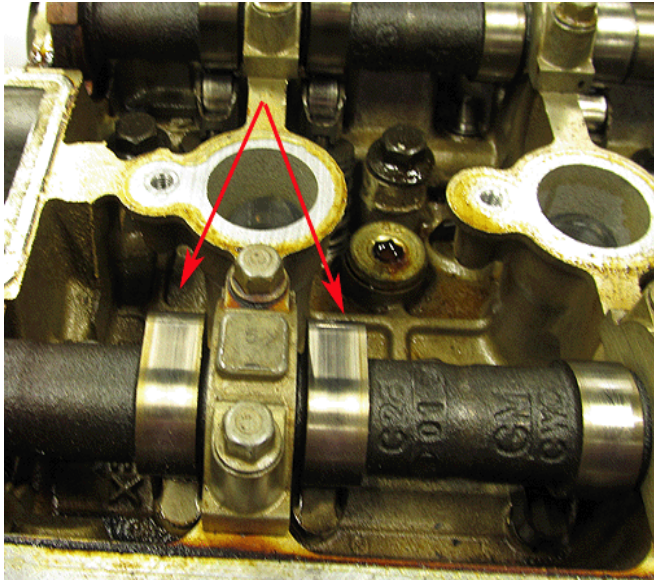
3409678

- Camshafts and roller follower will have wear markings. This is normal and do not need to be replaced (refer to picture above).

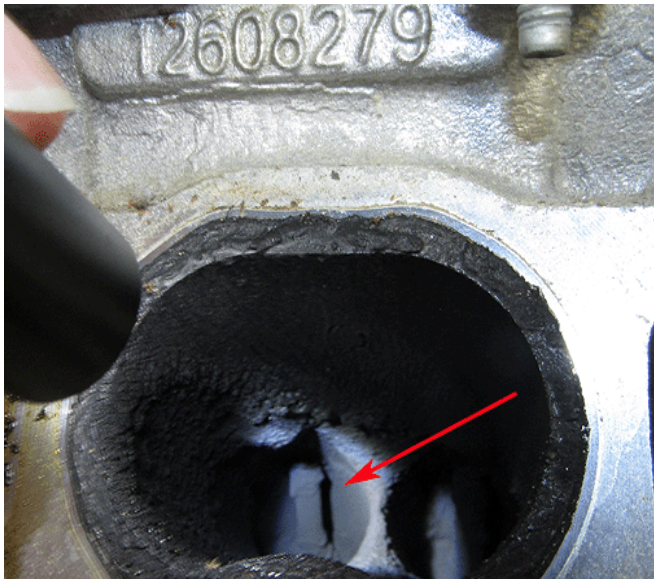
3409680

- Valves stems may have deposits build up on them. These deposits are characteristic of a direct inject engine. The valves stems do not need to be cleaned as they are not affecting engine performance (Refer to picture above).
